Exhibit Management & Image Acquisition Report

Case No: 2010888

Exhibit No: 2010888-E01

10 August 2010

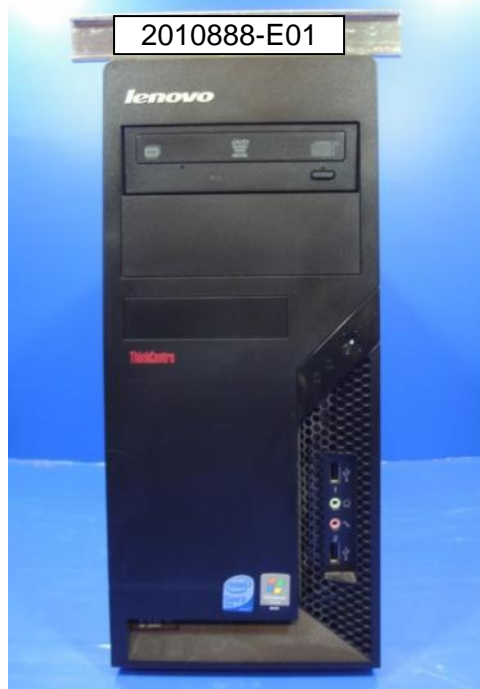
Front view of 2010888-E01

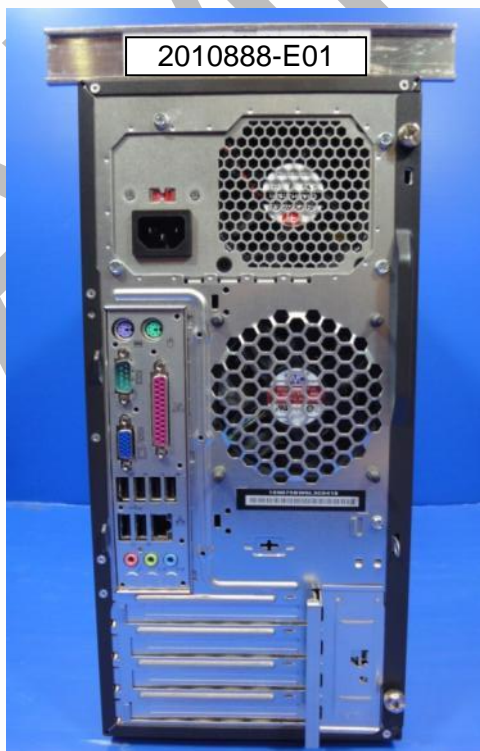
- 3.4.1 One power switch;
- 3.4.2 One power input;
- 3.4.3 One CD/DVD drive;
- 3.4.4 One serial port;
- 3.4.5 One parallel port;
- 3.4.6 One video port;

- 3.4.7 One LAN port;
- 3.4.8 One mouse port;
- 3.4.9 One keyboard port;
- 3.4.10 Eight USB ports; and
- 3.4.11 Five audio ports.

Back view of 2010888-E01

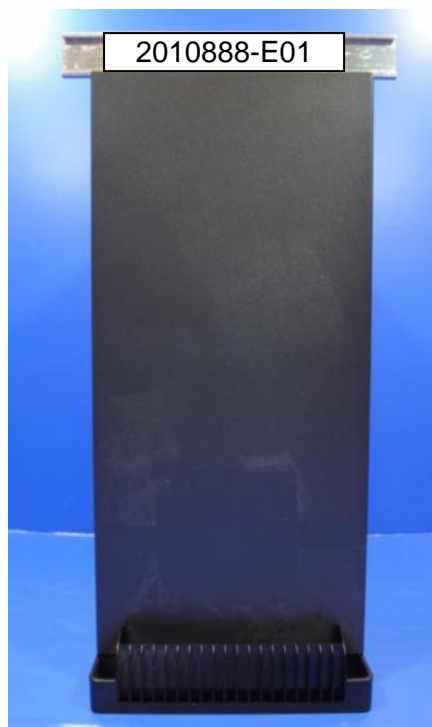
Top view of 2010888-E01

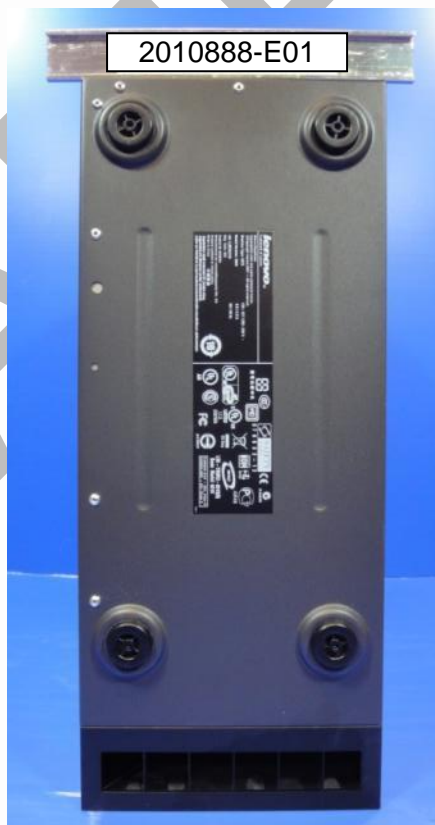
Bottom view of 2010888-E01

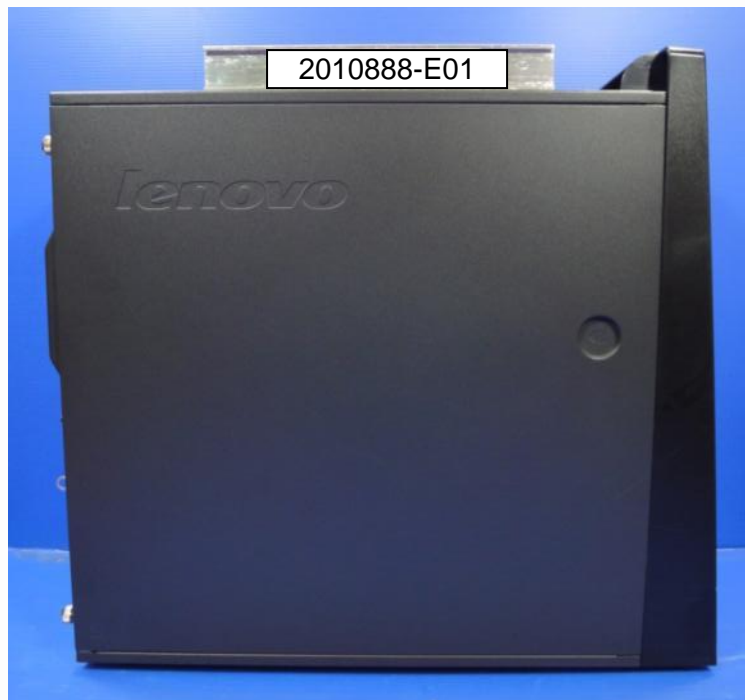
Left view of 2010888-E01

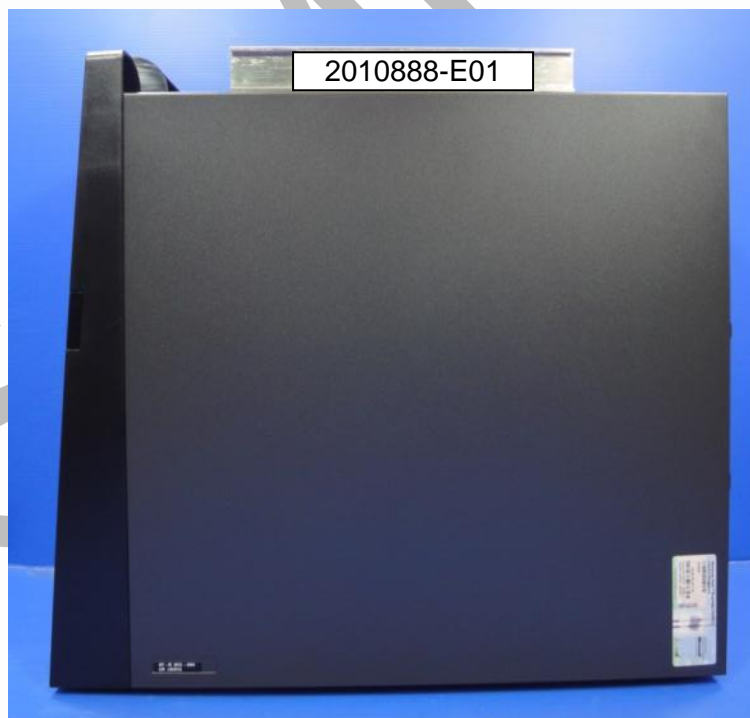
Right view of 2010888-E01

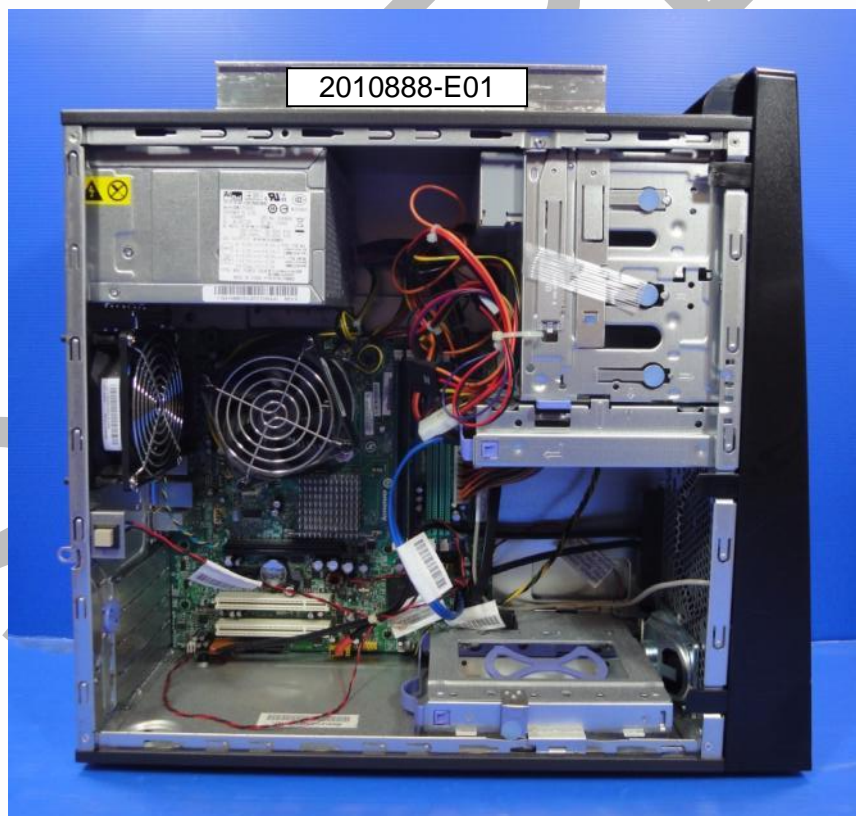
General view of internal chassis of 2010888-E01 with left casing opened

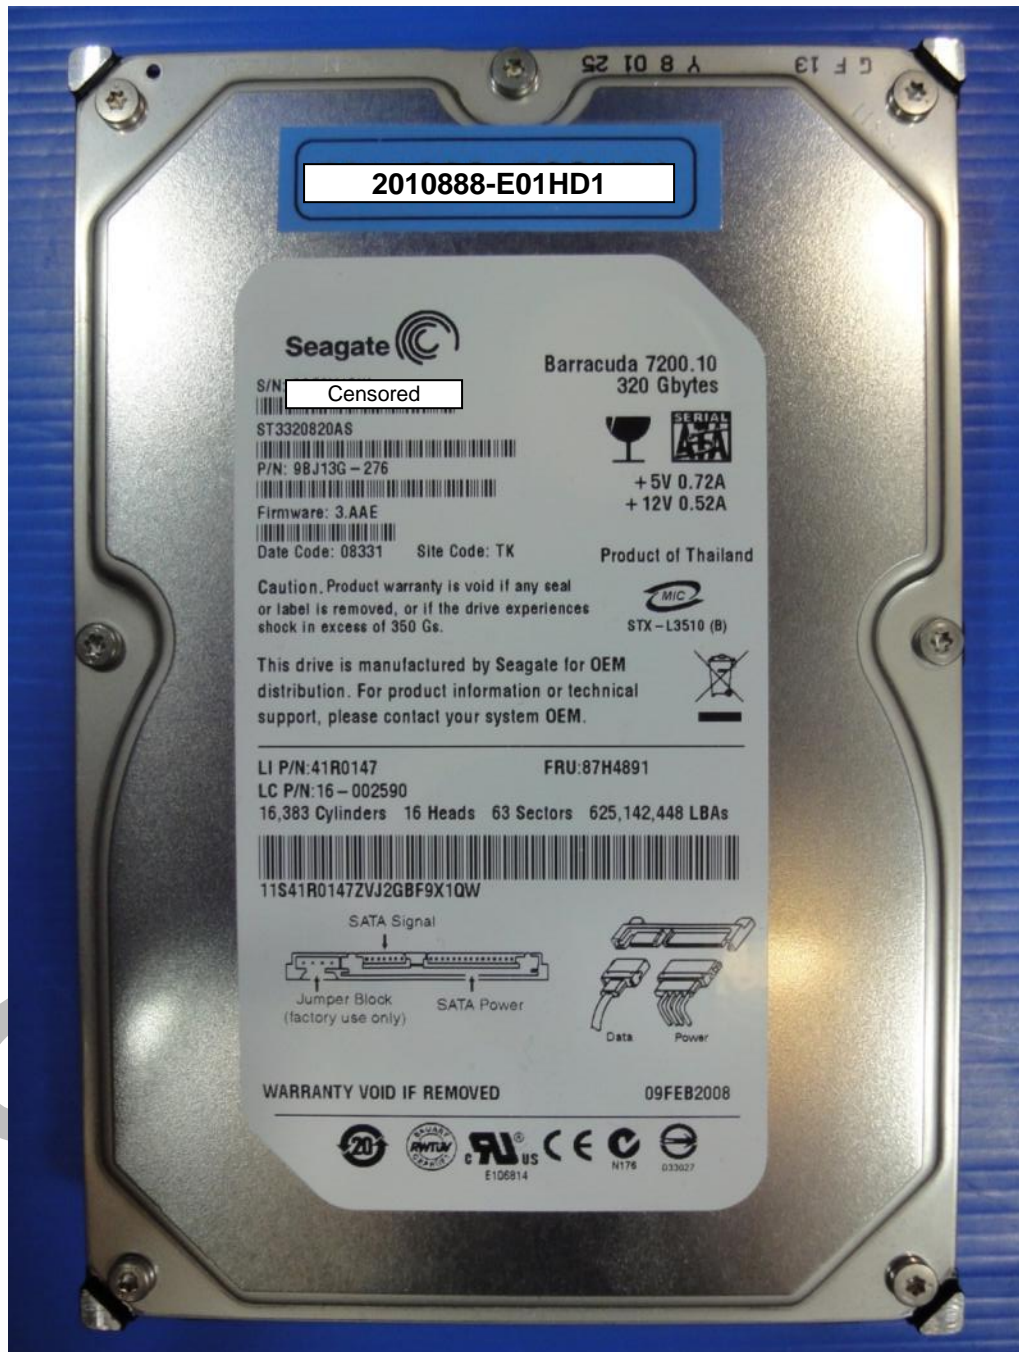
4.2.1 Brand/Model : Seagate Barracuda 7200.10;
4.2.2 Model Number : ST3320820AS;
4.2.3 Capacity : 320.0GB
4.2.4 Type : 3.5 inch SATA hard disk drive;
4.2.5 S/N : XXXXXXXX;
4.2.6 P/N : 9BJ13G-276; and
4.2.7 Date Code : 08331.

Front view of 2010888-E01HD1

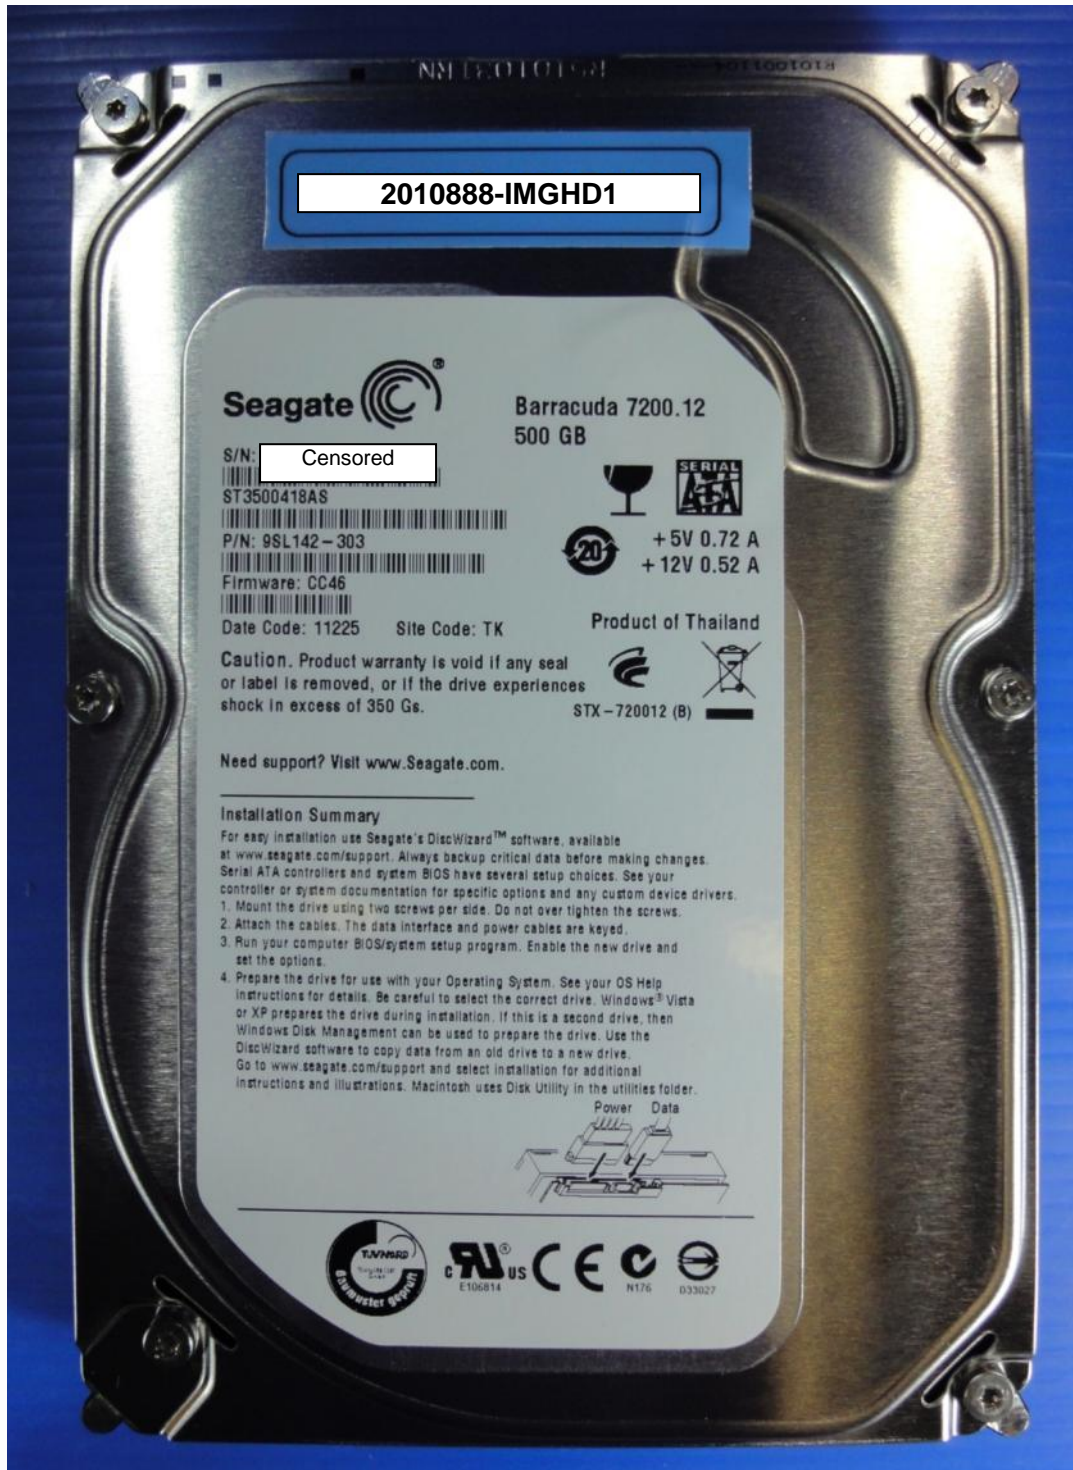
4.6.1 Brand/Model : Seagate Barracuda 7200.12;
4.6.2 Model Number : ST3500418AS;
4.6.3 Capacity : 500.0 GB;
4.6.4 Type : 3.5 inch SATA hard disk drive;
4.6.5 S/N : XXXXXXXX;
4.6.6 P/N : 9SL142-303; and
4.6.7 Date Code : 11225.

Front view of 2010888-IMGHD1

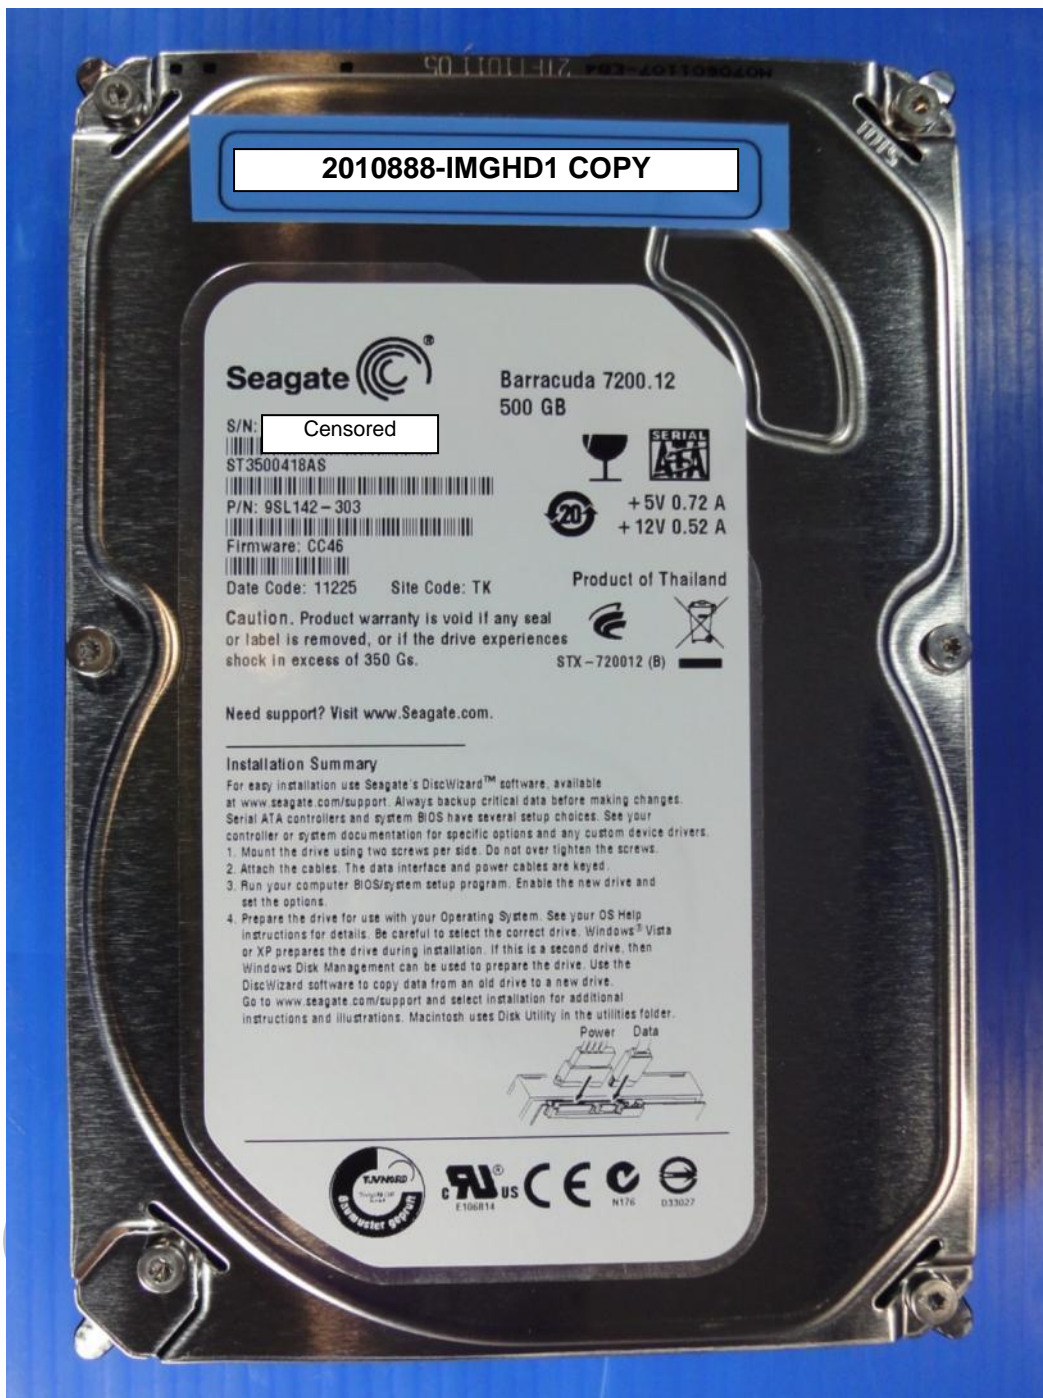
4.7.1 Brand/Model : Seagate Barracuda 7200.12;
4.7.2 Model Number : ST3500418AS;
4.7.3 Capacity : 500.0 GB;
4.7.4 Type : 3.5 inch SATA hard disk drive;
4.7.5 S/N : XXXXXXXX;
4.7.6 P/N : 9SL142-303; and
4.7.7 Date Code : 11225.

Front view of 2010888-IMGHD1 COPY
