## Investigation Report 2010 – R005

Irregular operation of Automatic Half Barriers at Ferns Lock,  
County Kildare, on the Dublin to Sligo Line,  
2<sup>nd</sup> September 2009

<b>Title</b>	Irregular operation of Automatic Half Barriers at Ferns Lock, County Kildare, on the Dublin to Sligo Line on the 2 <sup>nd</sup> September 2009
<b>Document type</b>	Investigation Report
<b>Document number</b>	2010-R005
<b>Document issue date</b>	24 <sup>th</sup> August 2009

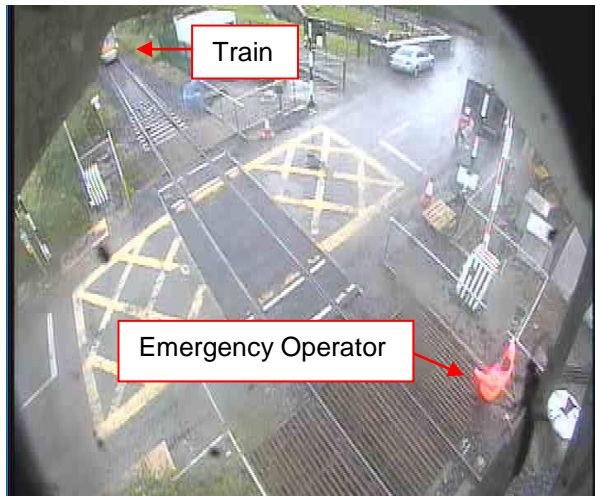
Photograph 1 – EO signalling to A907 train

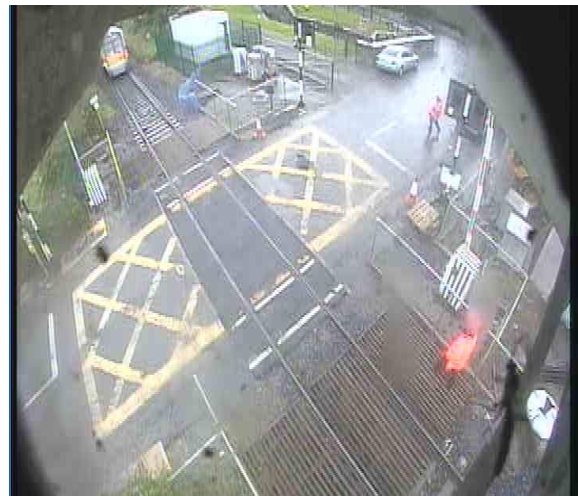
Photograph 2 – A907 approaching crossing

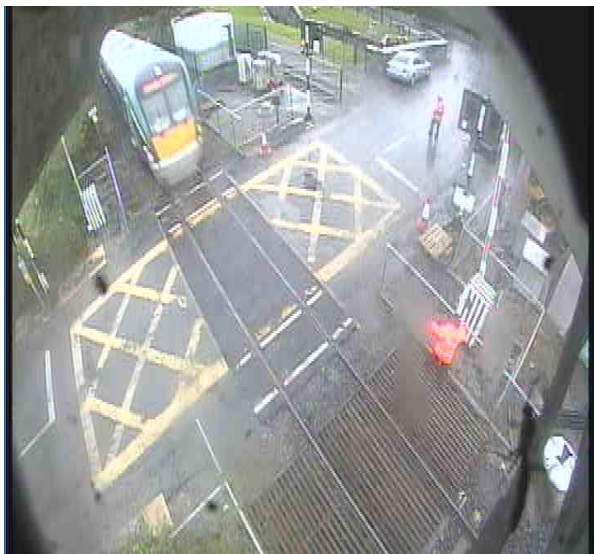
Photograph 3 – A907 entering crossing

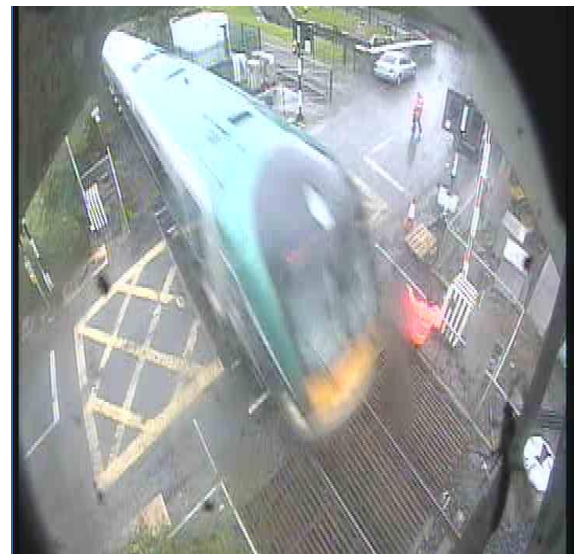
Photograph 4 – A907 on crossing

- 13.33 hrs The train passed through XG019 at approximately 65 kph while the barriers were in the raised position.
- 13.34.02 hrs The EO phoned the Sligo & Northern Line Signalling console and asked Signalman B why and who had let the train through the crossing from Enfield as the barriers were not lowered. Signalman B advised the EO that he had signalled the train from Enfield because he was advised by Signalman A that the EO was switching XG019 into local control to lower the barriers.

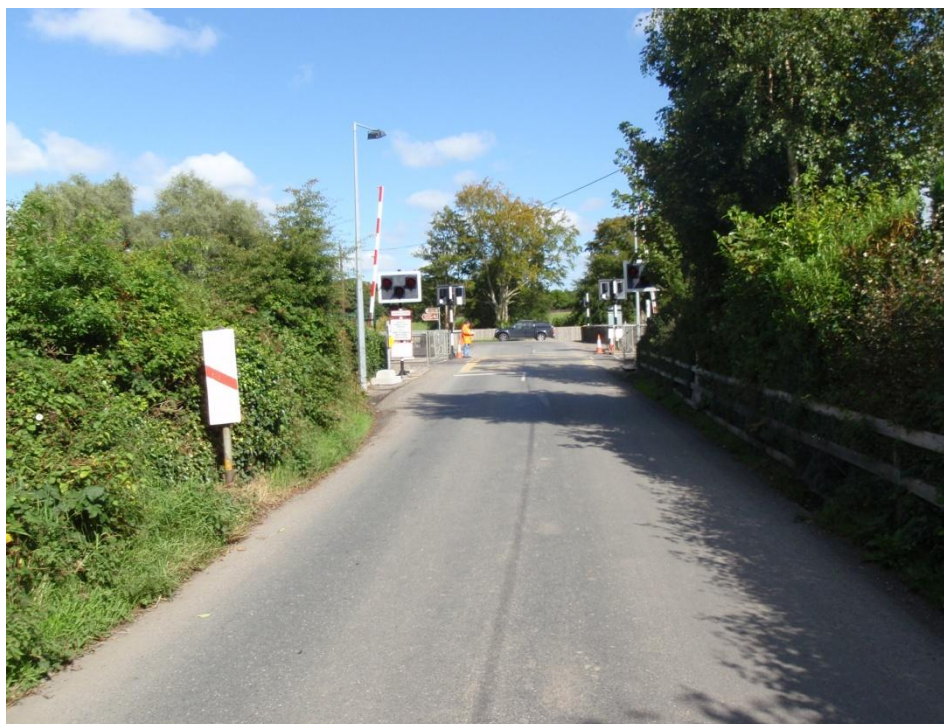
Photograph 5 – Approach to Ferns Lock AHB

At an AHB access for road users is prevented by means of two half-barriers that block the flow of road traffic approaching the crossing. The crossing is protected by a combination of road traffic light signals, audible warning devices and the physical half-barriers with road markings and signage on approach, see Photograph 5.
