# **CanSat 2023**

# **Post Flight Review (PFR)**

**Team 1032**

**Yes we CANSAT**

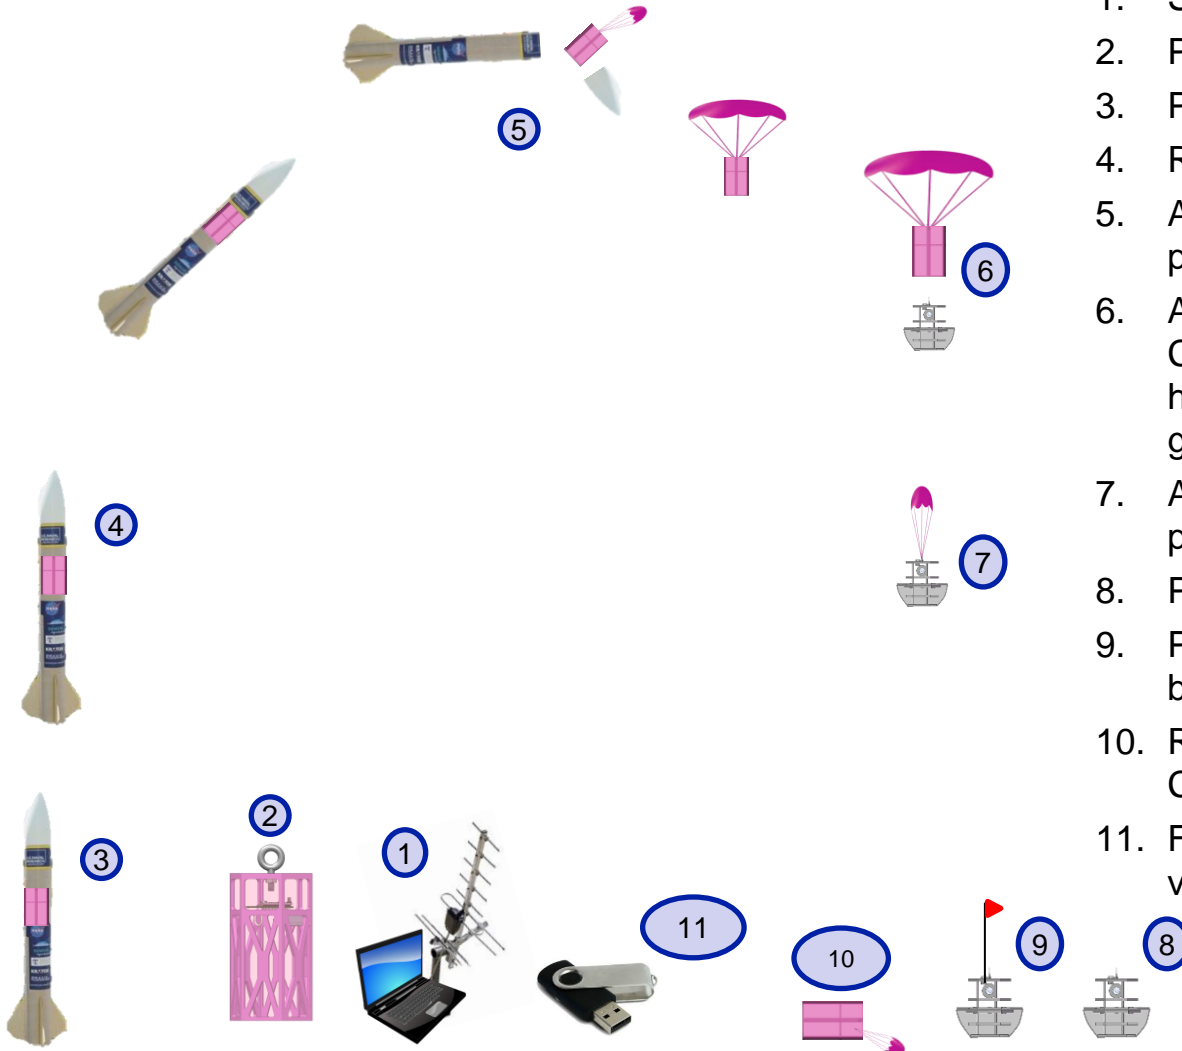
1. Set up ground station
2. Power on CanSat
3. Place CanSat into rocket
4. Rocket is launched
5. At 670-725m the CanSat separates and parachute opens
6. At 500m a probe will be released from the CanSat, which will deploy an aerobraking heat shield, with a camera facing the ground at all times
7. At 200m the probe will deploy a parachute too reduce descent rate
8. Probe will land upright
9. Probe will deploy a flag 500mm above the base of the probe
10. Recovery crew tracks and collects CanSat
11. FSW obtains and saves flight data & video recording to thumb drive

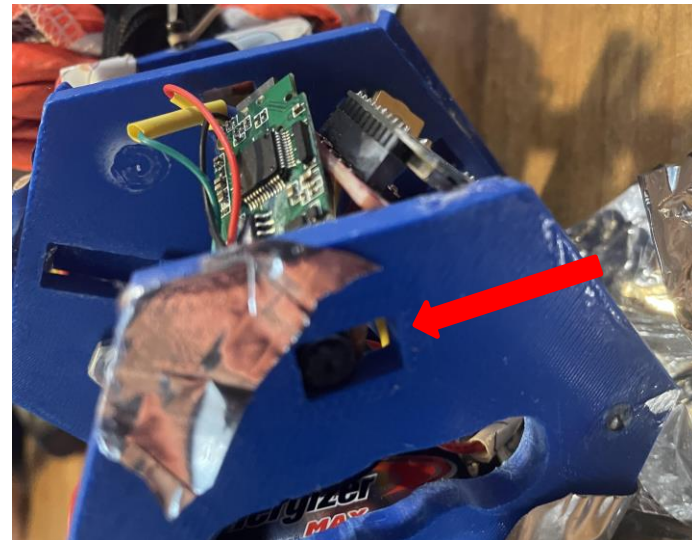
- **Camera failure:**

- Failure: The payload camera was properly activated and deactivated as intended, however, the AVI (video) files it saved to the microSD card became corrupted.
- Root Cause: Unknown, potentially excess heat in soldering, or the force from impact.
- Corrective Actions: Begin component selection earlier to ensure reliability.

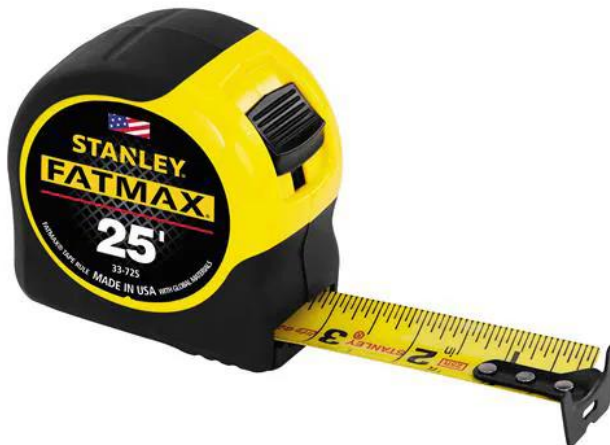
- **Flag Mechanism failure:**

- Failure: The flag mechanism was so heavy that it had to be removed from the payload to ensure it was within required weight.
- Root Cause: The use of a clock spring and a tape measure made it significantly heavy.
- Corrective Actions: Design a lighter mechanism.
