T. Swift¹

Development of the Fail-safe Design Features of the DC-10

REFERENCE: Swift, T., "Development of the Fail-safe Design Features of the DC-10," *Damage Tolerance in Aircraft Structures, ASTM STP 486*, American Society for Testing and Materials, 1971, pp. 164-214.

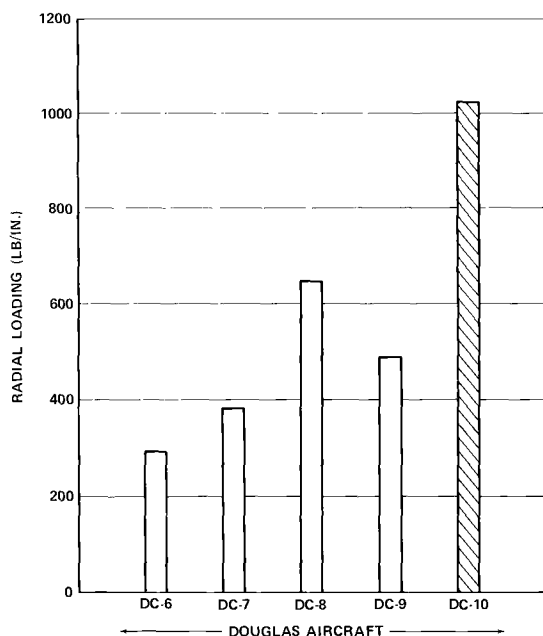
FIG. 1—Fuselage shell radial loading due to nominal cabin pressure.

Cabin pressurization is the main source of loading causing longitudinal skin cracks. Figure 1 shows that radial loading due to internal pressure on the DC-10 is $3\frac{1}{2}$ times as great as that for the DC-6, which was the first pressurized aircraft designed at Douglas. Testing on basic pressurized fuselage shell structure has indicated that longitudinal skin cracks are more likely to start in two critical locations, as follows:

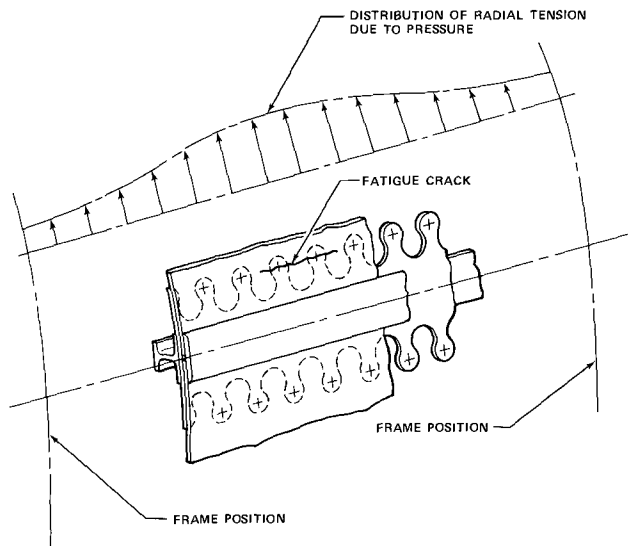
FIG. 2—Horizontal splice, fatigue crack location.

1. Along the line of attachments which attach the outer fingers of a longitudinal splice member to the skin, as shown in Fig. 2: The radial tension stress due to pressure varies across a longitudinal skin bay and reaches a

maximum value midway between frames. Transfer of load from the skin into the finger doubler causes a high attachment bearing stress which, when combined with the radial tension stress, may cause a fatigue crack in a longitudinal direction. A large number of configurations for the longitudinal splice shown in Fig. 2 were fatigue tested. The configurations were changed until all failures occurred as shown in Fig. 2, where they can be detected by visual inspection methods. Fatigue cracks hidden by splice plates could propagate a considerable distance before detection.

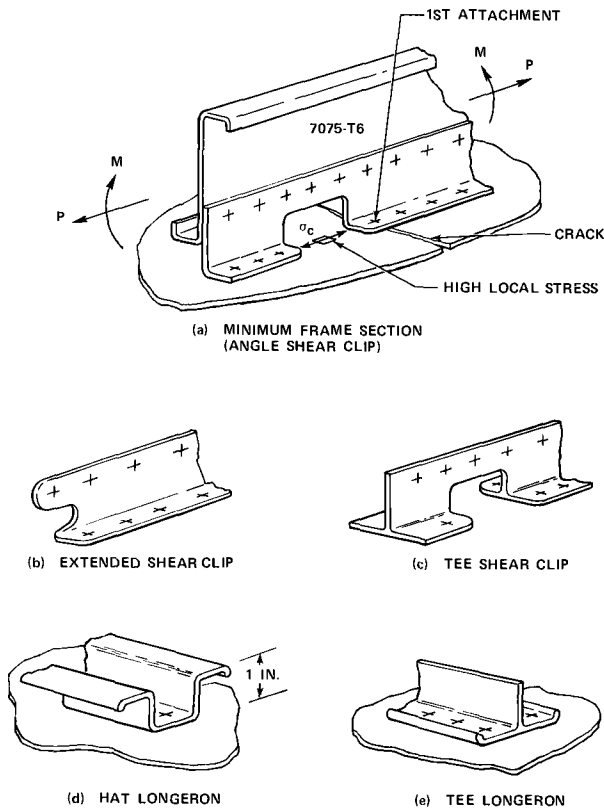
FIG. 3—Frame and longeron configurations.

2. At the first attachment of a frame shear clip to skin joint, as indicated in Fig. 3: The stress σ_c in the region of the shear clip cutout is higher than the midbay stress due to the discontinuity of the clip. In addition, the skin may be carrying tension stress due to frame bending. The high local stress, combined with the bearing stress in the first attachment hole as the shear clip picks up load, can cause a fatigue crack in the skin. The skin crack shown in Fig. 3a is just as likely to propagate into both adjacent bays as into one bay.

Hat-section longerons such as those illustrated in Fig. 3d have been used on all previous Douglas aircraft. However, analysis indicated that for the damage tolerance selected for circumferential cracks, T-section longerons riveted to the skin with two rows of rivets would give higher allowable stresses. The hat-section longerons were desirable from a cost standpoint because of the cost of the extra row of rivets required in the T-section longerons. Both T- and hat-section longerons were therefore chosen as candidates. Analysis and test programs were introduced to study the configurations.

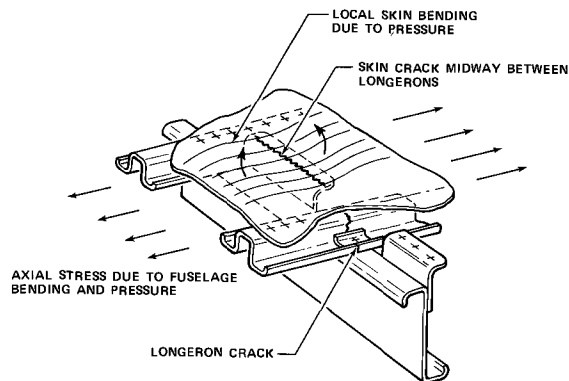
FIG. 4—Crack locations, fuselage shell.

1. At the attachment of the skin to frame shear clip midway between longerons, as shown in Fig. 4: Local bending of the skin due to pressure, combined with axial stress due to fuselage bending, can cause skin cracks in a circumferential direction.

2. In the longeron flanges where they attach to the frame, as shown in Fig. 4: Bending due to transfer of some of the pressure loading into the frame increases the axial tension stress in the longeron flanges locally, causing fatigue cracks. After failure of the longerons, the skin stress increases locally (see Fig. 12) causing fatigue cracks in the skin which propagate into the two adjacent skin bays.

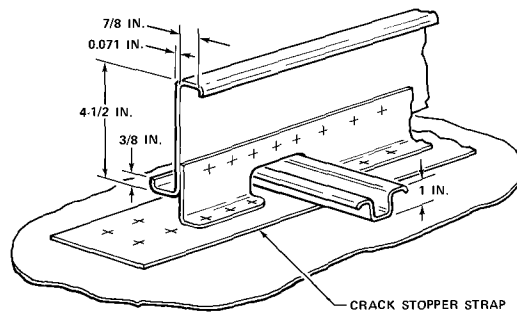
FIG. 5—Frame crack stopper configuration.

When crack stopper straps are required, it has been Douglas policy to install them at a frame location, as illustrated by Fig. 5, for several good reasons. Without crack stopper straps, the skin stress level in the vicinity of the frames between shear clips (Fig. 3) has been determined both from flat panel and curved panel pressure tests to be up to 18 percent higher than the midbay hoop stress. With crack stopper straps to provide continuity across the gap, the stress level in this critical area is reduced to 15 percent below the midbay stress, thus reducing the possibility of a fatigue crack starting. In addition, the crack stopper strap can be used as bending material to increase the frame stiffness and static strength. Tests have shown that after cutting a 3-in.-long slot in the skin over a titanium crack stopper strap almost 14,000 cycles are required at 15,500-psi gross stress with a stress ratio $R = 0.05$ to fail the strap. During this number of cycles, crack propagation was negligible until the crack stopper had failed. Prior to failure of the crack stopper, the increase in frame stress due to the crack was negligible, thus reducing the possibility of frame fatigue failure. With the strap at any other location, the possibility of starting a crack in the skin is increased, and, once a crack started, propagation would be much faster and the possibility of failing the frame in fatigue would be increased.

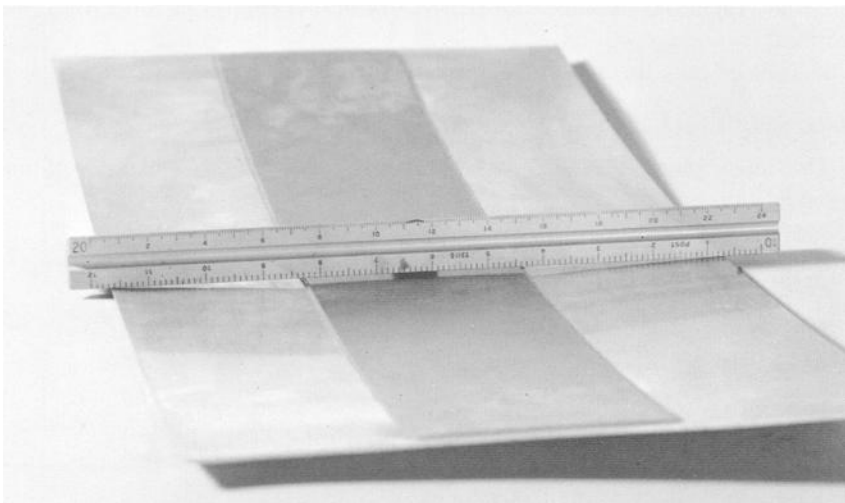
FIG. 6—Test panel distortion due to bonding process.

Another reason for abandonment of the bonding process, and possibly the most significant, is the distortion of the aluminum skin caused by thermal effects due to the difference in the coefficient of expansion of the titanium and the aluminum. A small test panel was fabricated as shown in Fig. 6 and a strap of 0.025-in.-thick titanium bonded to it and cured at a temperature of 250 F (121 C). On cooling to room temperature, the panel curved to approximately 70 in. in radius with the strap on the convex side. The panel was rolled to the correct radius with the strap on the concave side. The resulting

anticlastic curvature due to residual stresses is illustrated in Fig. 6. It was thought that this effect would be more severe on large panels, especially with longerons and frames assembled to the panels; the resulting quilted appearance of the shell would almost certainly be unacceptable to the customer.

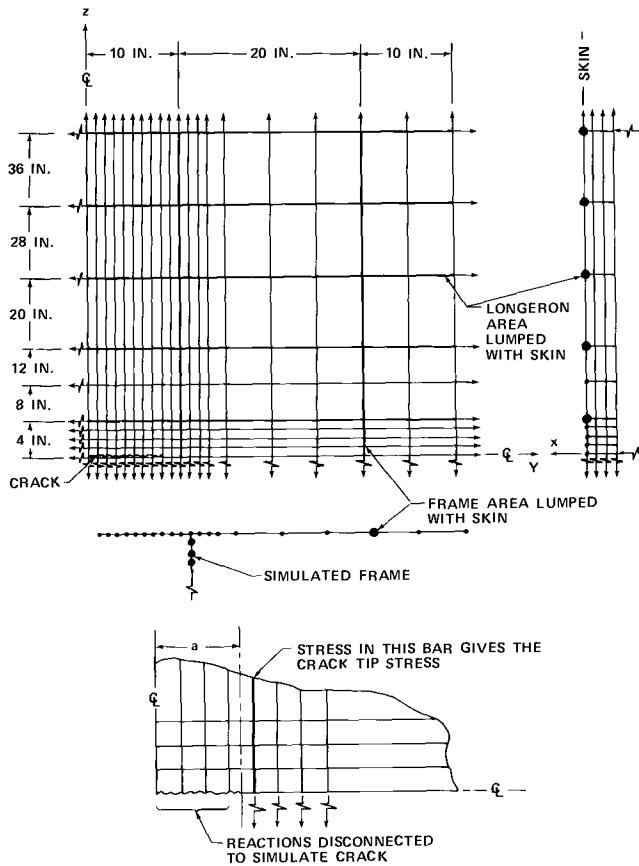
FIG. 7—Idealization for one-bay longitudinal crack.

a uniform stress level was applied to the upper boundary of the panels (shown in Figs. 7, 8, and 9) to both skin and stiffening elements. The results of the analysis cases considered are listed in Tables 2, 3, and 4. The frame cross sections for cases 1 to 12 and the hat sections for cases 13 to 18 are similar to those shown in Fig. 5. The stress ratio terms are defined below.

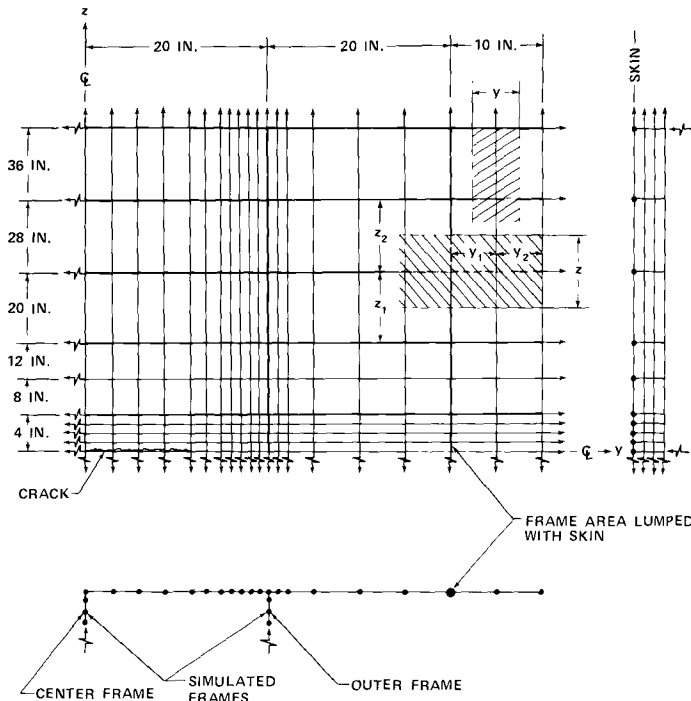
FIG. 8—Idealization for two-bay longitudinal crack.

The effects of stiffeners on the fracture strength of stiffened panels can be determined by a lumped parameter analysis of a structure representing the panel. The analysis is based on the matrix force method of structural analysis [8, 9] and uses the Fortran matrix abstraction technique (FORMAT) [10] to solve the matrix operations. Figures 7 and 8 show the idealized structure representing the stiffened panels for one- and two-bay longitudinal cracks, respectively. Figure 9 shows the idealized model for the two-bay circumferential crack. As illustrated, the panels are divided into a series of discrete bars and shear panels, the bars carry axial load and the panels carry shear load. The panels have the same thickness as the plate, and the bar areas are determined from the dimensions shown in Fig. 8 as follows:

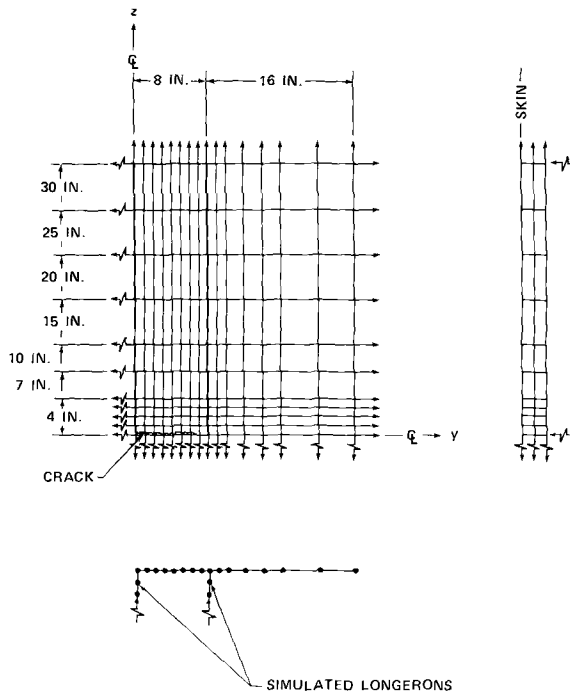
FIG. 9—Idealization for two-bay circumferential crack.

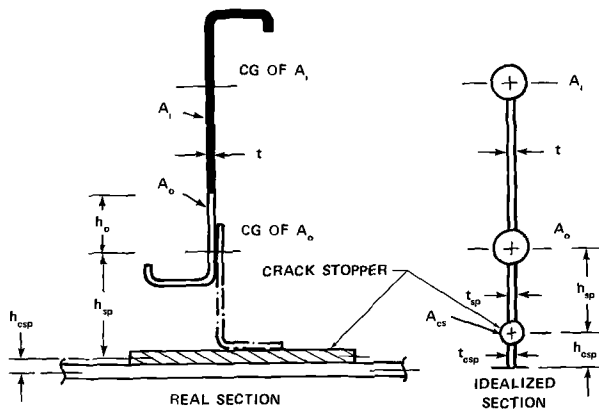
FIG. 10—Frame idealization with crack stopper.

A typical frame cross section with crack stopper strap is idealized by lumping areas as shown in Fig. 10. As the crack propagates in the skin, the frame outer cap picks up load through the shear clip-to-frame attachment row. The area of the outer cap, A_o , is therefore calculated so that its center of gravity (cg) lies on this attachment row. Frames without crack stoppers (see Fig. 3) are idealized by three lumped bars. The thickness of the idealized shear panels connecting the crack stopper and frame members to the skin is extremely important and is calculated to include the rivet stiffnesses.

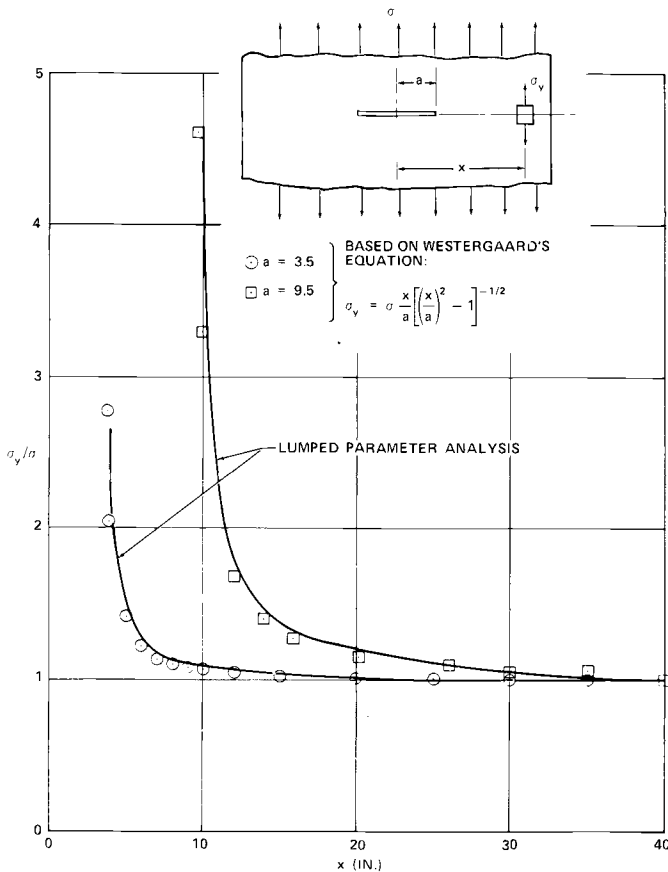
FIG. 11—Comparison of lumped parameter analysis with Westergaard's equation for infinitely wide plate.

K_c^* determined from tests on stiffened panels of one configuration can be used to determine the fracture strength of a fuselage shell of another configuration by using Eq 8, provided R_{ct} versus crack length has been determined. The use of R_{ct} , determined from analysis of a finite panel, can be justified for use in Eq 8 for an infinite plate if the panel is wide enough. A comparison of the net section stress for the panel of Fig. 7 to Westergaard's equation for the net section stress of an infinitely wide plate is shown in Fig. 11.

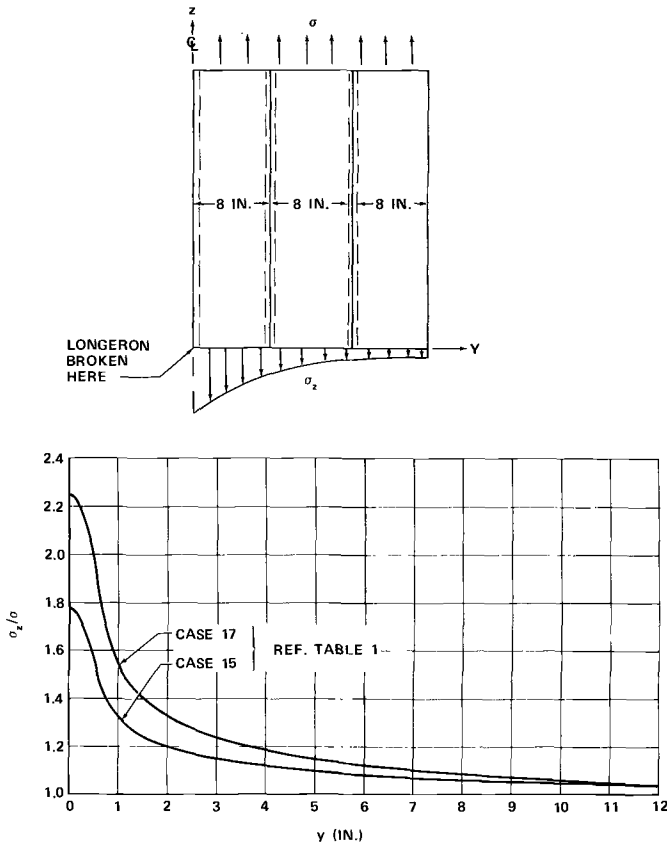
FIG. 12—Axial skin stress in the vicinity of a broken longeron.

All of the stresses shown are lumped stresses in the idealized members. The stress distributions in the sheet after a longeron is broken and prior to skin cracking are shown in Fig. 12 for conditions 15 and 17 of Table 1.

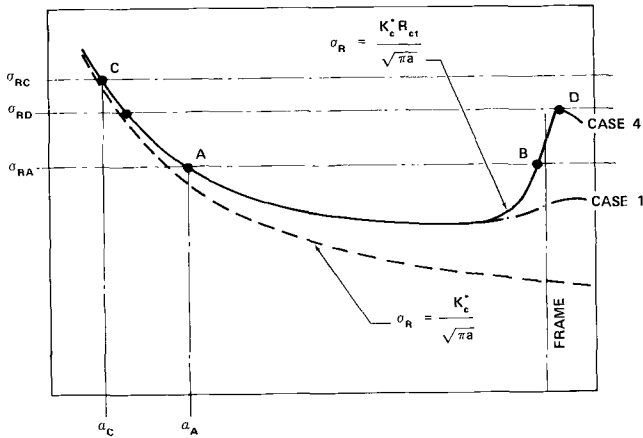
FIG. 13—Comparison of gross residual strength curves for unstiffened and stiffened panels, cases 1 and 4 of Table 1.

The significance of Eqs 7 and 8 is illustrated in Fig. 13 and represents the residual strength of a panel, based on skin criteria. The lower curve (dotted) represents an unstiffened panel and the upper two curves are for stiffened panels with longitudinal cracks plotted for cases 1 and 4 of Table 1. The change in slope of the curves for stiffened panels as the crack tip approaches the stiffener spacing is due to a reduction in crack tip stress as the stiffener picks up load. The maximum reduction in crack tip stress occurs in the region of the stiffeners, as can be seen by the increase in R_{ct} values listed in Table 2.

If the panel contains a fatigue crack of half length a_A , and a gross stress of σ_{RA} is applied, then fast fracture will occur at A and the crack will be arrested at B . If, on the other hand, a gross stress of σ_{RC} is applied with half crack length equal to a_C , then fast fracture will occur at C and the crack will not be arrested. The residual strength of the panel is represented as σ_{RD} and any fracture at stress level higher than σ_{RD} will not be arrested and would represent an explosive failure in a pressurized shell. The value of the crack stoppers for case 4 can be seen by their influence on the residual strength when compared to case 1 for the panel without crack stoppers. The frame, connected to the skin by a flexible shear clip, is not as effective in picking up load as a crack stopper strap connected directly to the skin with three rows of rivets.

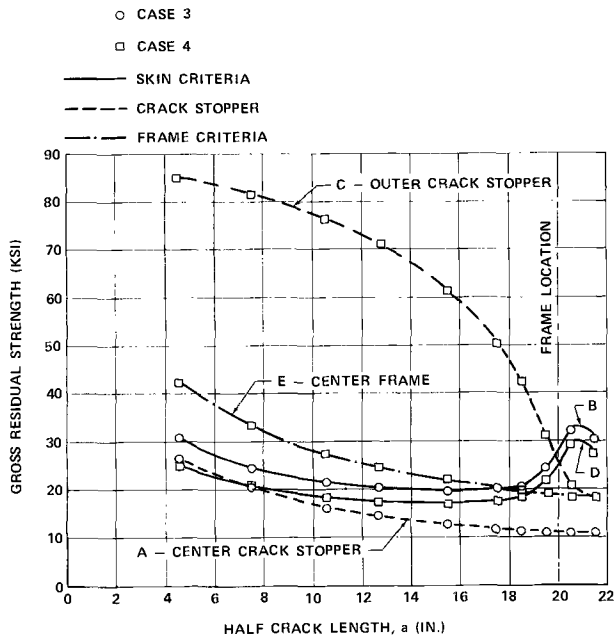
FIG. 14—Gross residual strength for a typical flat panel with two-bay longitudinal crack.

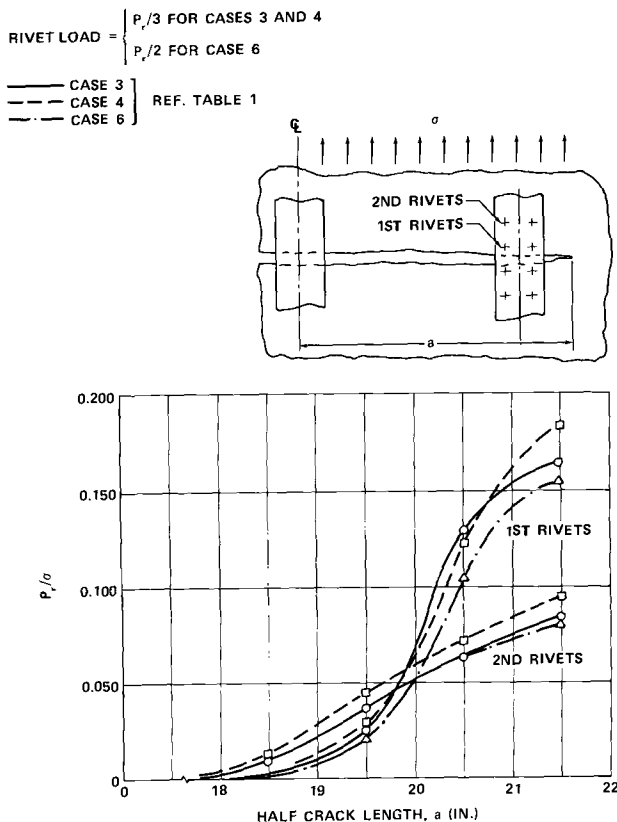
FIG. 15—Rivet shear load, outer crack stopper to skin rivets.

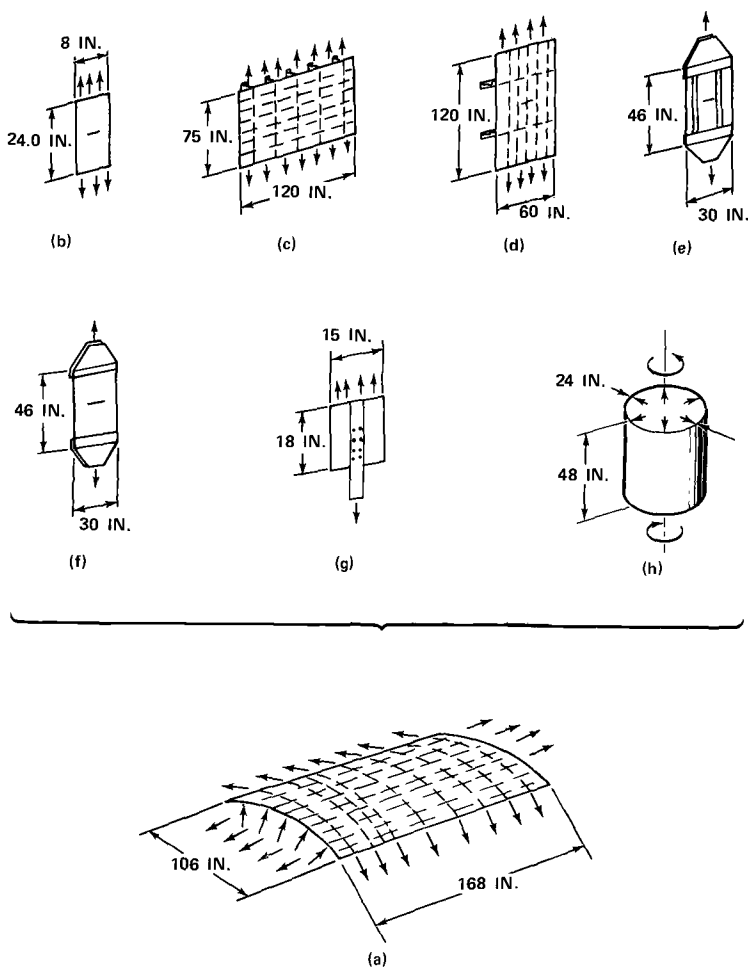
FIG. 16—Fuselage fatigue and fail-safe development tests.

Figure 16a shows a large curved panel of 118.5-in. radius which is stiffened by eight frames and eleven longerons. Axial loading is applied by a series of whiffletrees attached to the ends of the panel. Pressure loading is applied to the underside of the panel by lowering a vacuum chamber onto the panel and evacuating the chamber. Both axial load and pressure loading can be cycled or applied statically. Transverse and longitudinal saw cuts can be made in the

Figure 16*c* shows flat panels stiffened by longerons and frames. Fourteen tests were performed on six panels of this type. Frames on each of the panels were 7075-T6 with cross sections as shown in Fig. 3. Longerons were all 7075-T6 extruded hat section with a gross area of 0.312 in.². A description of the panel is given in Table 5. Three-inch-wide titanium crack stoppers 0.025 in. thick were incorporated into panels 5 and 6 with three rows of rivets. Cracks were propagated under uniaxial cyclic loading from saw cuts in the skin to simulate one-and two-bay longitudinal cracks. Static loading was applied at predetermined crack lengths to fast fracture the skin. Cracks were normal to the frames and crack stoppers provided the crack barriers.

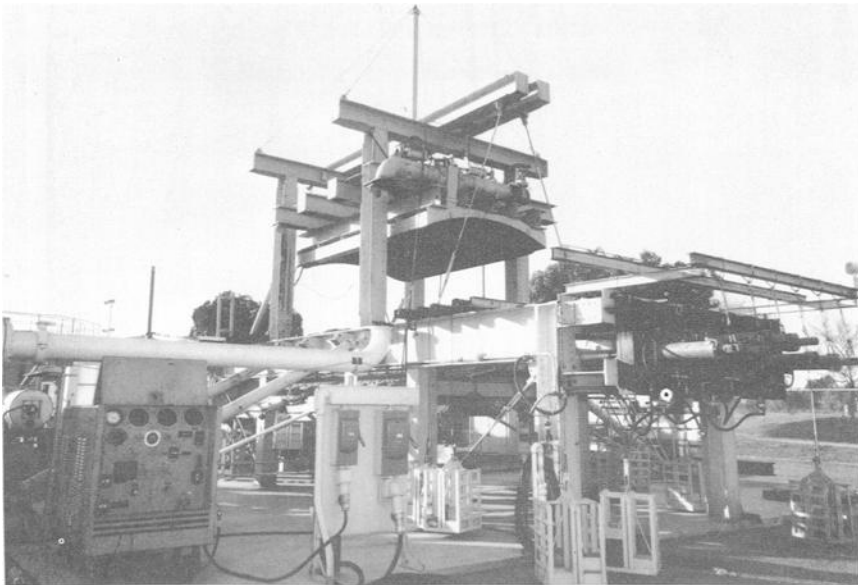
FIG. 17—Vacuum test rig for testing curved panels under combined pressure and axial loading.

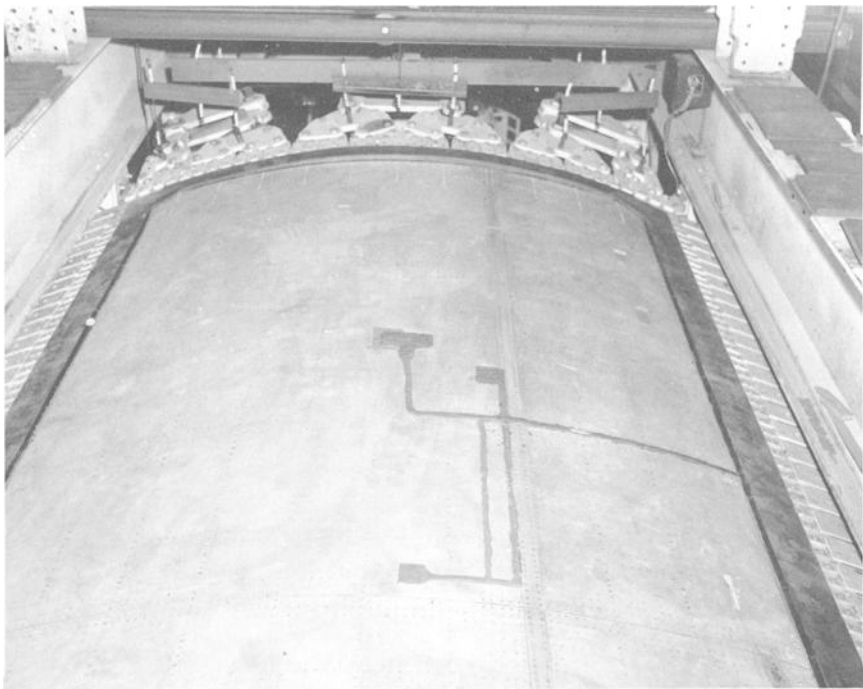
FIG. 18—Upper side of curved test panel 16.

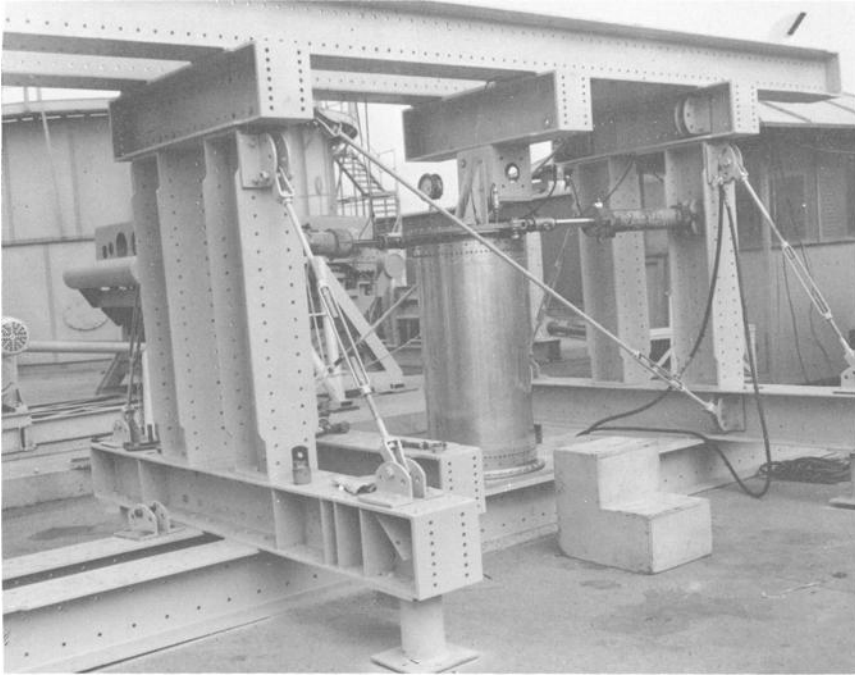
FIG. 19—Test fixture for 24-in.-diameter cylinders.

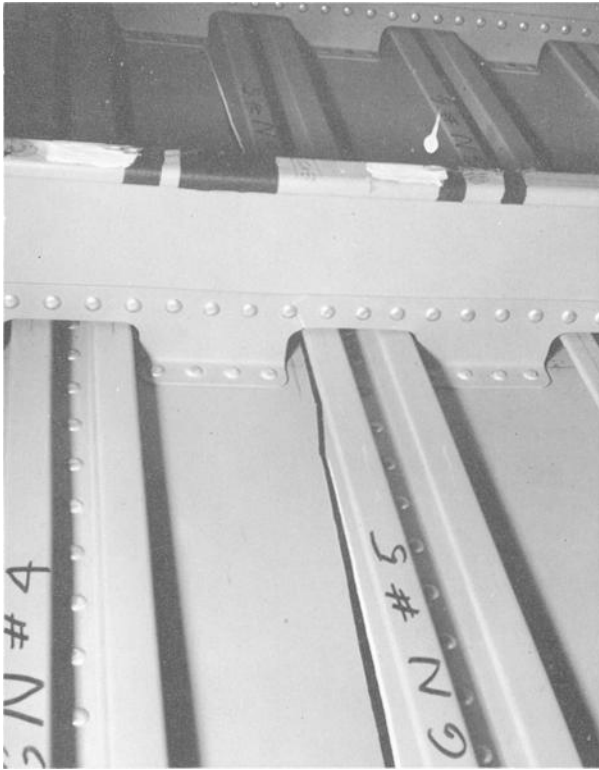
FIG. 20—Arrest of two-bay longitudinal crack after fast fracture, test 2, panel 3.

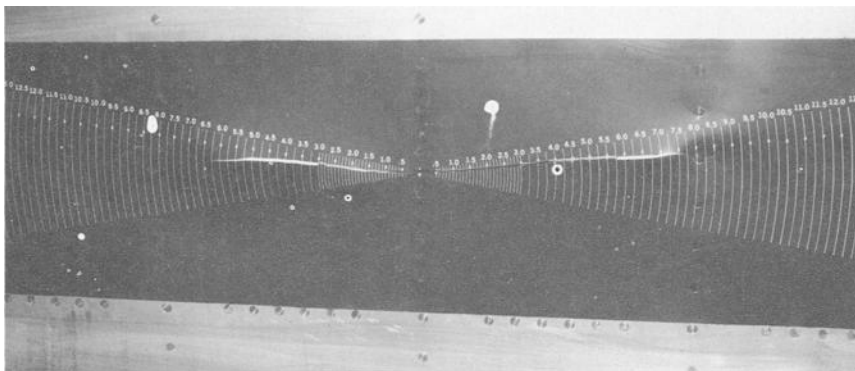
FIG. 21—Arrest of crack after fast fracture at gross stress of 39,931 psi, panel 11, test 2.

two cut longerons. The results of these tests are shown in Table 10. Figure 21 shows the crack arrestment during test 2 of panel 11; Fig. 22 shows the panel after final failure from a three-bay crack with two cut longerons.

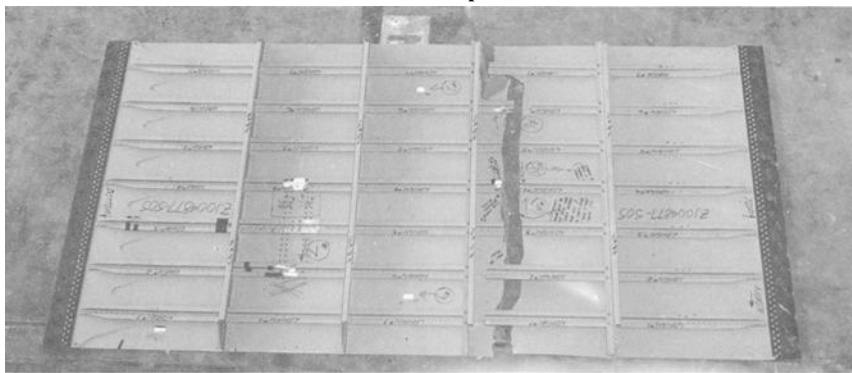
FIG. 22—Failure of panel 11 at gross stress of 27,920 psi from three-bay crack with two cut longerons.

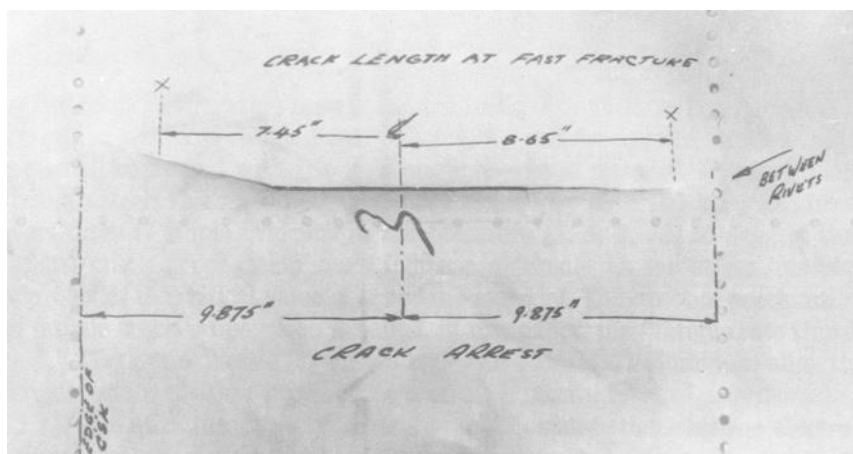
FIG. 23—View of panel 15 showing arrest of one-bay crack.

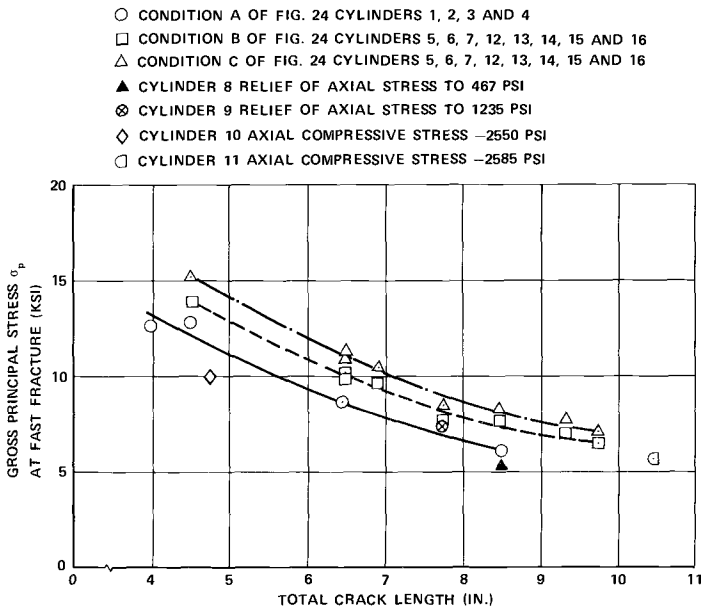
FIG. 25—Test results for 24-in.-diameter cylinder.

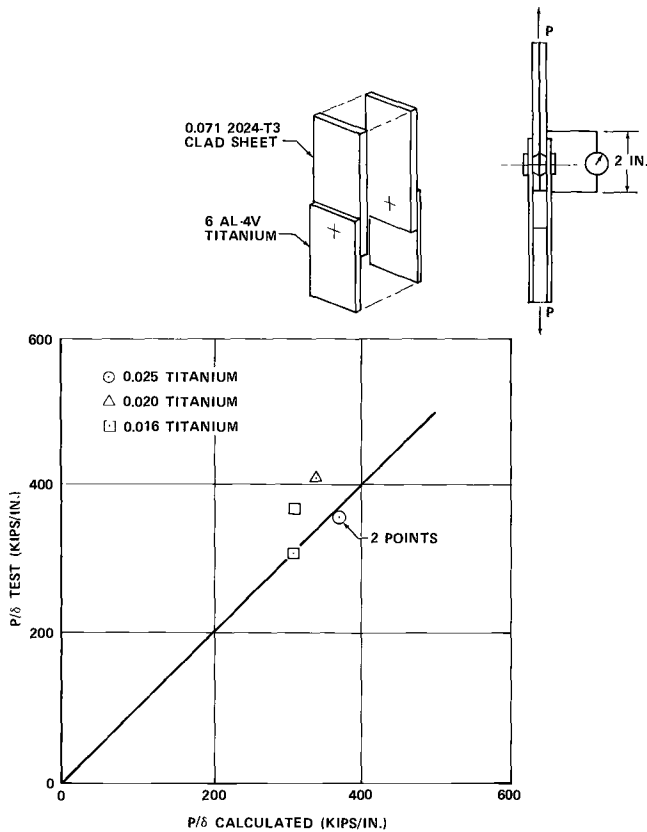
FIG. 26—Rivet shear deflection test result correlation.

These equations have been substantiated by test (see Fig. 26). The thickness of the idealized shear panels connecting the crack stopper to the skin is calculated as follows:

In order to verify the rivet deflection (Eqs 3 and 5) for titanium and aluminum, several small tests were performed on lap splice specimens. Each specimen consisted of a strip of 6Al-4V single annealed titanium which was riveted to a strip of 0.071-in. 2024-T3 clad sheet using RV-5197-6 countersunk rivets. The specimens were placed back to back as shown in Fig. 26 to eliminate local bending. Three thicknesses of titanium were used, 0.016, 0.020, and 0.025 in. The extension, under tensile loading, was measured over a 2-in. gage length using an extensometer. Extension of the sheet was calculated and subtracted from the overall deflection so that actual rivet deflection would be obtained. The stiffness P/δ , where P is the applied load and δ is shear deflection of the rivet (obtained from the elastic portion of the resulting load deflection curve), is compared in Fig. 26 to the value calculated from Eqs 3 and 5.

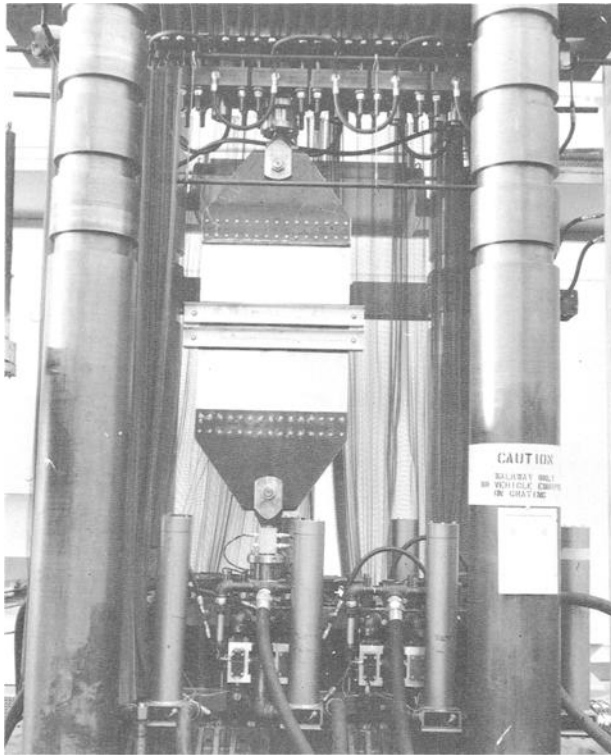
FIG. 27—Test setup for 30-in.-wide panels.

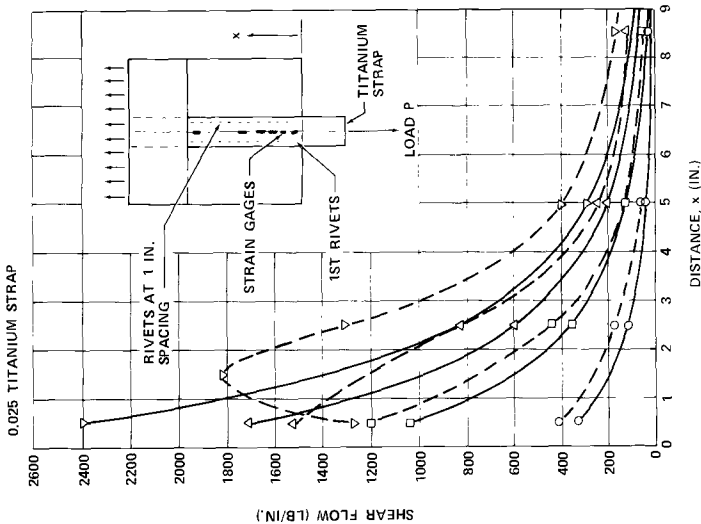
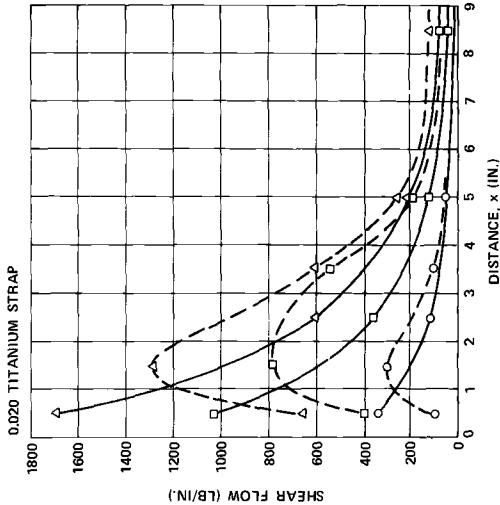
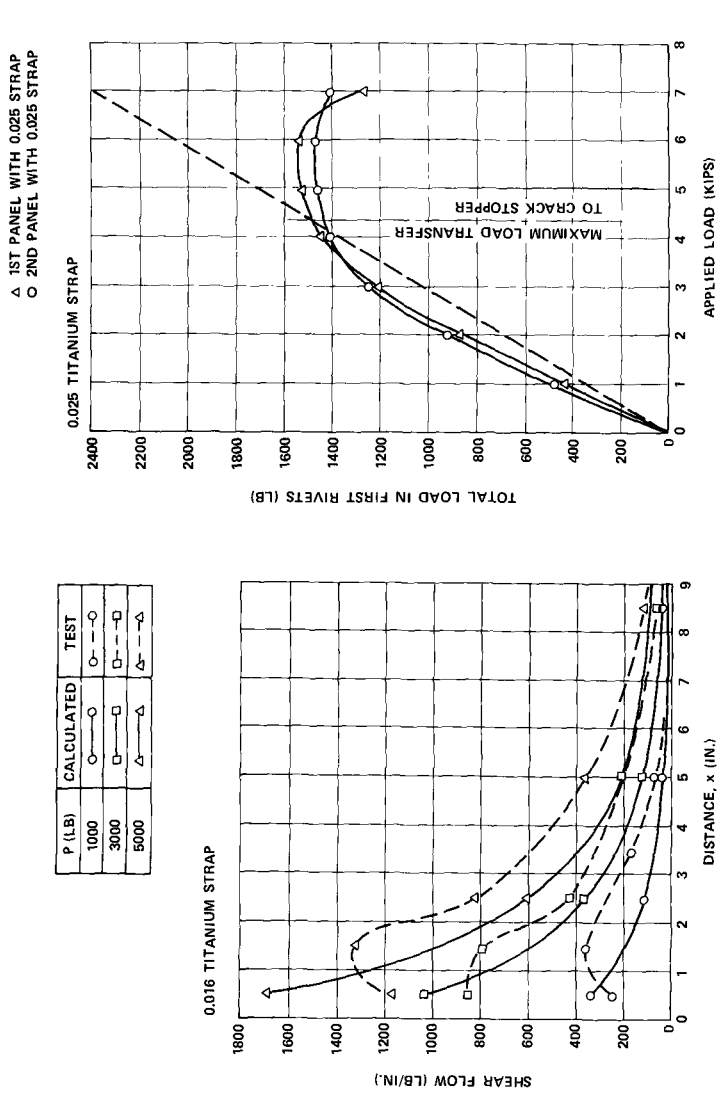
FIG. 28—Rivet shear load—analysis, test correlation: (a) 0.025, (b) 0.020, (c) 0.016, and (d) 0.025-in. titanium strap.

Figure 28 gives the results of tests performed on the small panels shown in Fig. 16g to determine the crack stopper to skin rivet shear load. A lumped parameter analysis, to determine the rivet shear load, was performed on one of the panels with a 0.020-in. strap. This analysis is used for a comparison with the results for the three thicknesses of strap. It is not expected that the strap thickness variation, in the ranges considered, will affect the calculated elastic load distribution to a high degree. The panel was divided into bars and shear panels similar to those shown in Fig. 7. The rivet loads were determined from strain gage readings on the strap. The ordinate of Figs. 28a to 28c is shown as shear flow in pounds per inch and, since the rivets are spaced 1 in. apart, this load would, therefore, be rivet load. The shear flow shown is applied to two rivets. Figure 28a shows a comparison between test and elastic analysis for a 0.025-in. strap. It can be seen that the first rivets yield at a load between 3000 and 5000 lb and more load is carried by the remaining rivets. Yielding

occurred early for both the 0.020 and 0.016-in. straps as shown in Figs. 28*b* and 28*c*. Figure 28*d* shows applied load versus shear load in the first rivets for tests on two panels with 0.025-in. straps. The maximum load transferred from the skin to crack stopper for DC-10 loading with a crack 42 in. long is 4370 lb. This is determined from case 6 of Table 1 with a cabin pressure of 9.2 psi and a skin stress 80 percent of PR/t hoop stress, where R is 118.5 in. It can be seen from Fig. 28*d* that little or no loss in first rivet load is experienced at this applied load. However, due to early yielding of the first rivets in the 0.020 and 0.016-in. straps shown in Figs. 28*b* and 28*c*, a loss in the crack tip stress ratio R_{ct} could be expected if 0.020 or 0.016-in.-thick straps were used.

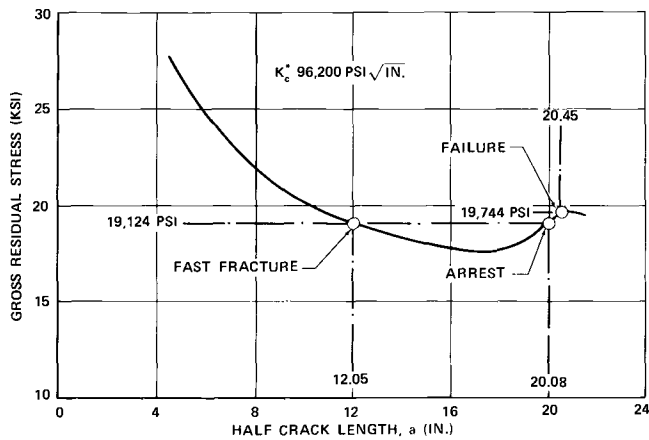
FIG. 29—Gross residual strength curve, test 2, panel 3.

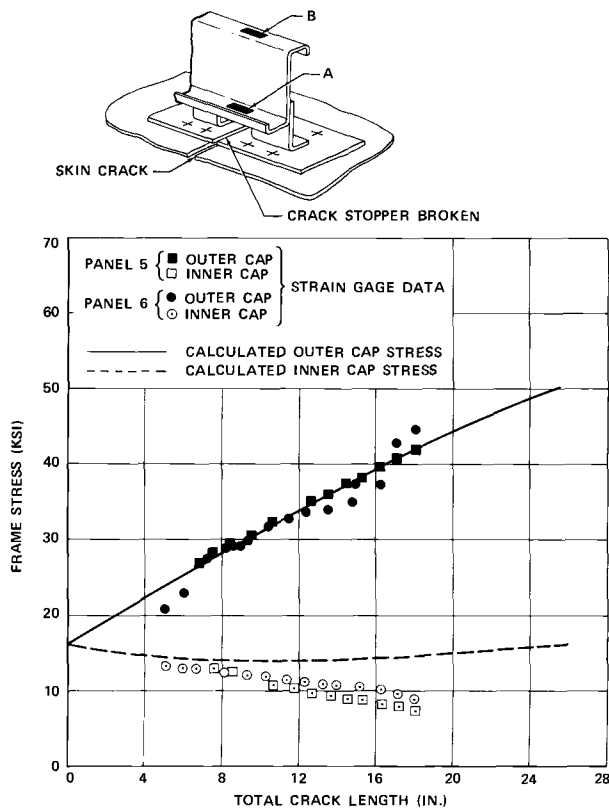
FIG. 30—Center frame stress correlation two-bay crack test, panels 5 and 6, test 2; gross stress, 16,400 psi.

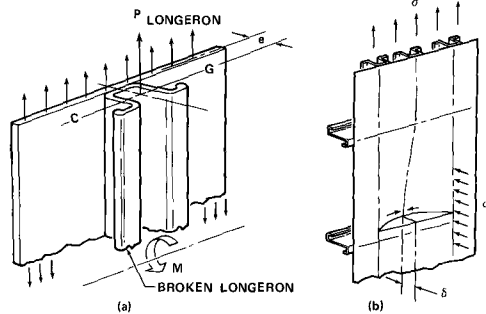
FIG. 31—Center longeron bending.

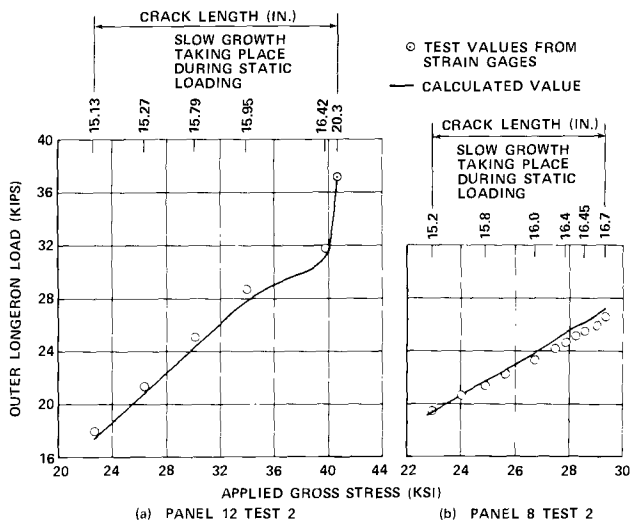
FIG. 32—Outer longeron load, flat panel with circumferential crack.

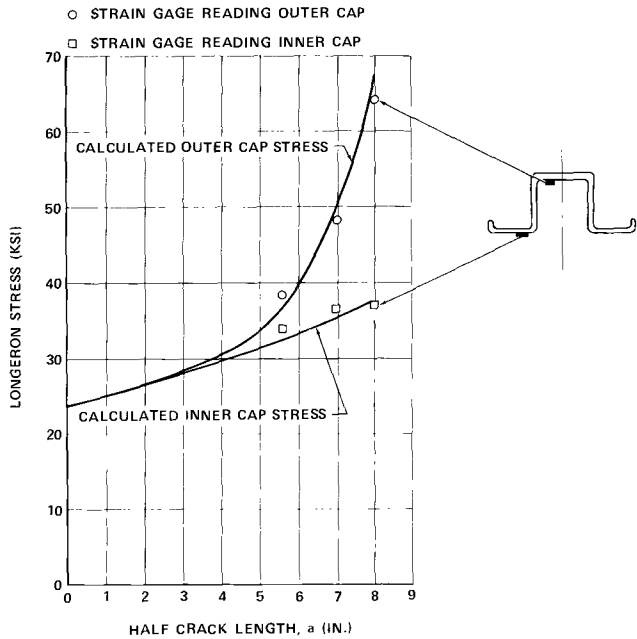
FIG. 33—Outer longeron stress correlation circumferential crack test, panel 16.
