SIMPSON BROTHERS STORE

9181 GLOVER ROAD, LANGLEY, BC

CONSERVATION PLAN

MAY 2018

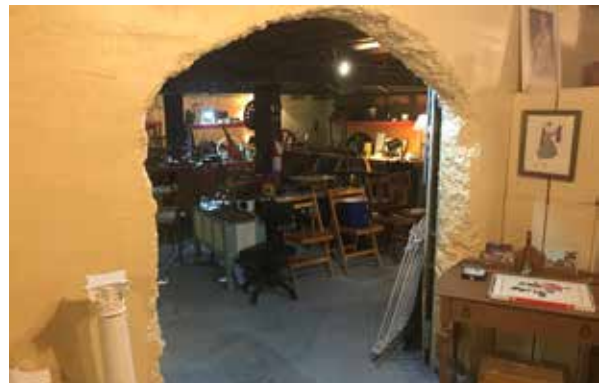
The Simpson Brothers Store sits on original concrete foundations with full below grade basement. A large opening has been cut through an existing concrete below grade wall. The concrete will be retained as part of the conservation scheme, and all exposed surfaces should be inspected to determine condition of concrete material and whether any necessary seismic reinforcing is required. Careful attention should be executed to ensure the exterior walls above grade, particularly the front façade, are not damaged during any rehabilitation work.

- Cap off and waterproof two existing coal chutes at the south elevation ground level.
- Existing foundations should be preserved, if possible.
- If new foundations are proposed, concrete is a suitable material. New material should match original in appearance, as viewed from the exterior.
- Foundations should be reviewed by a Structural Engineer. Once condition is assessed, conservation recommendations can be finalized.
- To ensure the prolonged preservation of the new foundations, all landscaping should be separated from the foundations at grade by a course of gravel or decorative stones, which help prevent splash back and assist drainage. New vegetation may assist in concealing the newly exposed foundations, if desired.

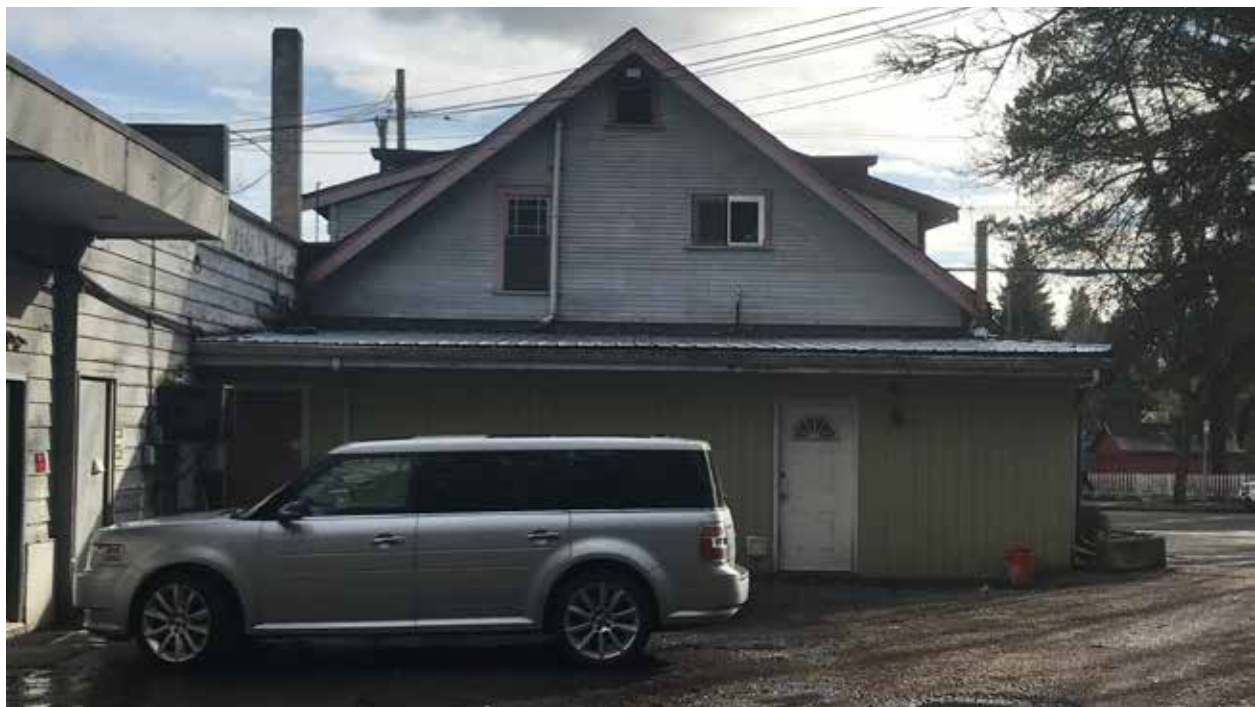
The Simpson Brothers Store features original wide lapped wood siding with cornerboards and dimensional wood window and door trim on the main structure and vertical wood siding on the rear extension, which appears to be in fair condition. Exterior wood materials are character-defining elements of the historic building and should be preserved and rehabilitated, as possible. Further investigation required to determine full condition of all exterior wood surfaces. Siding and trim will be retained and repaired as required.

- Due to the integrity of wood frame structure, the exterior walls with lapped siding, cornerboards and wood trim should be preserved through retention and in-situ repair work.

- Replace damaged siding to match existing in material, size, profile and thickness.
- Design structural or seismic upgrades so as to minimize the impact to the character-defining elements.

- Any existing trim should be preserved, and new material that is visually physically compatible with the original should be reinstated when original fabric is missing. Combed and/or textured lumber is not acceptable. Hardi-plank or other cementitious boards are not acceptable.

- Cleaning procedures should be undertaken with non-destructive methods. Areas with biological growth should be cleaned using a soft, natural bristle brush, without water, to remove dirt and other material. If a more intense cleaning is required, this can be accomplished with warm water, mild detergent (such as D/2 Biological Solution®) and a soft bristle brush. High-pressure power washing, abrasive cleaning or sandblasting should not be allowed under any circumstances.

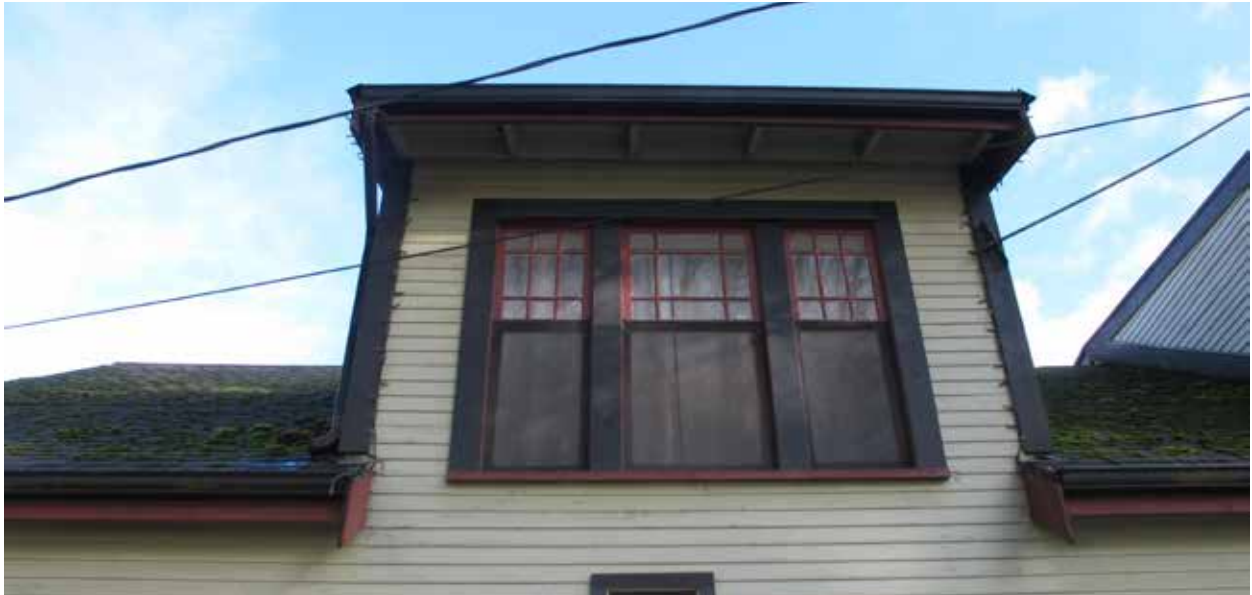
The Simpson Brothers Store features a number of original character-defining windows, including three 9-over-1 multipaned double-hung wood-sash windows with upper horns on the south elevation, one 9-over-1 double-hung wood-sash window and two rectangular wood-sash casement windows on the west elevation. The four front facade windows have been replaced with unsympathetic assemblies. Further investigation is required to determine status of north elevation when access is available.

- Inspect for condition and complete detailed inventory to determine extent of recommended repair or replacement.
- Retain existing original window sashes; repair as required; install replacement matching sashes where missing or beyond repair.
- Preserve and repair as required, using in kind repair techniques where feasible.
- Consider replacing front windows with appropriate wood-sash assemblies.
- Overhaul, tighten/reinforce joints. Repair frame, trim and counterbalances.
- Each window should be made weather tight by re-puttying and weather-stripping as necessary.
- Retain historic glass, where possible. Where broken glass exists in historic wood-sash windows, the broken glass should be replaced. When removing broken glass, the exterior putty should be carefully chipped off with a chisel and the glazier's points should be removed. The wood where the new glass will

be rested on should be scraped and cleaned well, and given a coat of linseed oil to prevent the wood from absorbing the oil from the new putty. The new glass should be cut 1/16-1/8th smaller than the opening to allow for expansion and irregularities in the opening, to ensure the glazing does not crack due to natural forces. Window repairs should be undertaken by a contractor skilled in heritage restoration.

- Replacement glass to be single glazing, as possible, and visually and physically compatible with existing.
- Prime and repaint as required in appropriate colour, based on colour schedule devised by Heritage Consultant.

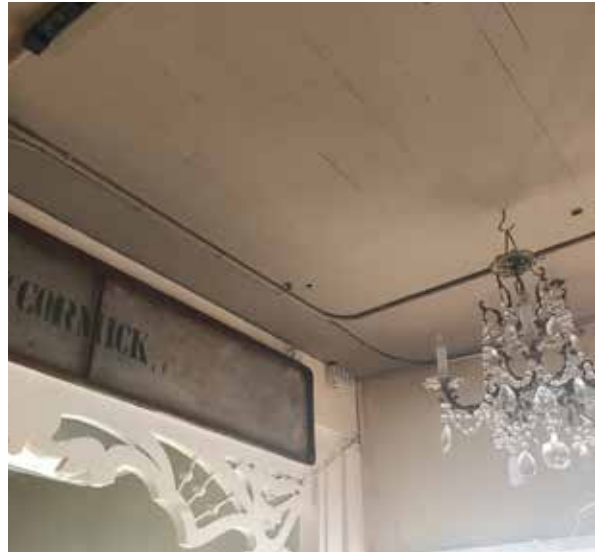
The Simpson Brothers Store features original interior wood plank ceilings and walls, which are character-defining elements of the historic building and should be retained. Wood plank ceilings and walls appear to be in fair condition, but further investigation is required to determine the full extent of their condition.

Determine upgrades that may be required for functional reasons. Retain original finishes as possible, or replace with historically compatible material where too deteriorated to repair. Clean and repaint as required.
