THE WATER PROJECT

PREDICTING WATER PUMP
FUNCTIONALITY IN TANZANIA

A project by Elena Salgueiro

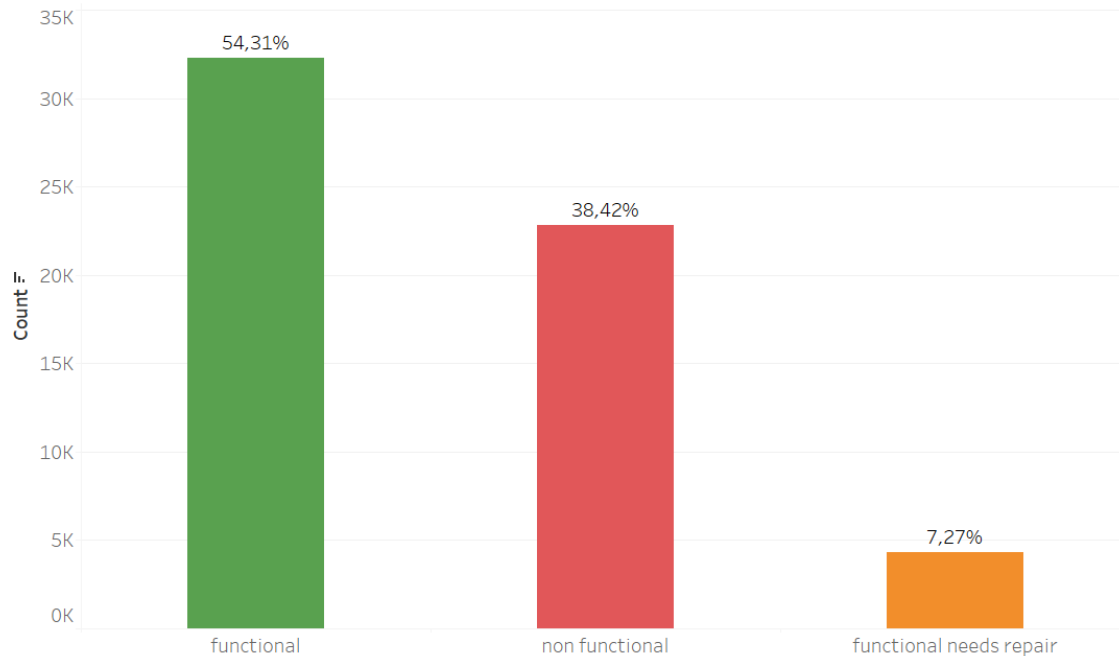
#Water points functionality status

Almost half of the waterpoints installed are not functional or they do not work properly.

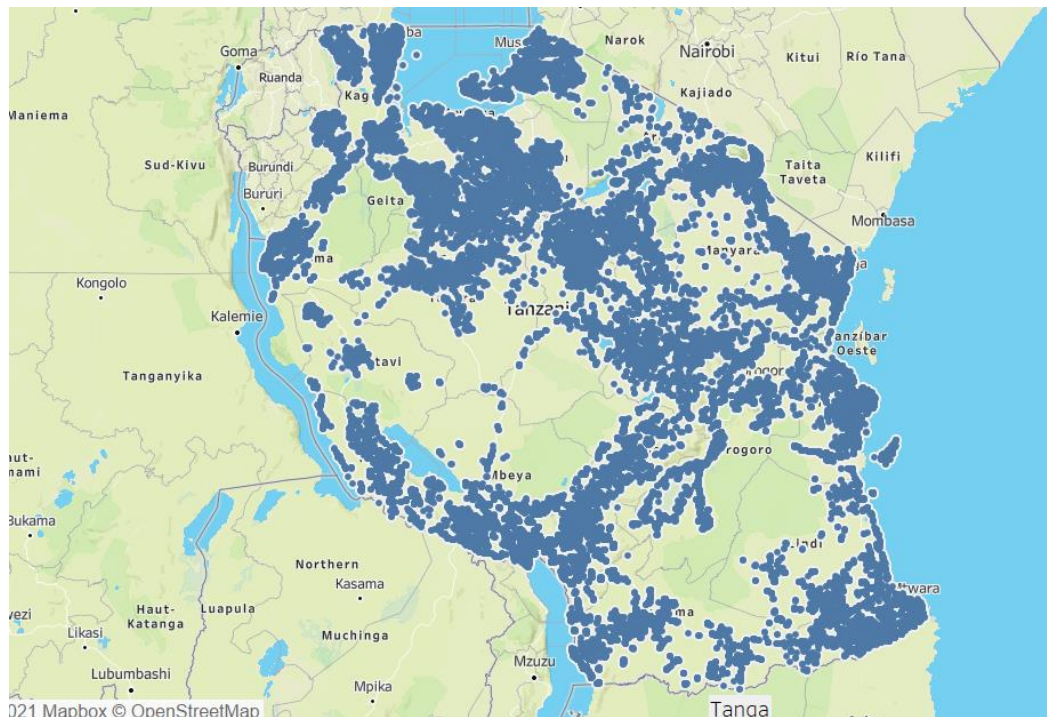
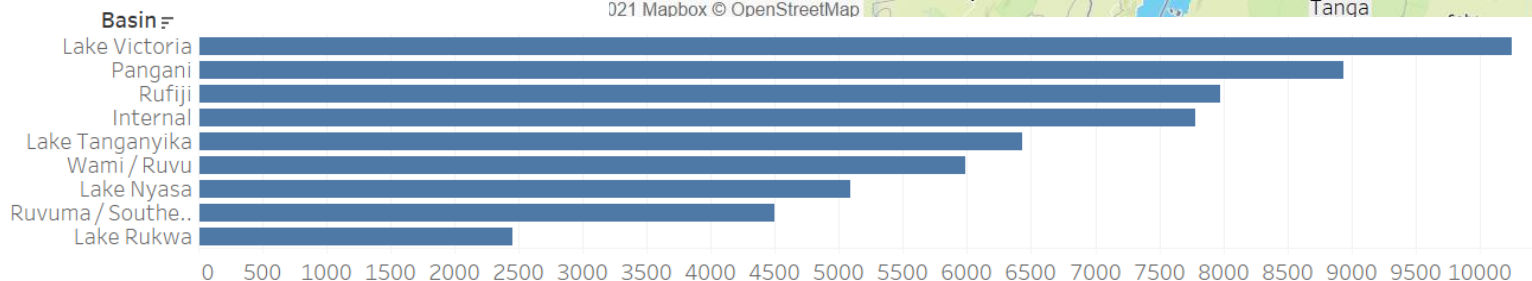
#Geographical distribution

*Water points are situated around
the main lakes and rivers within
Tanzania*

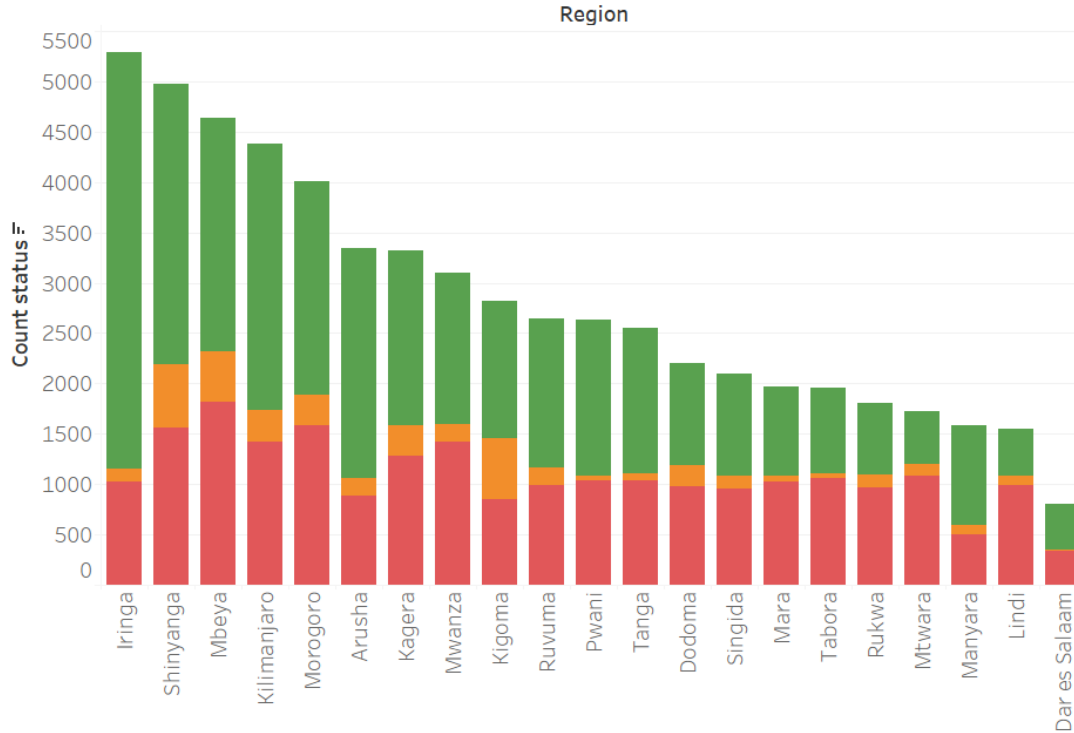
#How does the **region** of a well relate to its functionality?

Non functional rate is extremely high in some regions.

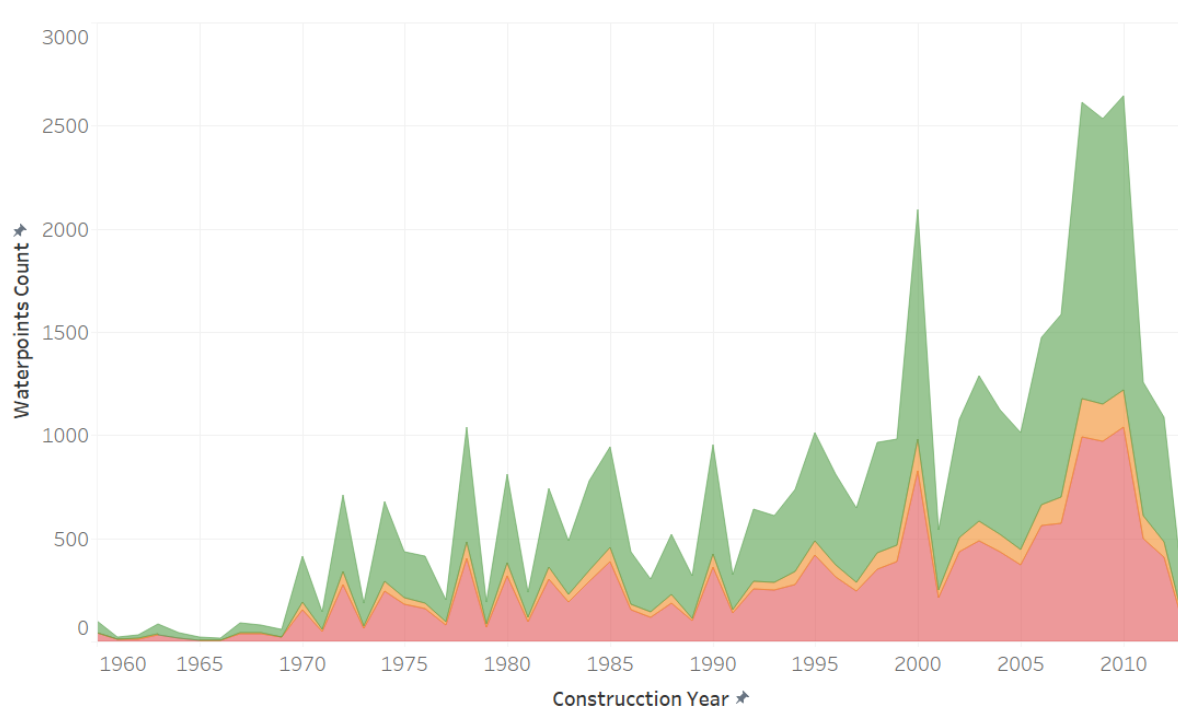
#How does the **age** of a waterpoint relate to its functionality?

The ones that were built recently are as likely to be not functional as older one.

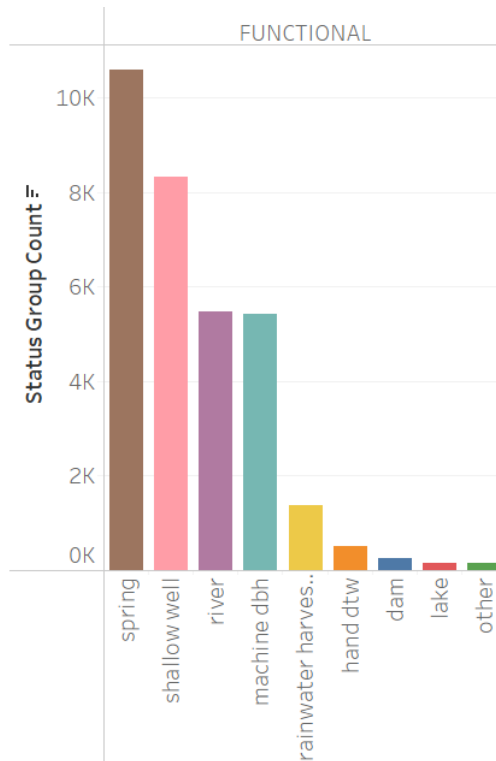
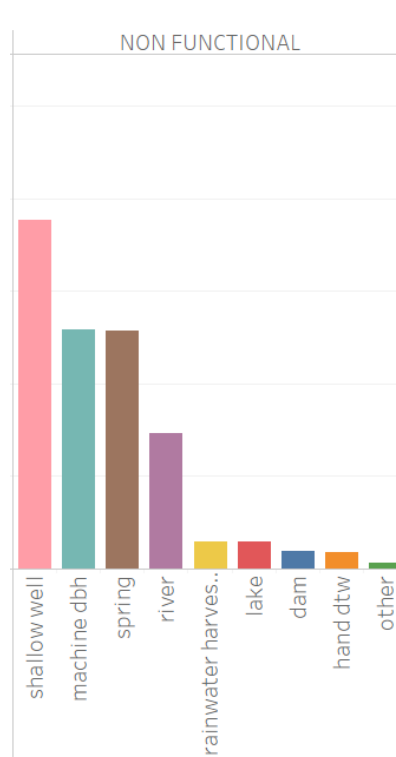
#The **source** of a waterpoint affects its functionality

Ground water is the major source of water, but those water points are more likely to be unfunctional

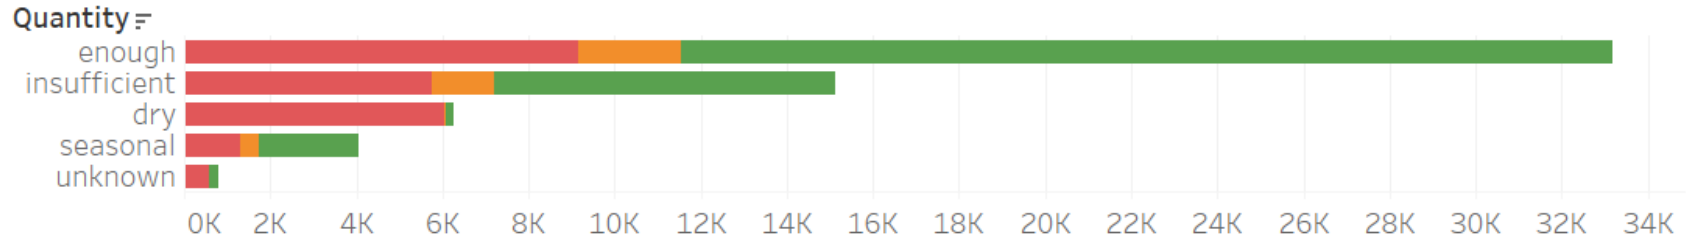
#The **quality and quantity** of the water matters

*Obviously dry water pumps are the most likely to be non-functional.
But not functional rate in those with enough and good water is also worrying!*

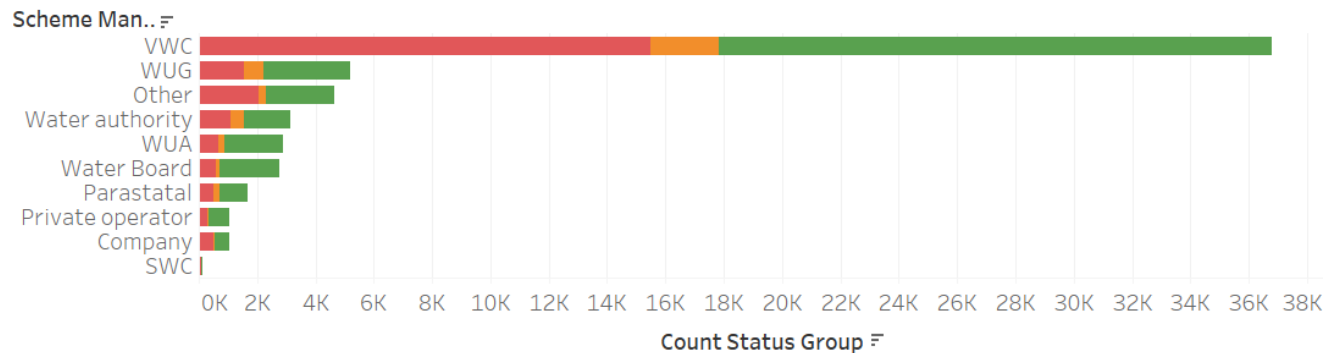
Management Authority

Private operators, minority contributor but they are doing the best job.

User-groups are doing a bigger bulk of work managing water points

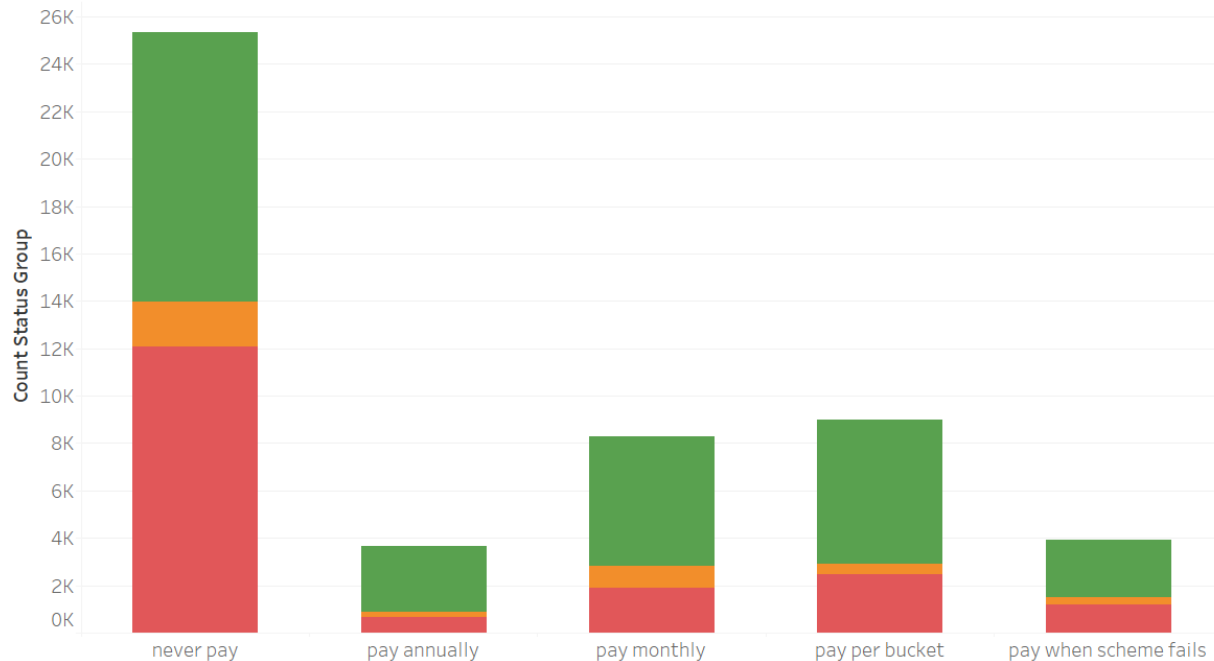
Payment System

If the water point management charges money, the more likely that it is better maintained and kept functional.
