Figure 67-19. Elevator Spar Damage

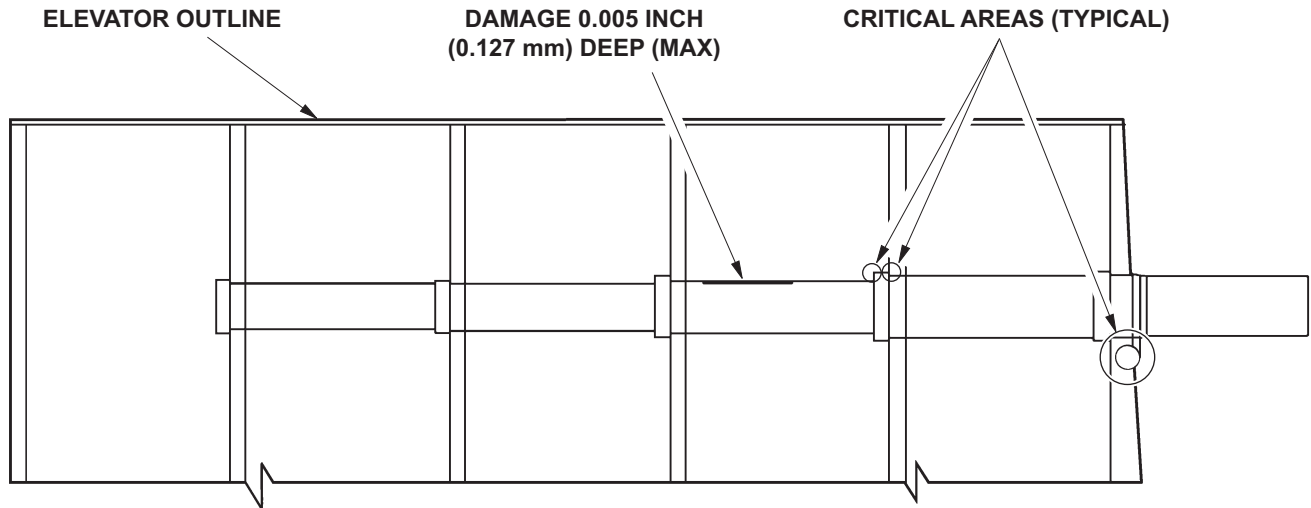
1. The entire elevator spar tube is a critical fatigue area. The area where the elevator attaches to the horn and the radii adjacent to the rib lands are especially critical because these are the points where loads are transferred to the spar. If an elevator sustains damage, the elevator skin must be removed for inspection of the spar prior to repair of the internal damage.

LIMITS - REPAIRABLE DAMAGE. Scratch and scoring damage is limited to 0.005 inch (0.127 mm) depth after clean-up with 400 grit or smoother abrasive paper to a polished smooth surface. Scratch and scoring damage is further limited as follows: 0.50 inch (12.7 mm) radially. 1.00 inch (25.4 mm) longitudinally. No dents which result in visible tube wall depressions are permitted. The allowable limit on pit corrosion is 10% of wall thickness. No corrosion is permitted after clean-up.

2. Apply two coats of epoxy polyamide primer (C-204) to spar in clean-up areas and a light coat of super koropon primer (C-202) or epoxy polyamide primer (C-204) to portion of spar which fits inside horn.
