# CanSat 2018 Post Flight Review

1138

Robotics for Space  
Exploration

10 June 2018

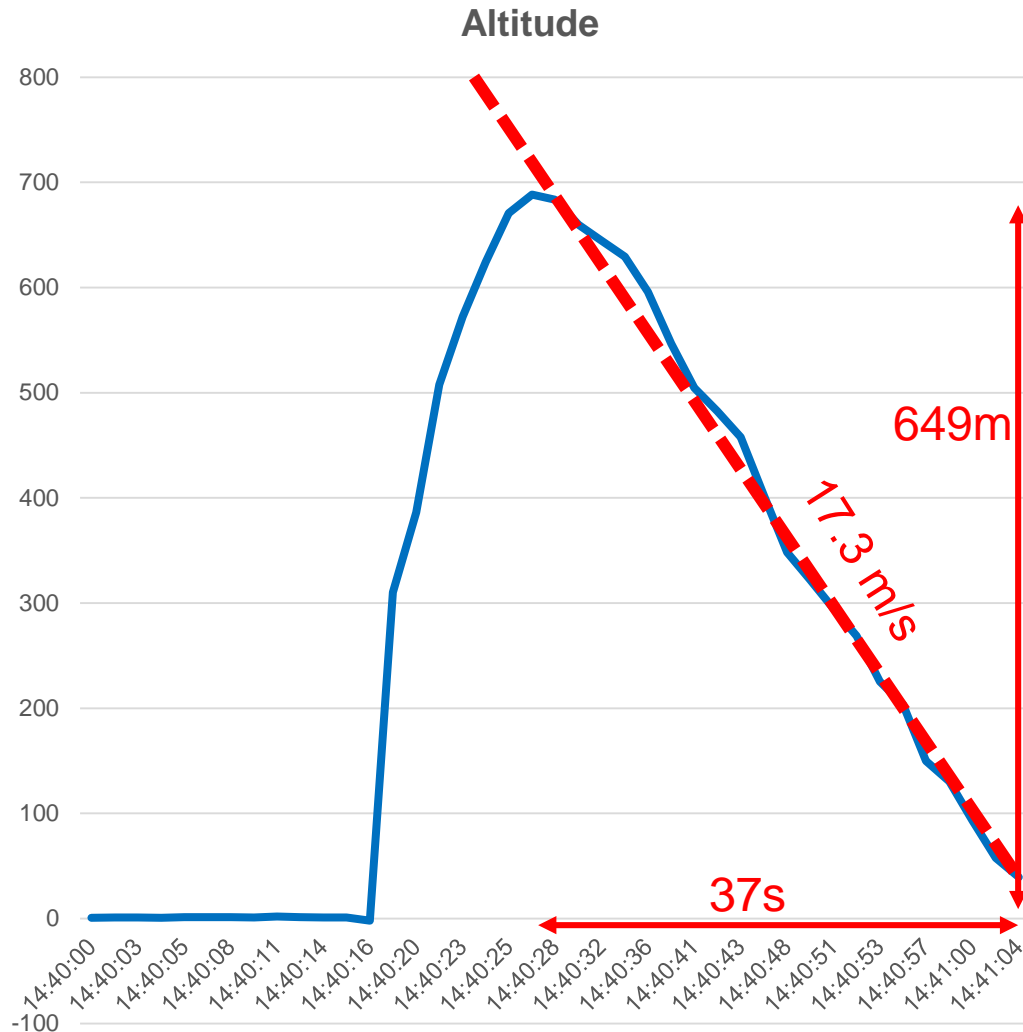
- **Max Altitude Recorded: 688m**
- **Heatshield deployment stage fell at ~17m/s**
- **Estimated 18m/s in CDR**
- **Parachute failed to open**

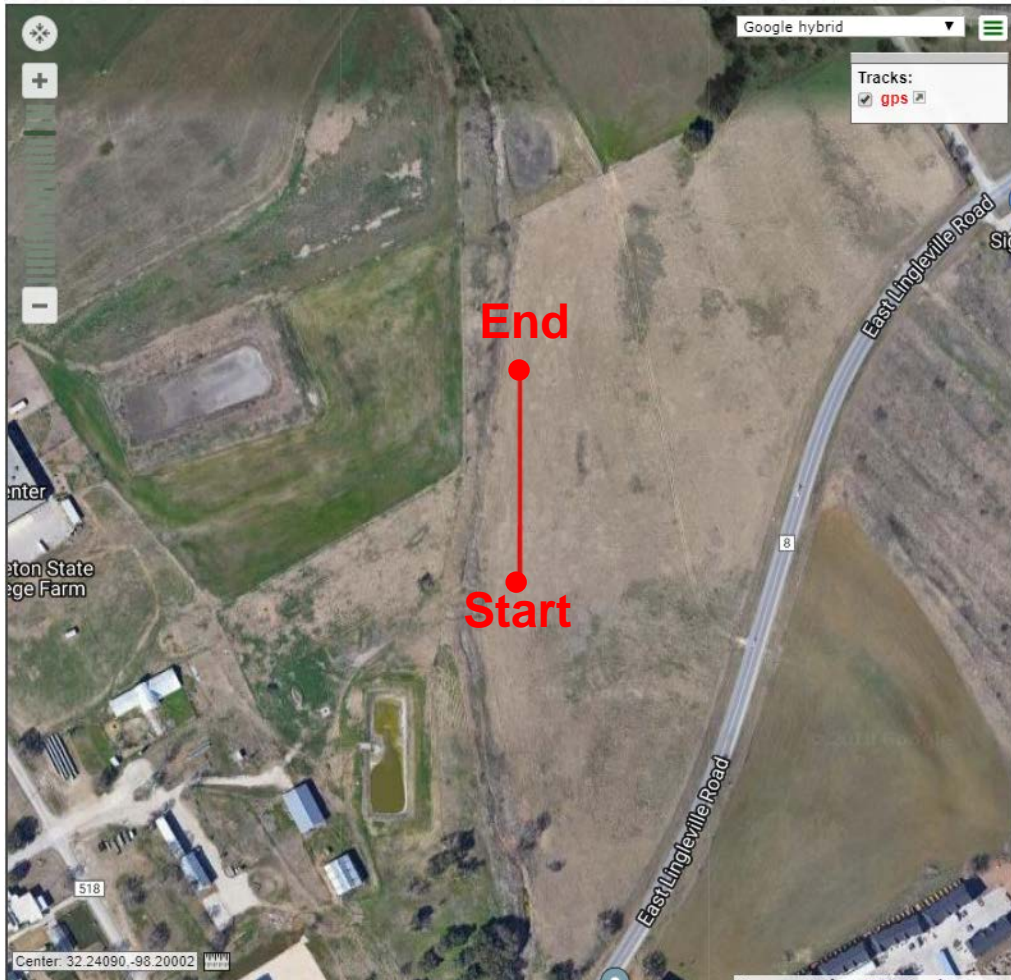
- **Starting coordinates:**  
32.240798, -98.199958
- **Landing coordinates:**  
32.241786, -98.199958
- **GPS failed to update during a portion of flight**

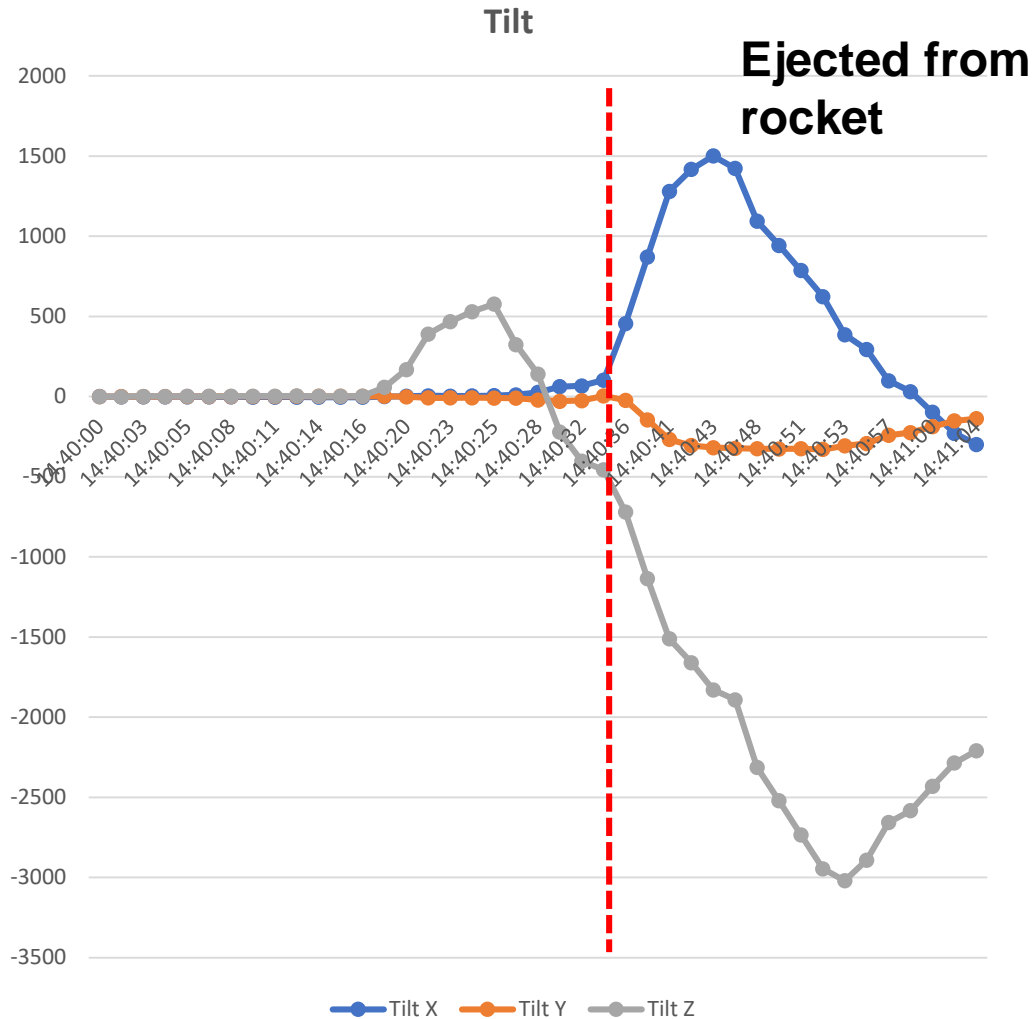
- X-axis and Z-axis shows that the probe was rotating during flight
- Actual flight looked like a steady descent
- Error may be due to piecewise integration of gyroscope readings

Failure	Root Cause	Corrective Action
Tilt sensor indicates tumbling, despite visual and logical evidence of steady flight.	Poor mounting of tilt sensor and/or erroneous interpretation of data.	Account for impact of poor mounting and/or use more sophisticated integration techniques.
GPS failed to update for a short time.	Probably poor connections between GPS and rest of electronics.	Mount GPS more securely and make connections more secure.

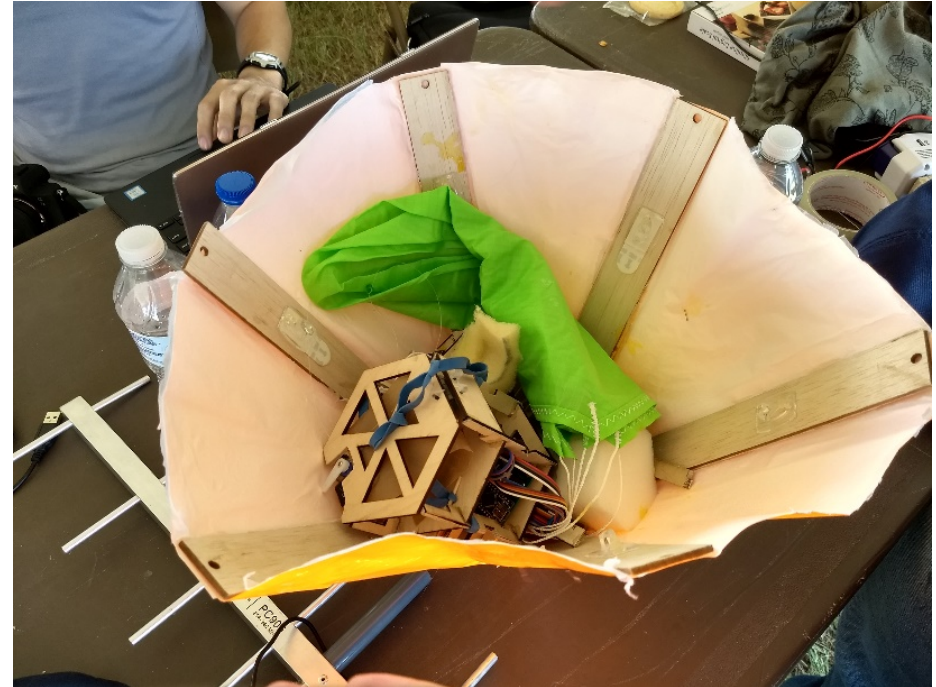
- Either the parachute lid failed to open, or the parachute fell between the probe and the heat shield and did not open.
- A fix for either problem would have been to increase the force acting on the parachute compartment lid, helping it open and/or launching the parachute farther to clear the heat shield and unfurl properly.
