KENWOOD TS-2000 stop transmit and receive

Strange coincidence on two TS-2000's mine and a friends 20 miles away

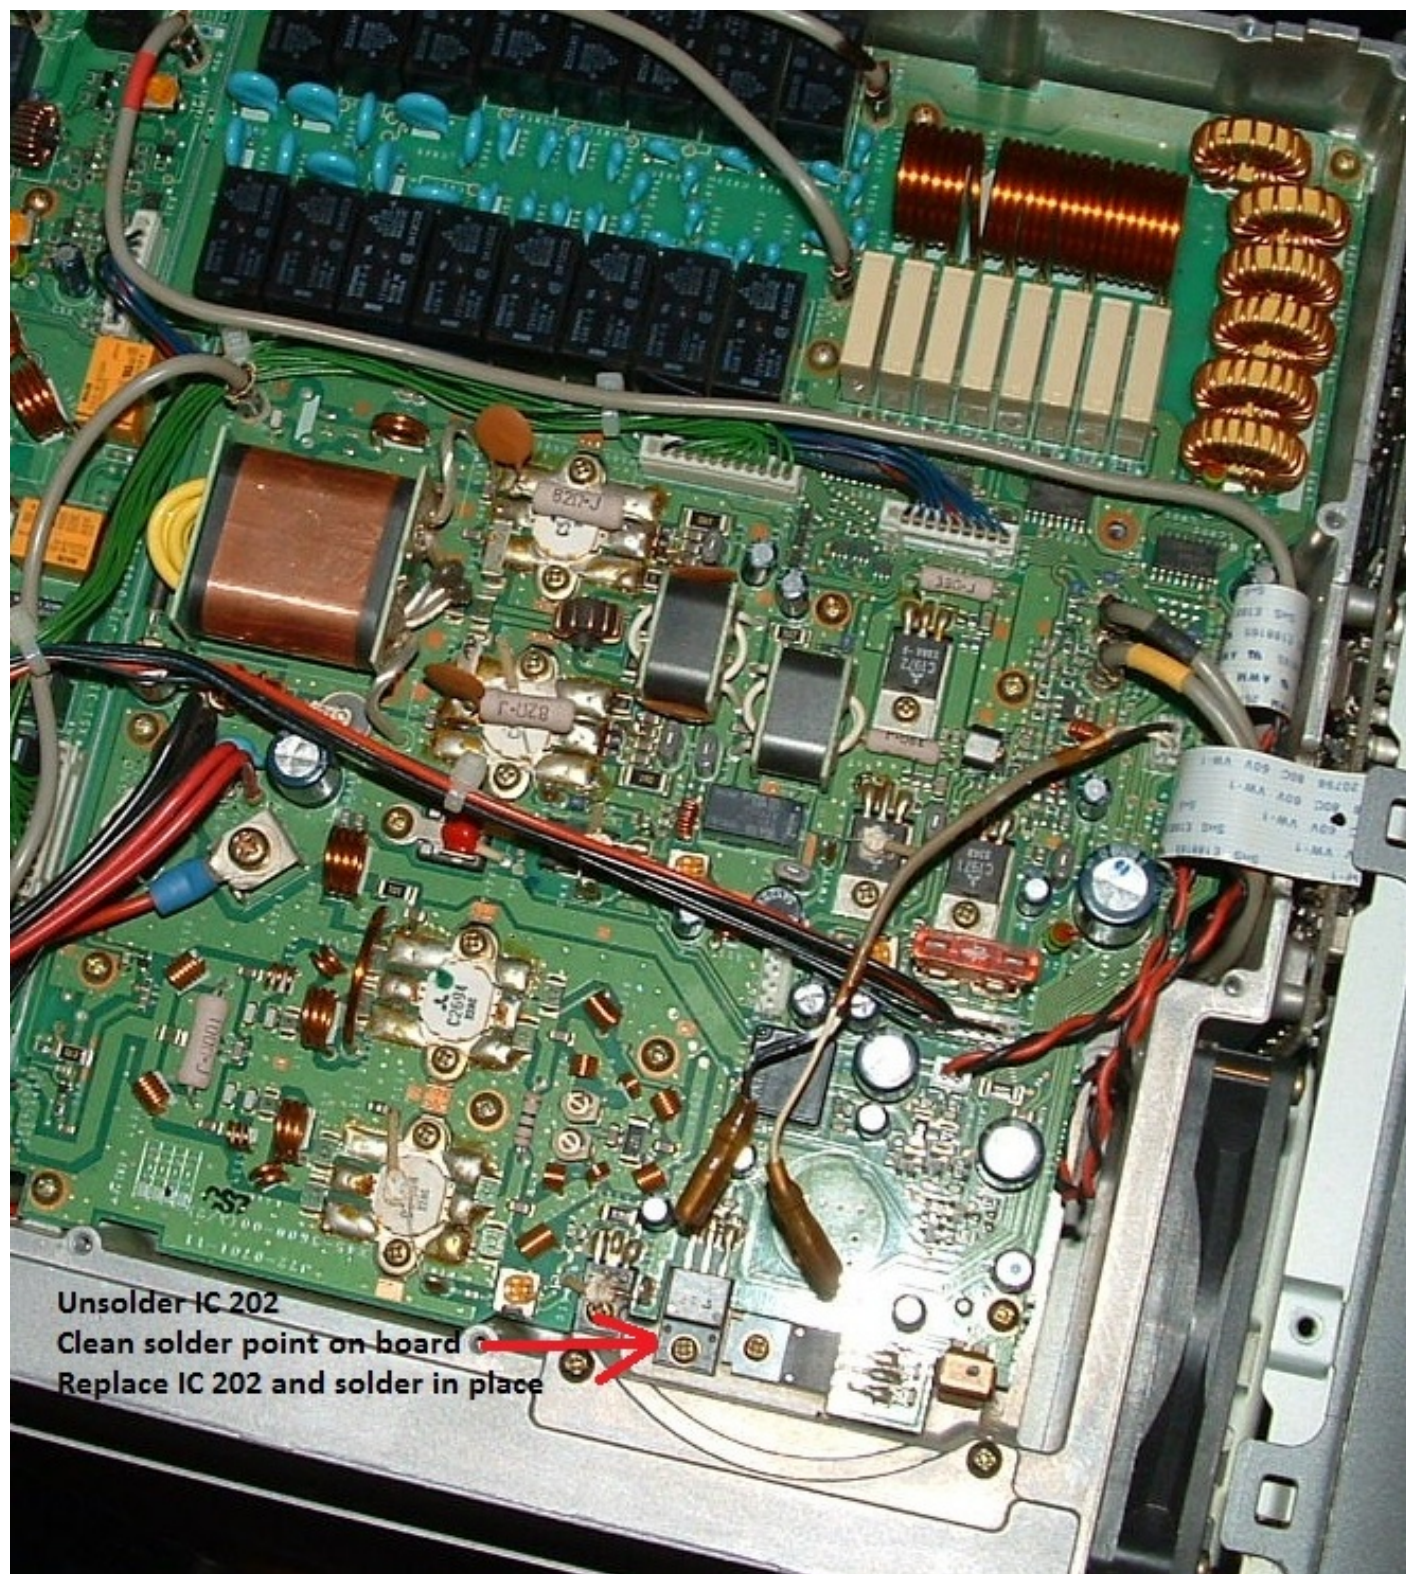
The very first screw removed to take off the board was for IC-202, which was to the left of where K201 was and mounted under the speaker. When this screw was removed, something was odd, ALL THREE LEGS barely had any solder on them and all three popped up off the board!

"Thanks William, sure enough that Voltage Regulator was not soldered to the PCB at all. And I took it off and resoldered it to the board and brought the rig back up stair from the basement and it works fine. I took it very easy going down and up the stairs but I had to check out that IC #202. Thank you so very much, now I have a Radio, a TS-2000 back on the air and it did not cost me a thing. Unlike the last few times it was sent in for repairs."

WOW!!!!!! SO before removing anything else, CAREFULLY cleaned up IC-202 and the board, re-soldered the three legs and fired the radio up.

It worked perfect, I would press on the K201 relay and the radio would not stop working.
