HISTORIC AMERICAN ROOF TRUSSES

V. The Evolution of Roof Trusses

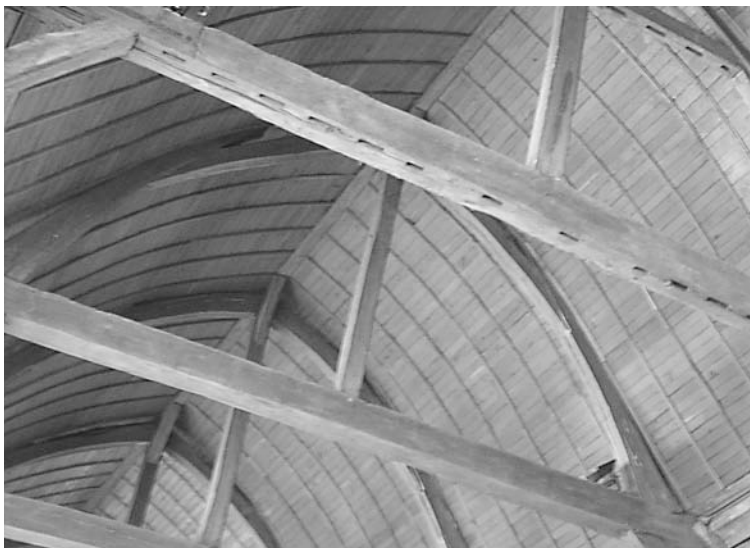
Fig. 1. St. Catherine's Church, Honfleur, Normandy, late 15th century.

VERNACULAR ORIGINS. The truss form emerged from the timber framing methods of classical antiquity in the Mediterranean region and only during the last two centuries became shaped by engineering analysis and design. Truss construction has always been associated with the high end of vernacular carpentry; trusses are rarely found in private homes or barns, but almost always in prestigious public buildings such as temples or churches, or in bridges. While we have only a small body of evidence for the exact form of the trussed roofs of antiquity, we have abundant extant examples of long-span roof systems from the Middle Ages through the Renaissance. The variety of forms and the inventiveness of their framers seem without end. Many of these pre-modern roof frames are fully realized trusses with a captured kingpost hanging the middle of the tie beam, and the ends of the rafters restrained within the same tie (Fig. 1).

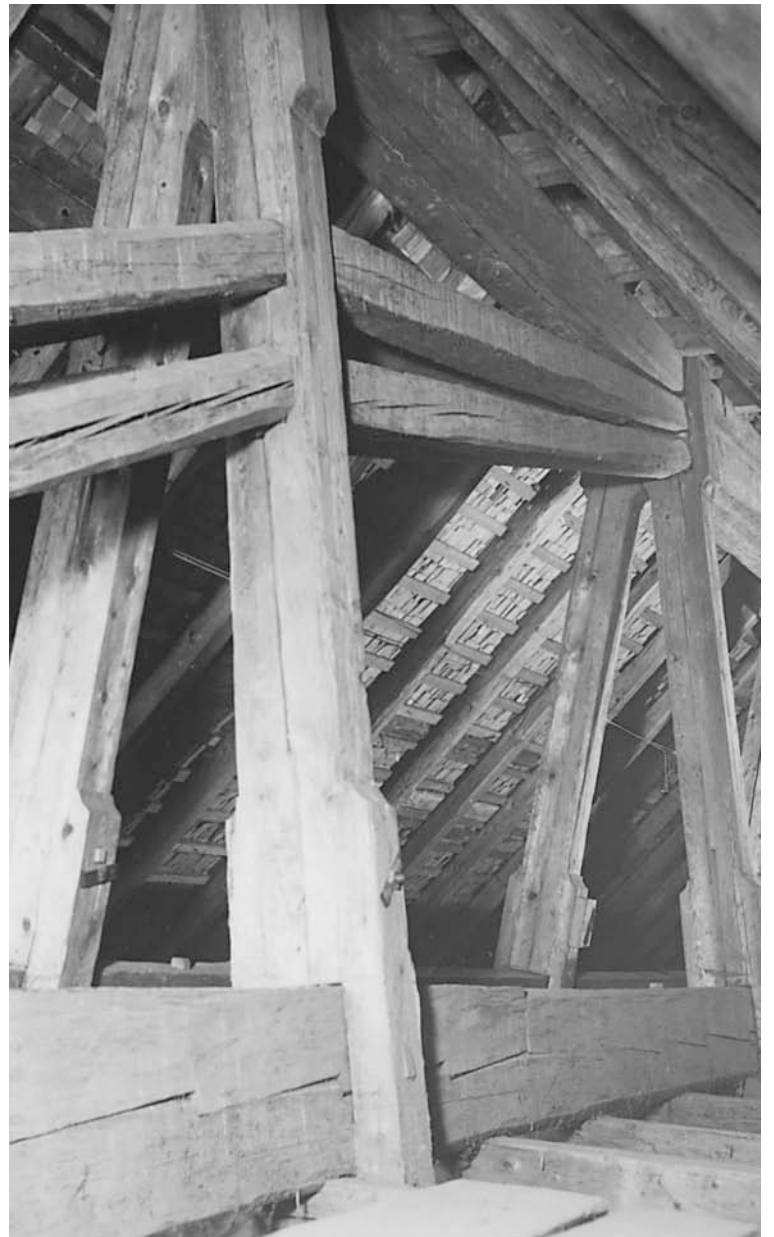
Fig. 2. Lengthwise truss, Reformed Church at Grub, Switzerland, 1752.

Multiple kingpost and queenpost examples exist in Switzerland in the work of the self-taught designers and builders Jakob, Johannes and Hans Ulrich Grubenmann. Their longitudinal roof truss in the Reformed Church at Grub (1752) and the Bridge on the Linth (1766) represent the culmination of an established central European tradition of *hängewerk*—that is, using posts in tension to suspend tie beams or truss bottom chords (Figs. 2 and 3).

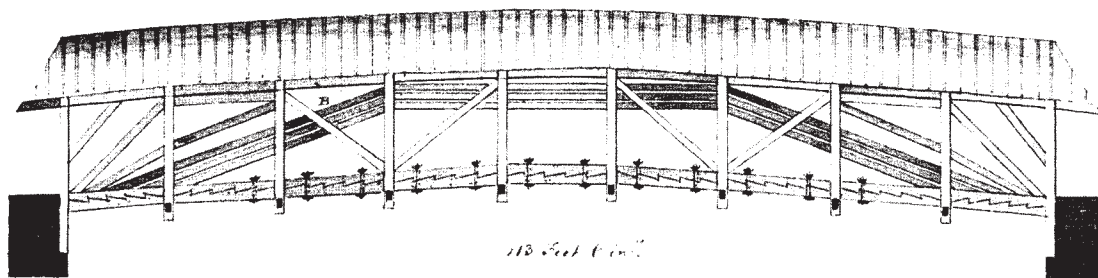
Fig. 3. Bridge on the Linth at Ziegelbrücke, Switzerland, 1766, detail, after Cristoforo Dall'Acqua and Michael Shanahan, ca. 1792-3.

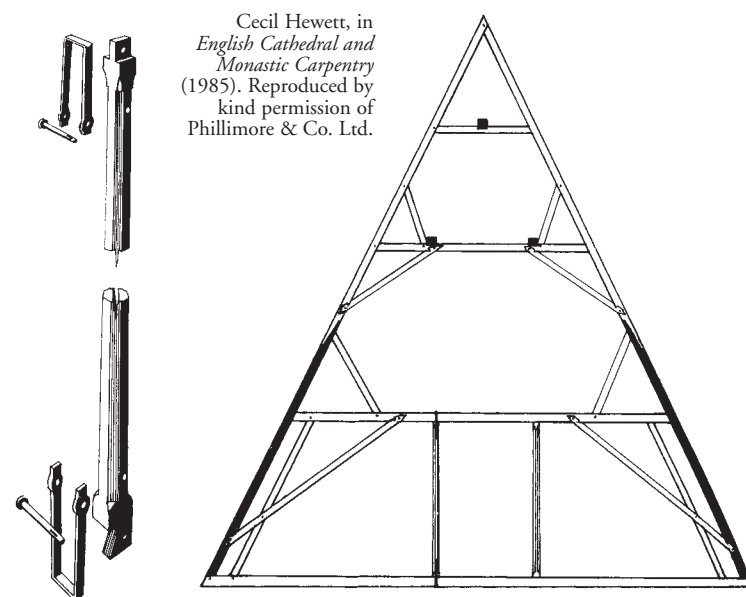
Fig. 4. Elevation and tension post detail of the Angel Choir high roof at Lincoln Cathedral, before 1280.

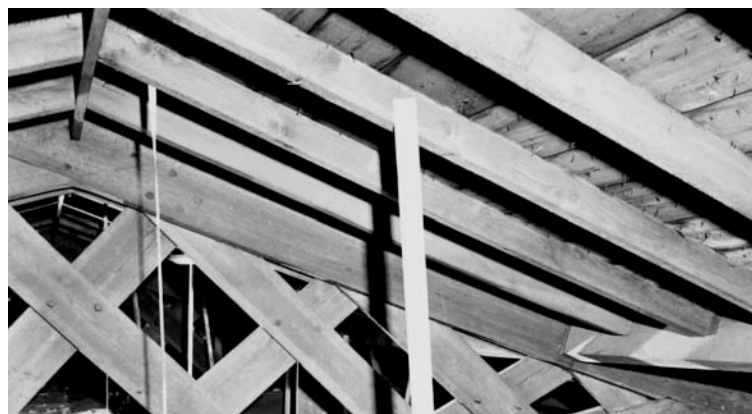
Fig. 5. Town Lattice truss adapted to scissor form, supporting roof of First Presbyterian Church, Fayetteville, N. C., 1832. A rare instance.

In rare cases, new truss types first applied in bridge design, particularly the Town Lattice truss, were introduced into the church roof systems of the early and mid-19th century. The Second Presbyterian Church (1835) of Madison, Indiana, has a plank lattice roof system as does the First Presbyterian Church (1832) of

Fayetteville, N.C. (Fig. 5 facing page). Other examples, some designed by Town's firm itself, exist in North Carolina, Alabama and New York City (Conwill, 6).

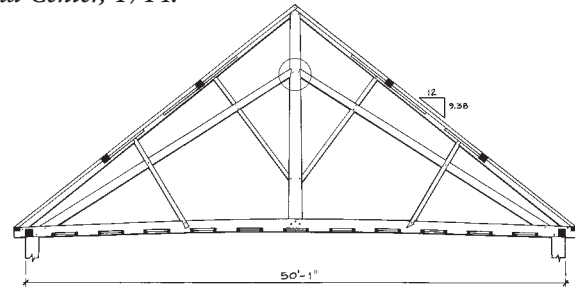
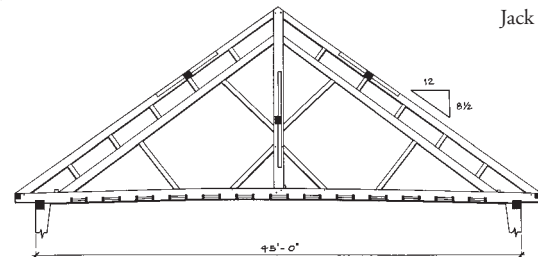
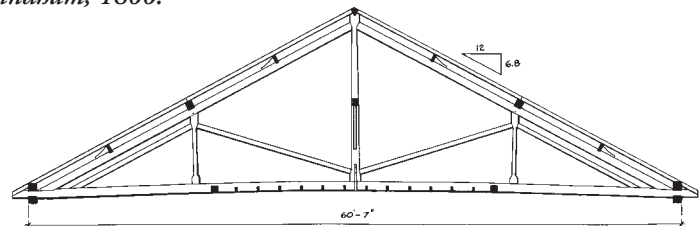
Fig. 5. Typology of American double-raftered trusses. Only Castleton carries a separate deck of rafters, European style.

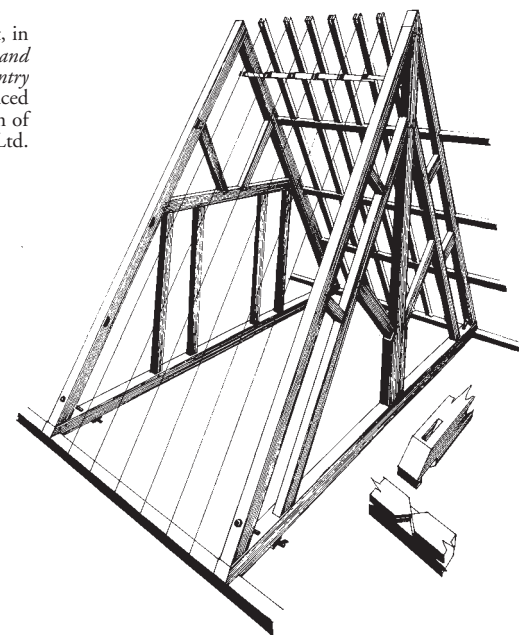
Fig. 6. Lichfield Cathedral, high roof of the south transept, repaired 1661-69 after the ravages of the English Civil War. Heavy forelock bolts reinforce rafter-to-tie joint where relish is short.

Double-raftered trusses existed in England and continental Europe at earlier dates as well. In Fig. 6, Hewett illustrates a relatively modern looking double-raftered kingpost truss in the high roof of the south transept of Lichfield Cathedral (1661-9), which he calls, along with the roofs over the rest of the church, "probably the best post-medieval roofs for a great church that exist in England" (Hewett 1985, 66).

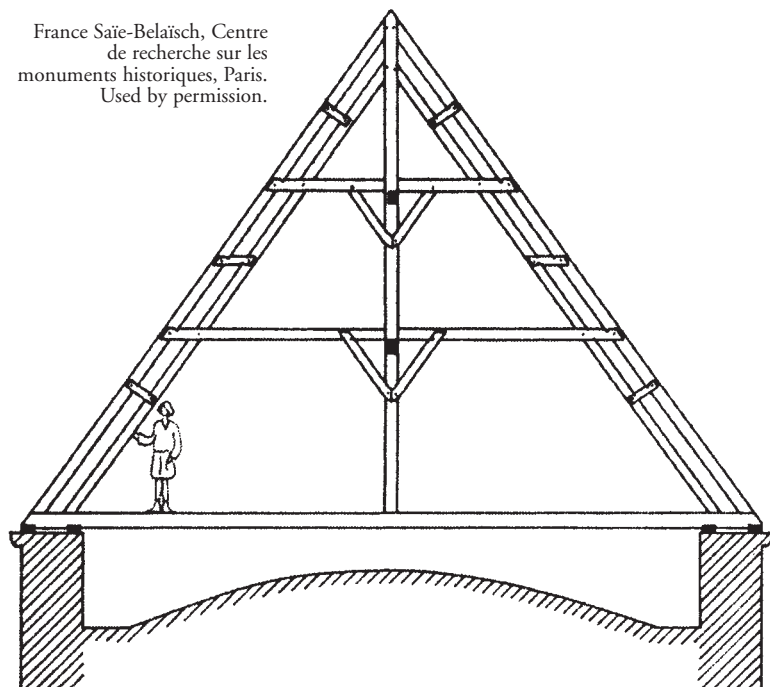
Fig. 7. Notre-Dame d'Étampes, 12th century. Doubled rafters are frequently bound together.

Patrick Hoffsummer et al. illustrate numerous medieval double-raftered examples including the Church of Notre-Dame at Étampes (1177-87) and the late 15th-century roof above the choir at the Cathedral of Notre-Dame in Reims (Figs. 7 and 8 below; Hoffsummer, 186 and 306).

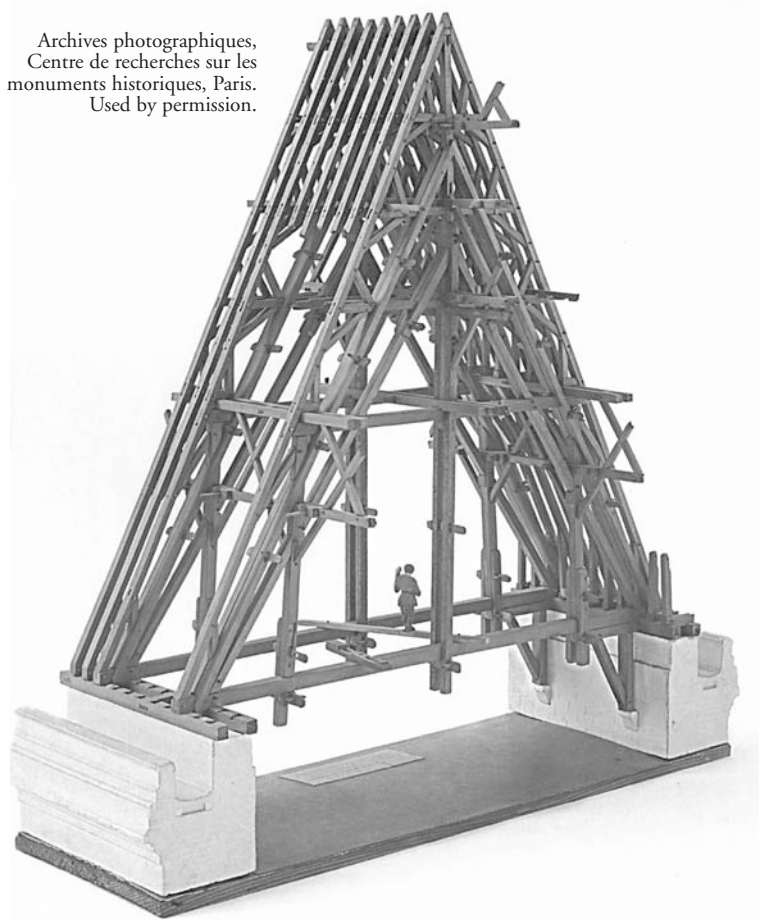
Fig. 8. Cathédrale Notre-Dame at Reims, 15th century, exceptional timberwork superbly modeled by Henri Deneux in the 20th century. The tie beam is hung from the collars as well as from the inner rafters.

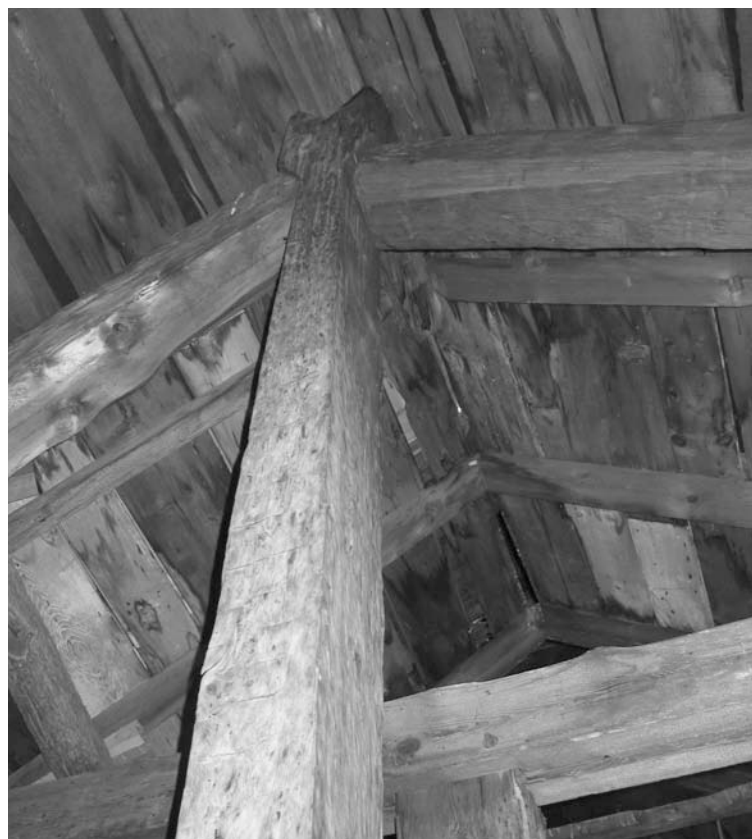
Fig. 9. Kingpost at Castleton Federated Church, 1832, much reduced below the head joggles to reflect its simple function as a tension member.

The aesthetics of framing. The dramatic entasis of the kingpost at the Castleton Federated Church, necked down from 11½x10 at the joggles to barely 5x10, can only be attributed to the framer's concern that his frame proportionally reflect load at every point and in that way be beautiful, rather than maintain surplus capacity. (The Castleton framer was Thomas Dake, famous for interior joiner's work such as pulpits and entryways.) In general, the earlier the truss the more likely it is to contain tapered rafters, tie beams with hewn or natural as well as induced camber, entasis in the kingpost, and curved inner rafters; Lynnfield Center, Strafford and Rindge provide us good examples. The later trusses illustrated in builder's guides such as Benjamin, Nicholson and Tredgold are drawn rectilinear and substantial, all the members uniform in section along their length other than at the joggles, stout looking and without curves or tapers.

framer and worker, and a view of beauty unwedded to decoration. The shaping of the kingpost at Castleton was expensive, making it proportional but not stronger, and any beneficial reduction of truss weight was minimal.

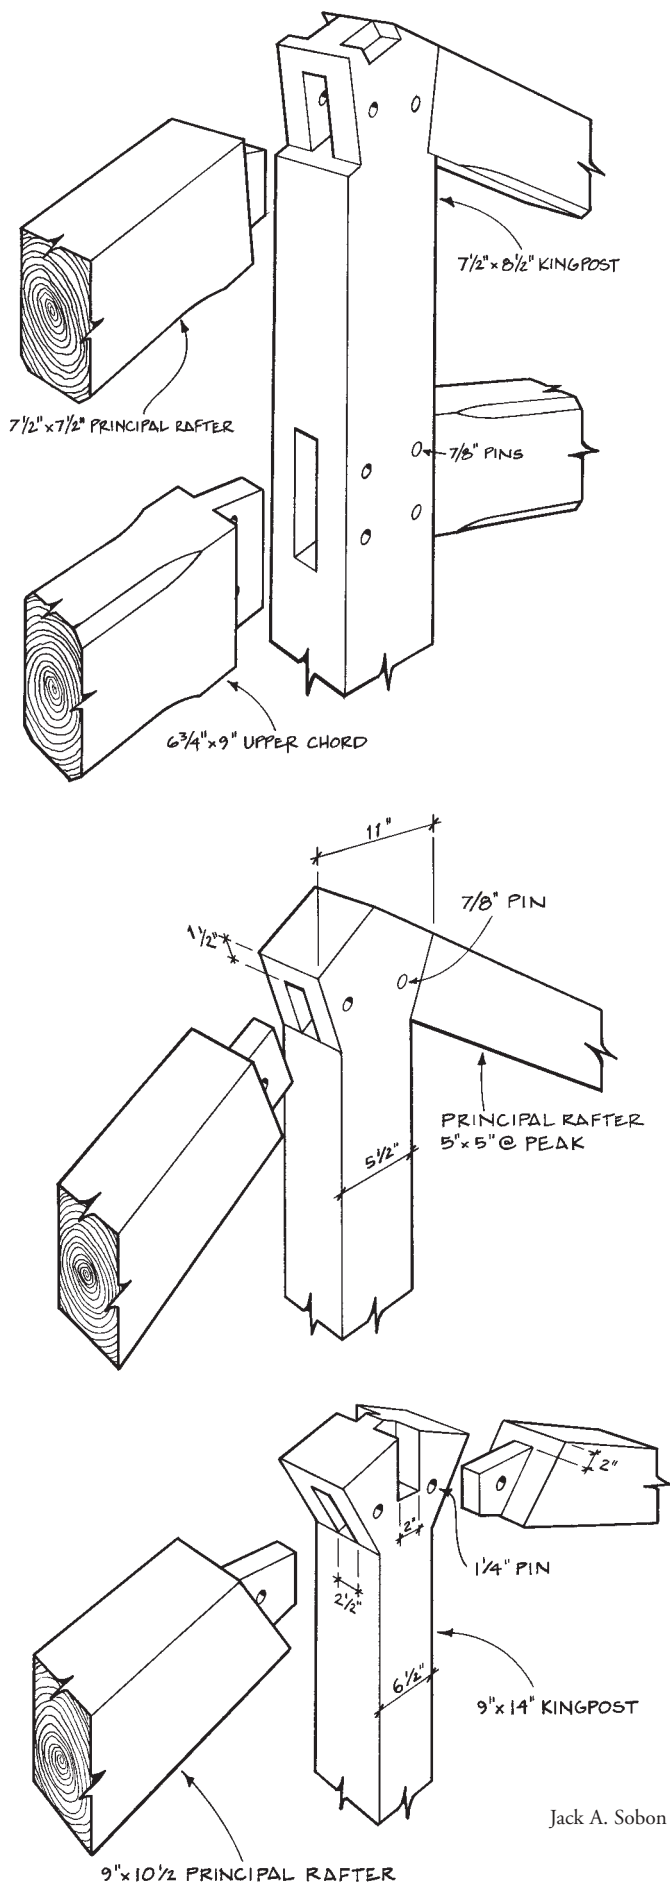
Fig. 10. Joggle angles at the kingpost head vary substantially, from negligible or nearly so (top, Lynnfield Center, Mass., 1714), to normal or nearly so (middle, Shrewsbury, N.J., 1769) to well undercut (above, Portsmouth, N.H., 1807). Some kingpost heads have no joggle at all.

Joggles. Where principal rafters or upper chords meet the kingpost head, what is the importance of normal bearing? Of the roof trusses investigated for these articles, five presented normal (perpendicular) bearing between principal rafters and kingpost head joggles; six had some lesser degree of joggled slope or small bearing shoulder; and four allowed the tenon, friction and compression on the brace shoulder, together with any pins, to do all the bearing. Fig. 10 illustrates various angles of joggle incidence.

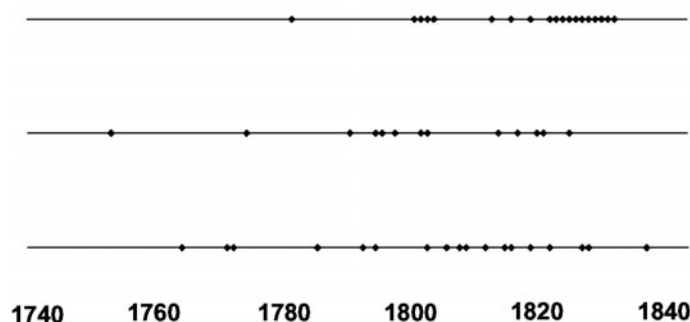
Fig. 11. Frequency distribution of joggle types over time. Bottom line represents no joggle, middle line some joggle, top line normal bearing.

The results are presented in Fig. 11, with the church roof frames divided into three categories: normal bearing with joggles (top line); some joggling or shoulders but always less than normal bearing (middle line); and no joggles at all (bottom line). Trusses with perpendicular bearing at their joggled shoulders, as recommended in the builder's guides, become more common over time, but theunjoggled or slightly joggled forms don't diminish correspondingly, rather they coexist during the time period, which is one of transition. (The square rule displaces the scribe rule in those same years, and the cut nail displaces the wrought.) In my research, church attics after about 1845 never contain trusses without normal bearing between rafters and kingpost joggles.

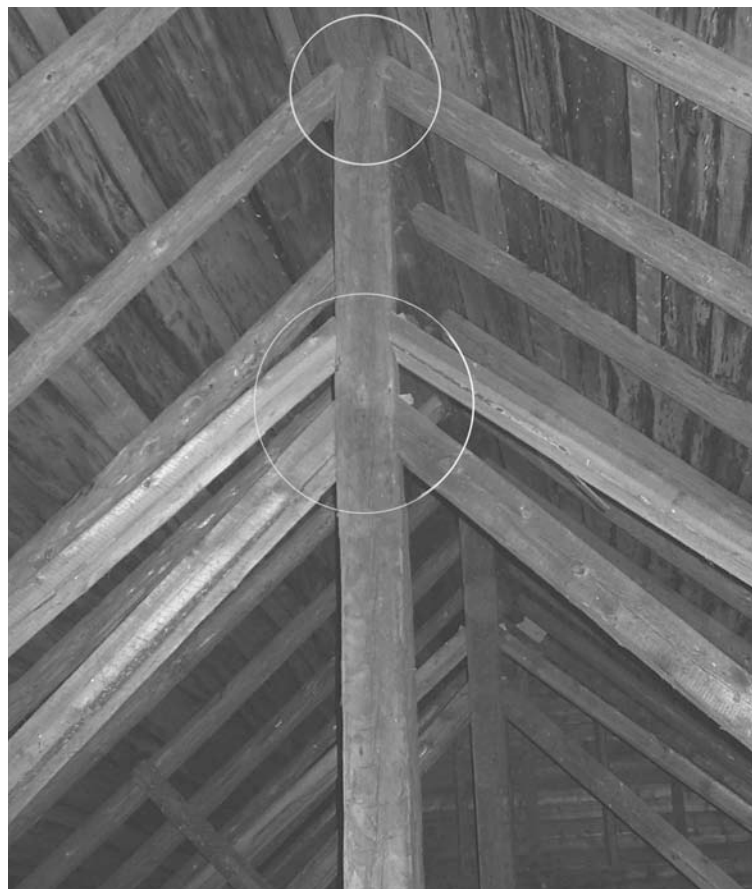
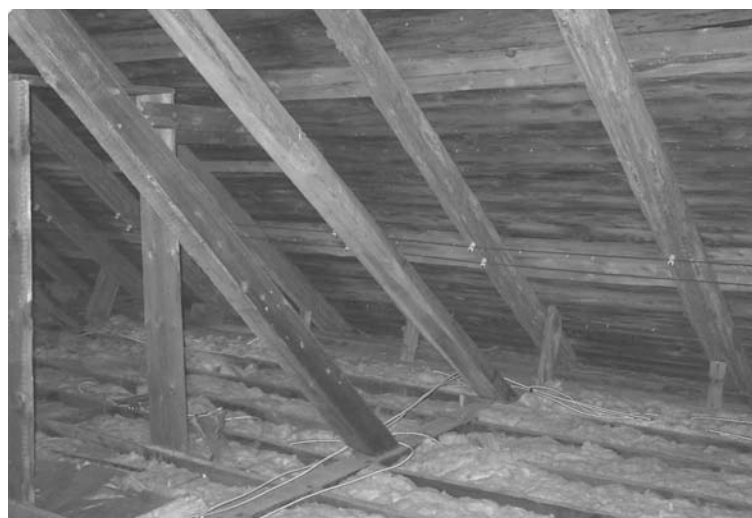
Fig. 12. Triple-rafter array at Craftsbury, Vt., Town Hall, mid-19th century. Uppermost rafters terminate in ridgepole (upper circle); inner rafters prop the kingpost (lower circle), offering unconventional path for roof load to tie beam (lower photo).

At the Craftsbury, Vt., Town Hall, there are actually triple rafters, all tenoning into a 38-ft. 8x10 tie beam. The outermost is an 8-in.-dia. spruce log flattened on top that rises from the overhanging end of the tie to tenon into a mortised ridgepole carrying the tops of the common rafters in the same plane. The first inner rafter is a 6x7 tenoning into the kingpost and bearing on the tie beam about a foot from the wall. The second inner rafter is a 6x6, also tenoning into the kingpost and bearing on the tie beam nearly 5 ft. inside the plate. The kingpost picks up the tie beam with a wedged half dovetail joint that is now pulling itself open, probably because of the troublesome positioning of the shortest, stiffest rafter of the array, the inner 6x6 (Fig. 12).

If load goes to stiffness, any depression of the kingpost by roof loading on the upper rafter system will push down the second inner rafter upon an unsupported length of tie beam and tend to force the kingpost joint apart. In this assessment of the forces, the upper part of the kingpost is in compression while its lower part, below the junction with the second inner rafter, is in tension.

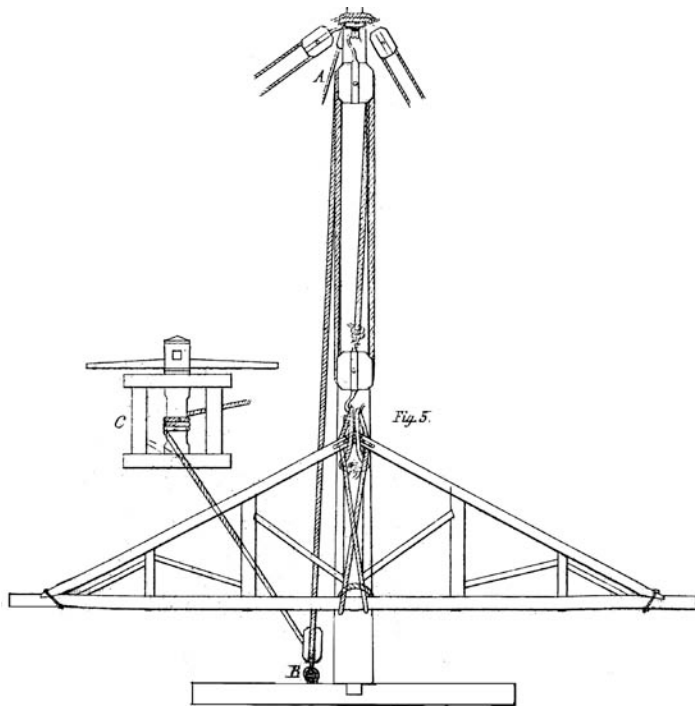
Fig. 13. Chester Hills' Fig. 5, an 1836 truss-lifting rig, showing footed gin pole with tensionable guys (A), anchored load pulley (B), windlass (C) and well-lashed demonstration truss. No tag line.

Another truss-raising method is described in Chester Hills' *The Builder's Guide* (Hartford, 1836) and shown in Fig. 13 at left:

Fig. 5 shows the method of raising a truss by a gin pole. This should be of a suitable length to raise the truss to its destined height and should be made either of pine or spruce, so as to be easily raised or lowered, a stick that is from 10 to 12 inches in diameter at the bottom and from 6 to 8 inches at the top will be sufficiently large to raise a truss from 60 to 90 foot span. . . . In raising the trusses of a church they should be put together on the main floor and well secured . . . when you have got one raised and placed to its proper place and well braced, slip the gin along to where the second one is to stand. A good set of hands working under a master workman will generally be able to complete the whole in one day.

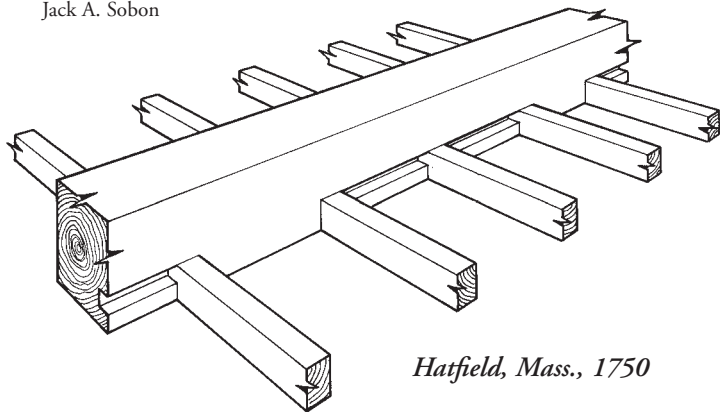
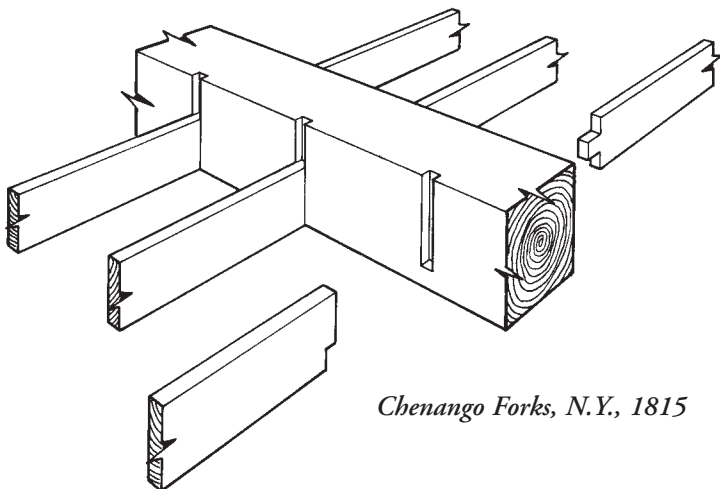
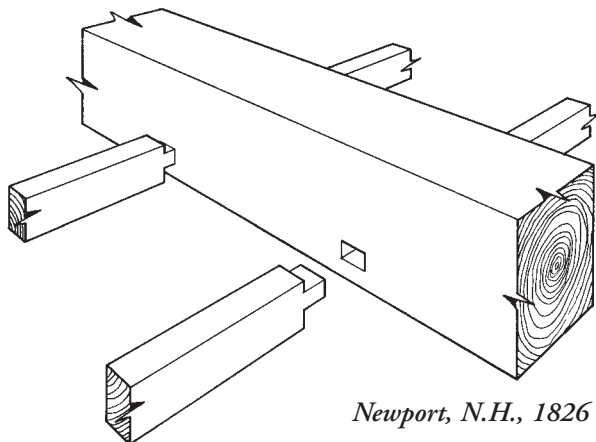
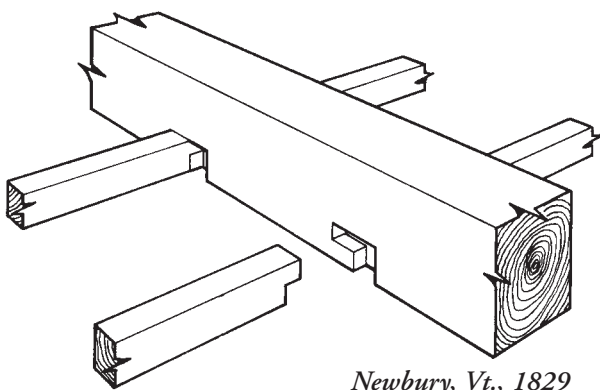
Fig. 14. Four strategies to admit ceiling joists between erected trusses.

Long chase or pulley mortises might be provided in the tie beam at one end of a bay of joists and closed mortises in the tie at the other end, as at Rindge or the 1715 Hatfield, Mass., Meetinghouse. An analogous method, used at Brimfield, Mass., and Newbury, Vt., was to tenon joists into a mortise at one end and into an L-shaped slot on the other, the latter entering from the bottom of the tie and sliding over to the right position. A third method was to cut back the tenon shoulders at one end of a ceiling joist and chop its mortise extra deep in the tie beam, allowing the joist to be inserted deeply enough at one end to clear the face of the tie beam at the other. The joist then could be shifted safely to enter its far end into the mortise in the far tie beam; a nail tacked into the overlong tenon at the near end kept the joist in place. This system can be found in the 65-ft. trusses of the 1826 South Congregational Church at Newport, N.H. A fourth system, used at the 1815 Chenango Forks, N.Y., Methodist Church, provides stopped grooves open at the top to allow notched joists to be

dropped in (Fig. 14). With closely spaced trusses such as those at South Strafford Universalist (TF 67, 25), the problem of ceiling joists is simply avoided by nailing heavy furring on 24-in. centers directly to the bottom of the tie beams as the ceiling base.

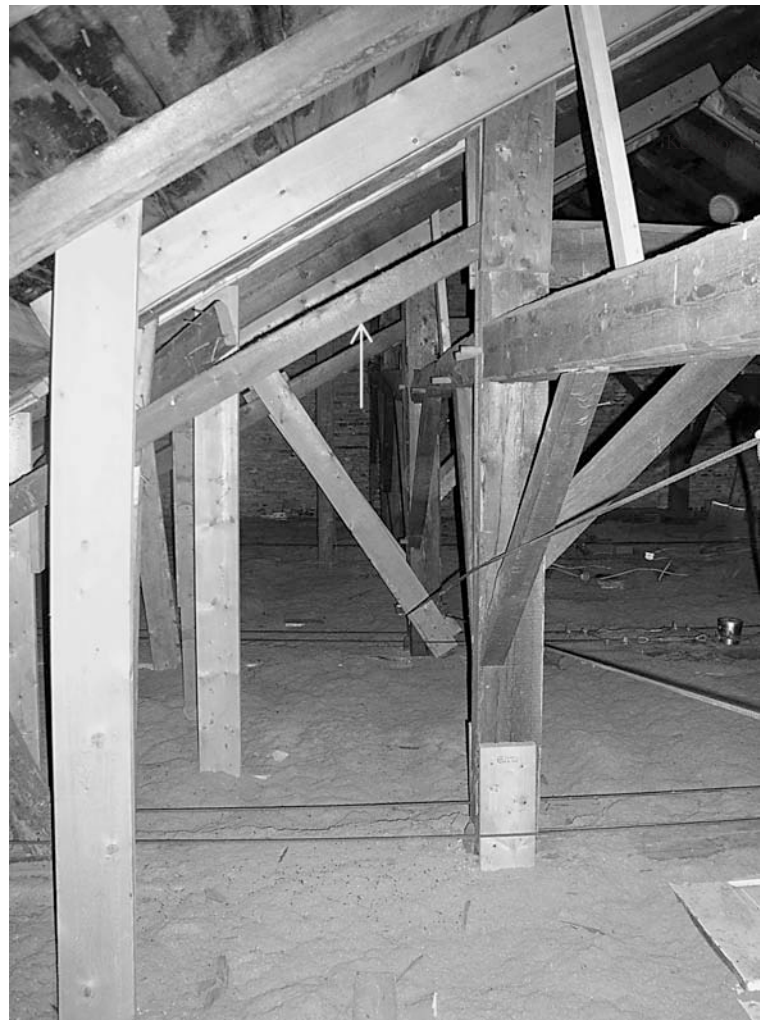
Fig. 15. Waterbury Center, Vt. (1831) has been patched up and cabled following queenpost truss failures. One evident cause is undersized main braces (white arrow), which descend from the queenposts to the tie beams and must withstand considerable compression.

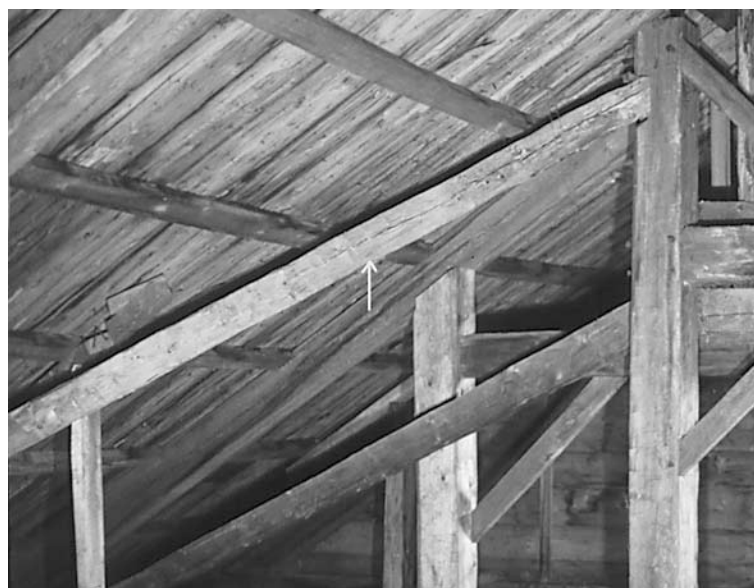
Fig. 17. Long brace (white arrow) flies back from rear post of steeple frame at Newbury to lodge near good support in next tie beam (left). Ken Rower
