Technical Bulletin: Regrooving Elevator Sheaves

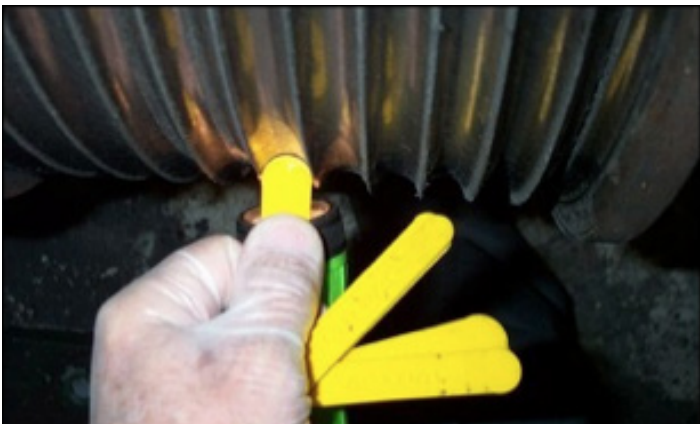
Grooves being checked with groove gauges

Worn sheaves place additional wear on ropes, which in turn add wear onto sheaves, setting up a cycle of destruction for both. Replacing or regrooving sheaves may be necessary to prevent this. Check groove profiles annually to verify the fit between ropes and the sheave. A proper fit means good traction. Without good traction, you’re either sacrificing rope life, sheave wear, or both. Take the time to perform a quick check and measure whether all the ropes sitting in their sheave grooves are at equal height.

Drive sheave grooves being checked with groove gauges for 5/8" rope

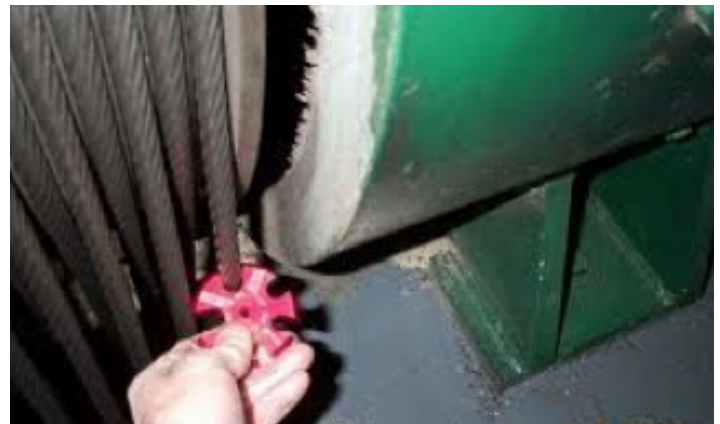
Rope measuring

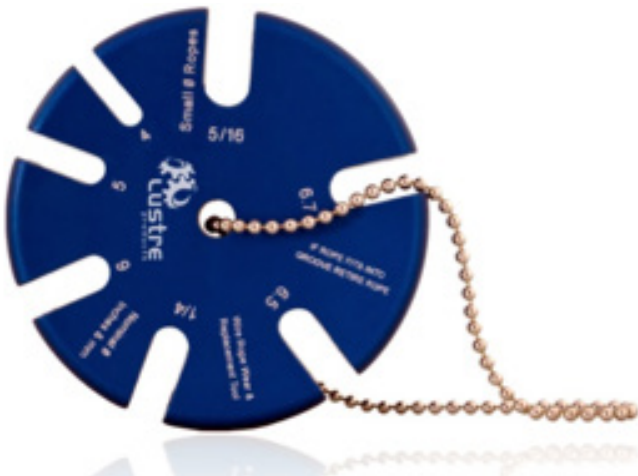
Rope gauge
