Diagnostics of Coating Breakdown in Ballast Tanks

Testing - Assessment - Prevention (TAP)

Peter Contraros

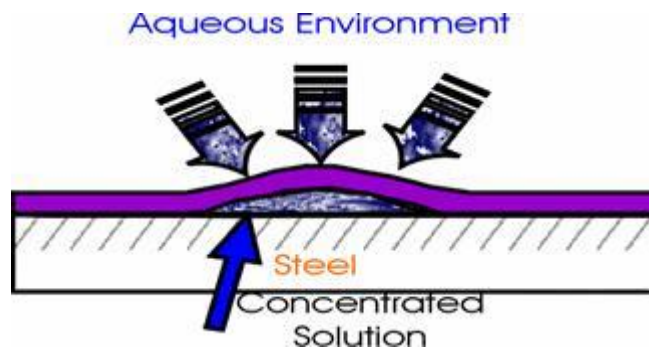
Figure 1

During the initiation phase, the coating is still relatively plastic and pores (otherwise known as 'D' areas) are dynamically forming and being blocked by corrosion products. This phase can last in the order of 18 months to 2 years.

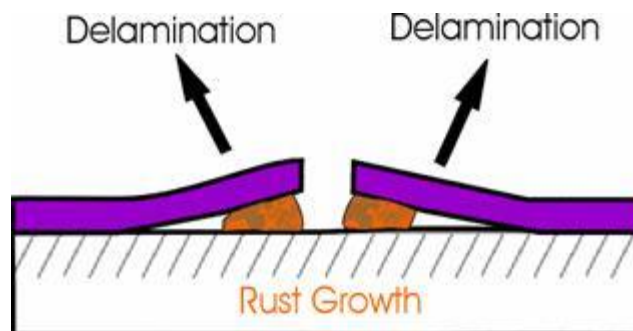
Figure 2

In the *stabilisation* phase, small areas of coating become detached from the steel by one or more of cathodic delamination, rust jacking (see Fig 4) and cyclic micro blistering (see Figs 1 and 2). This results in a steady deterioration in the barrier properties of the coating, which is also losing its retained solvents and any plasticisers (where used) into the ballast water and thus becoming more brittle.

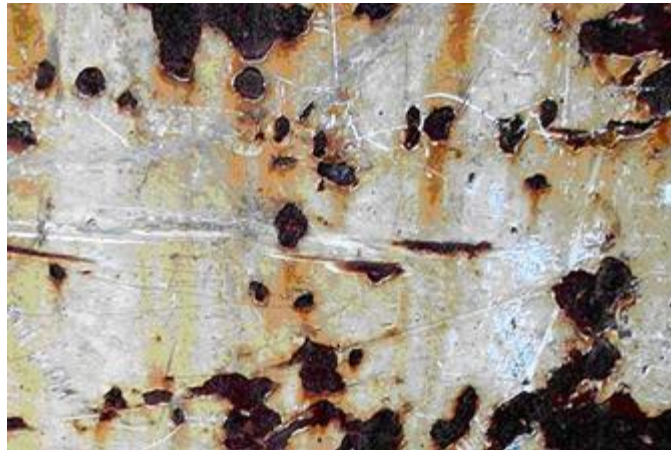
Figure 3 Rust jacking

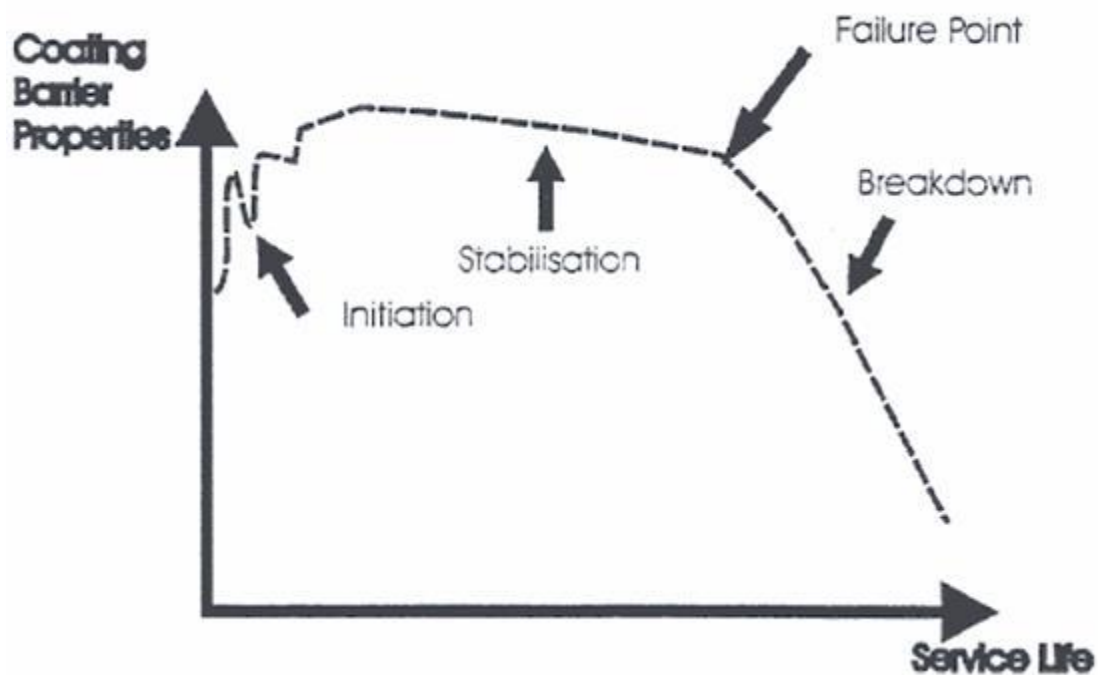
Our understanding is that the barrier properties of the coating change with time and that change is non linear. Figure 4 shows schematically these changes.

Figure 4 – Sketch of Coating barrier degradation during the vessels Ballast tank life
(See Reference 8)

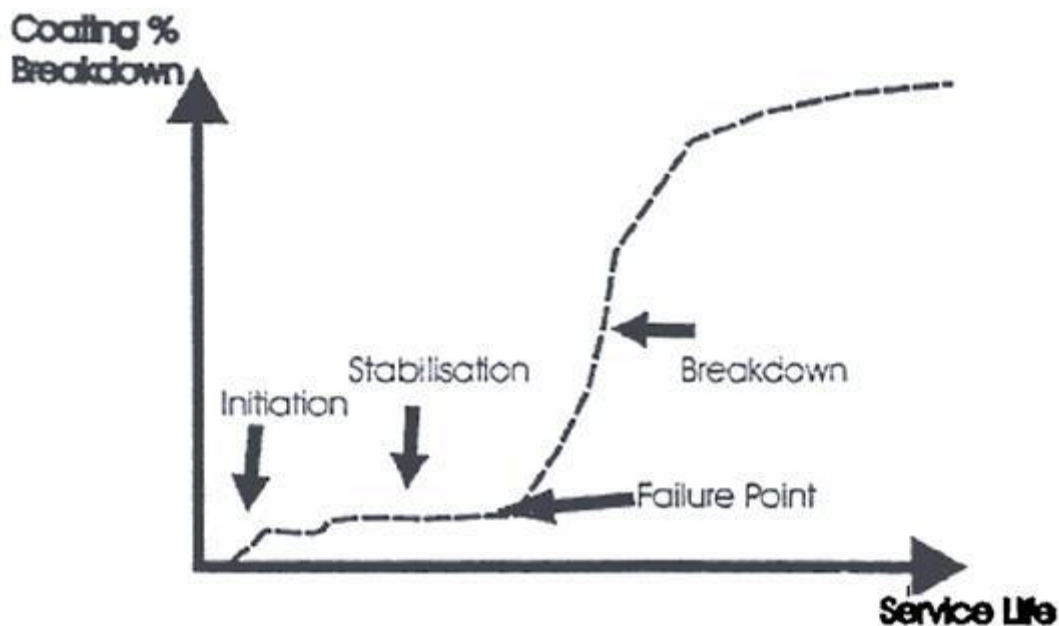
As we have indicated above, coating barrier properties may be categorised into three basic stages: Initiation which may be approximated over the first six months of the life of the coating. Stabilization over six months to 20 months, where the barrier properties are non linearly sustained and stabilized and finally the Breakdown stage which generally starts after 6 years of the coating's service life. The following diagram in Figure 5 shows the three stages of coating barrier breakdown:

Figure 5. Diagram of Ballast Tank Coating Area Breakdown against Service Life Time
(See Reference 8)

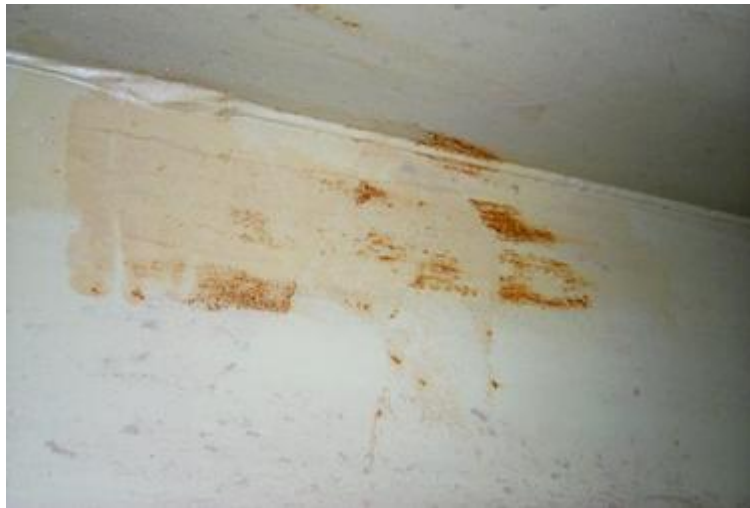
Fig. 6 Breakdown at Areas of Coating Touch up – Connection of Shear Strake to side Deck stringer in Double Hull Tanker (15 months old).

However, it would appear that coatings still breakdown well before the estimated duration. It has been noticed that coating breakdown commences on the most serious locations (see Fig. 6 & 7) in the structure like the welding of critical joints and edges of structural of stiffeners and girders.

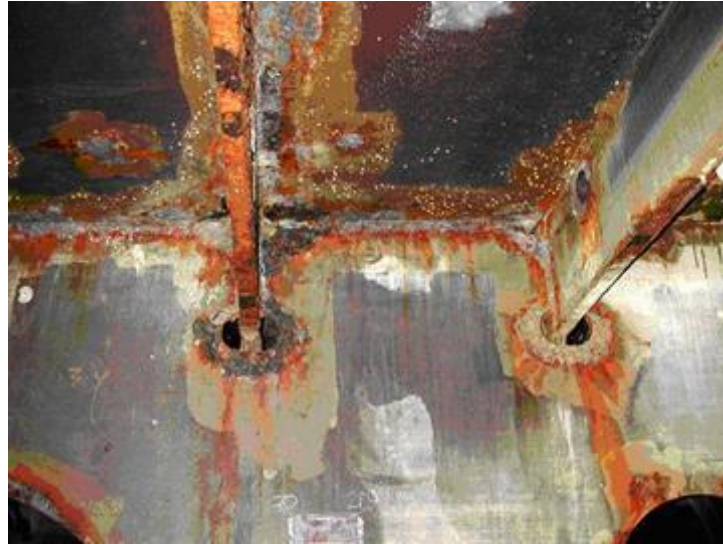
The photograph in Figure 7 was taken onboard a 15 month old double hull tanker and shows corrosion on a high tensile shear strake in way of its connection to the main deck stringer. This area structurally is one of the most important connections on the ship where any failure may well undermine the ship's survivability. It is obvious that the crew's touch ups did not work. This is a representative picture of typical non-effective coating repair, which can also be found in many other locations and in many similar vessels. Similarly, Figure 7 shows severe corrosion at the end

connections of the deck longitudinals and deck plating to the transverse web of top side tank in a bulk carrier, where maintenance by the crew is not feasible and yet the remaining coatings on the deck between webs and the web appear to be visually satisfactory. However the severity of the coating breakdown in the connection may well make the longitudinals redundant and thus propagate into catastrophic failure.

Fig. 7 - Severe Corrosion at the End Connections of Main Deck Plating & Longitudinals to transverse web

Determination of coating breakdown mechanisms in ballast tanks may well be very difficult as these mechanisms are electrochemical in nature with large cathodes on flat plate surfaces, driving a small anode, which may be the weld connections and edges (see Reference 8). Again the concentration of corrosion current, which is in addition to the high stress, will drive the coating breakdown in the most vulnerable areas of the structure with some severity as shown in Figure 7.

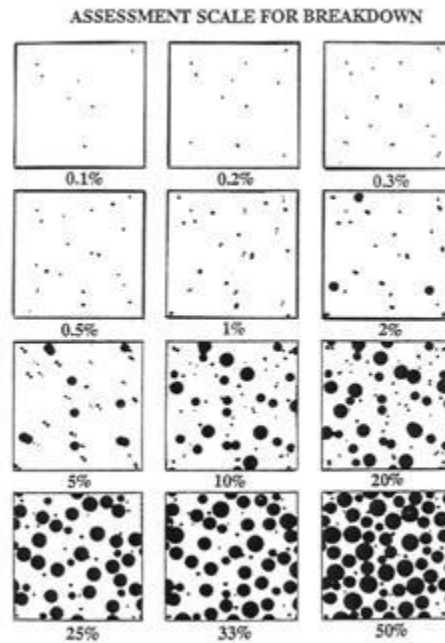
Assessment of coating breakdown in ballast tanks of ships after construction is regulated by IACS and all IACS Class Societies and based on the following diagram of Assessment Scale for Breakdown (Figure 8). This extent diagram provides an overview of the general tank condition, where several areas of particular structural importance have not been able to be identified.

Figure 8 Current Class scatter diagrams for corrosion and coating breakdown assessment

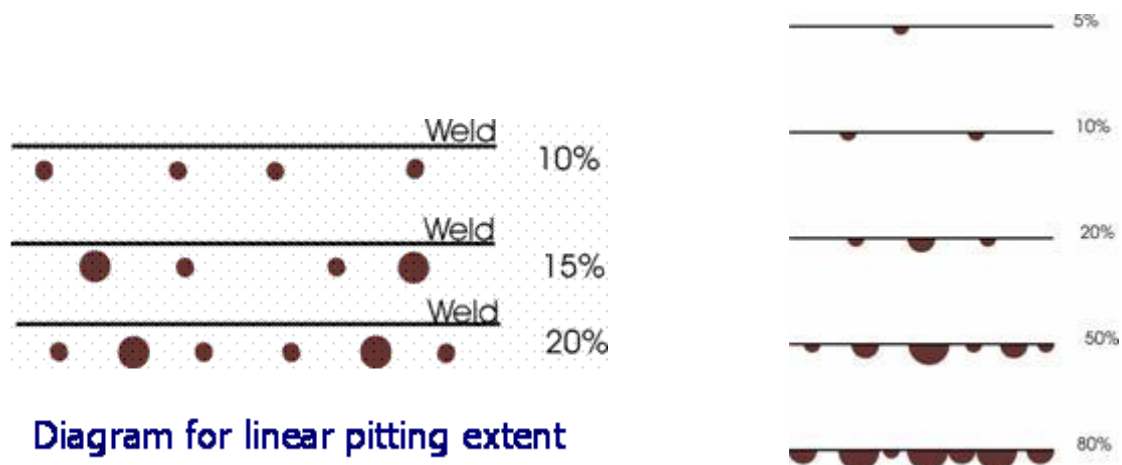
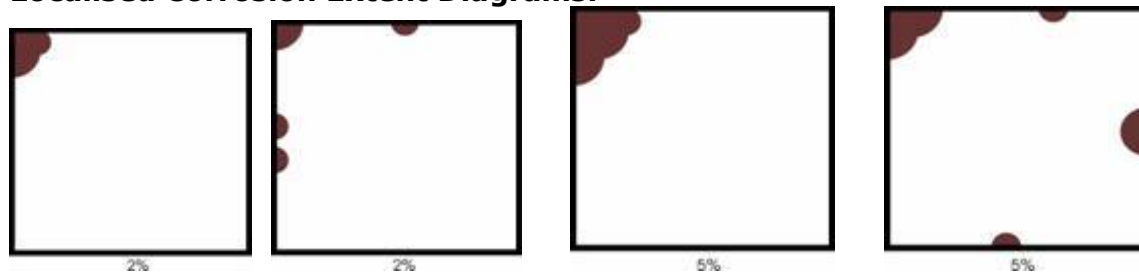
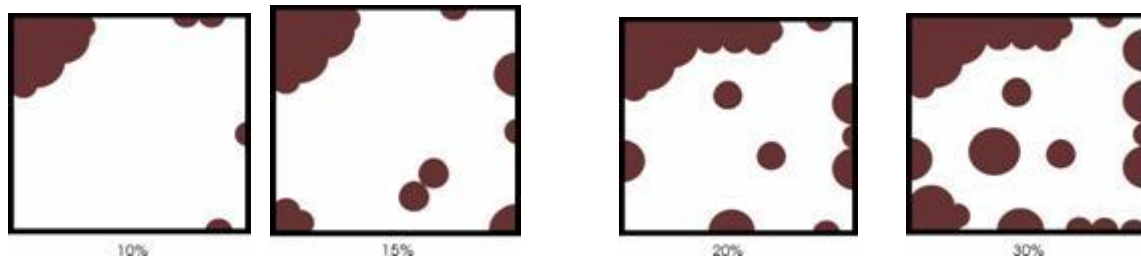
It is therefore possible to identify these areas using the following New Extent Diagram for assessment of corrosion at edges and weld joints (see Figure 9) that can be addressed by the attending Inspector and rectified in good time. A failure of addressing such coating breakdown may lead to the complete collapse of the coating system, leading to substantial diminution of the steel weld substrate. All the above maybe accompanied by a specific protocol that identifies the type of coating breakdown, extent of corrosion, diminution of the substrate and effectiveness of the sacrificial anodes if fitted. All these maybe achieved in numerical form and thus assess the coating barrier visually in totality and provide some intelligence to the coating manufacturer/supplier and ship-owner/operator about the type and extent of the problem in the coatings in the ballast tank.

Diagram for linear pitting extent

New extend diagram for assessment of corrosion at edges

Localised Corrosion Extent Diagrams.

Figure 9. New localised breakdown extent diagrams.
