The passenger station and agent's house: reconstruction of Liverpool Road elevation in 1830.

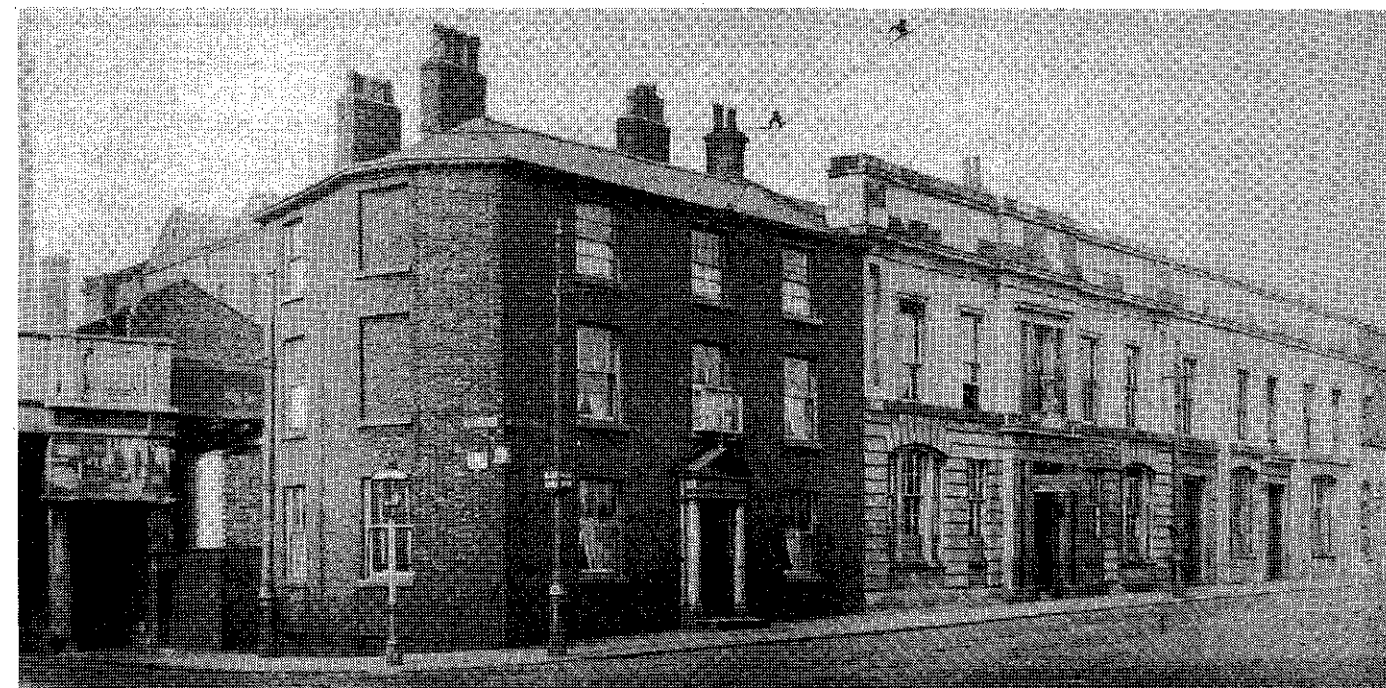
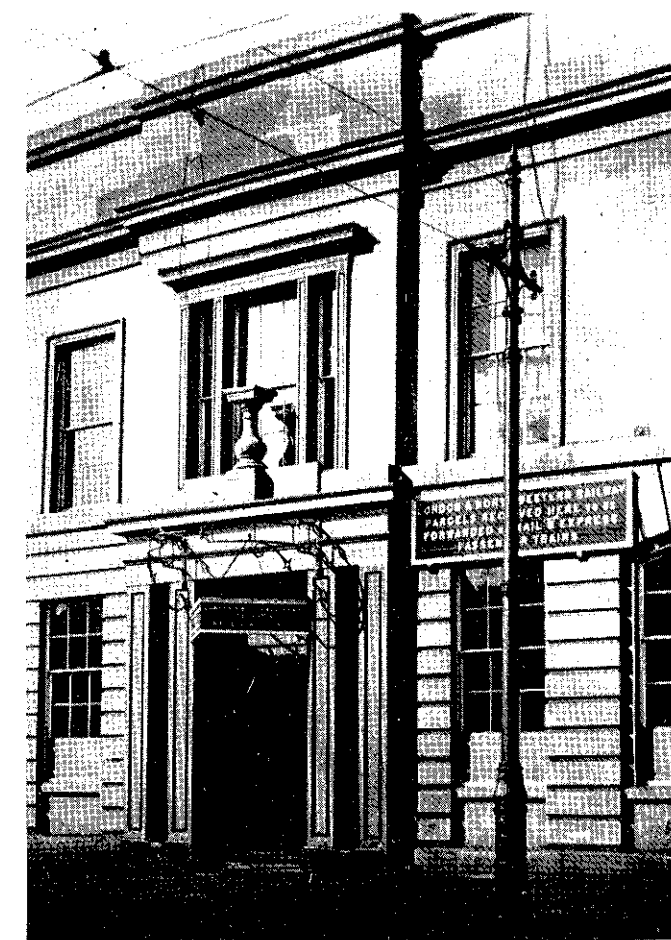
Liverpool Road Station in 1905 (above). (Right) the first-class entrance. Its condition is that of 1830.
