Arrangements for the Termination of a Nuclear or Radiological Emergency

Case Study: Part 2. The Fukushima Daiichi Nuclear Power Plant (NPP) Accident in 2011

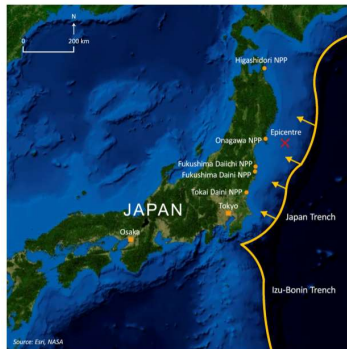
FIG. on the left: The epicenter of the Great East Japan Earthquake and the NPPs nearby, International Atomic Energy Agency, The Fukushima Daiichi Accident, Report by the IAEA Director General, IAEA, Vienna (2015)

FIG. on the top right: The variation of tsunami wave impact, inundation (top) and runup (bottom), based on the coastal geography and topography, International Atomic Energy Agency, The Fukushima Daiichi Accident, Report by the IAEA Director General, IAEA, Vienna (2015)

FIG. on the bottom right: The elevations and locations of structures and components at the Fukushima Daiichi NPP, International Atomic Energy Agency, The Fukushima Daiichi Accident, Report by the IAEA Director General, IAEA, Vienna (2015)

1. The Great East Japan Earthquake (magnitude 9.0) led to tsunamis that struck a wide area of coastal Japan, notably along the north-eastern coast, which led to the loss of many lives (15 000 people killed, over 6000 injured) and widespread damage to buildings and infrastructure (see map on the left);

2. A number of nuclear power plants are located along this coast (map on left), and while a number of them experienced waves heights considerably in excess of 10 m (see map – upper right hand side), only Fukushima Daiichi experienced a sustained loss of power on-site following inundation by the tsunami. The conditions at the other sites were such that they were able to withstand the tsunami or able to recover power;

3. At Fukushima Daiichi, the sea wall was at a height of between 5 to 10 m above normal sea level, and essential equipment, including the emergency diesel generators, were at a lower or similar level (see map – lower right hand side) and were flooded and rendered inoperable by the tsunami;
