# **Arrangements for the Termination of a Nuclear or Radiological Emergency**

**Case Study Part 1:  
The Nuclear Incident in the Paks Nuclear Power  
Plant in Hungary and the Radiological Accident  
in Goiânia, Brazil**

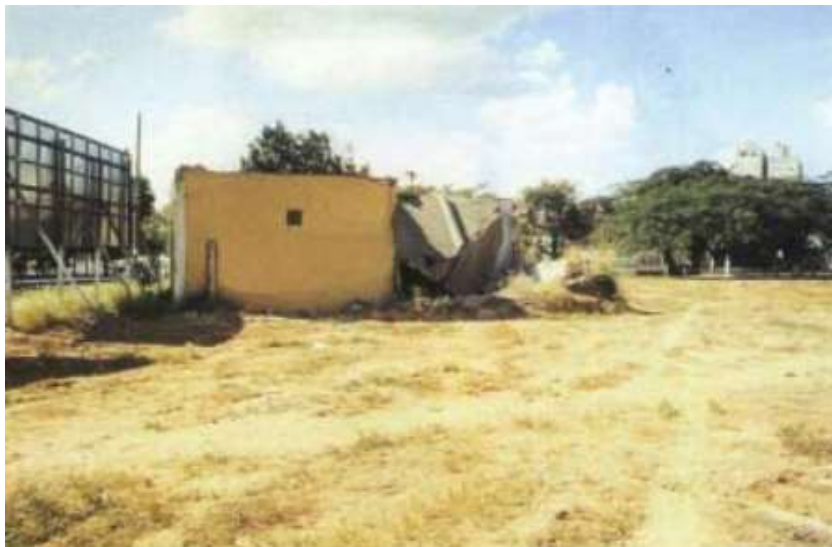
- Person A and Person B dismantled a teletherapy unit found in an abandoned clinic in Goiânia, a small city located in central Brazil.

*Images reproduced from 'The Radiological Accident in Goiânia', IAEA , Vienna (1988)*

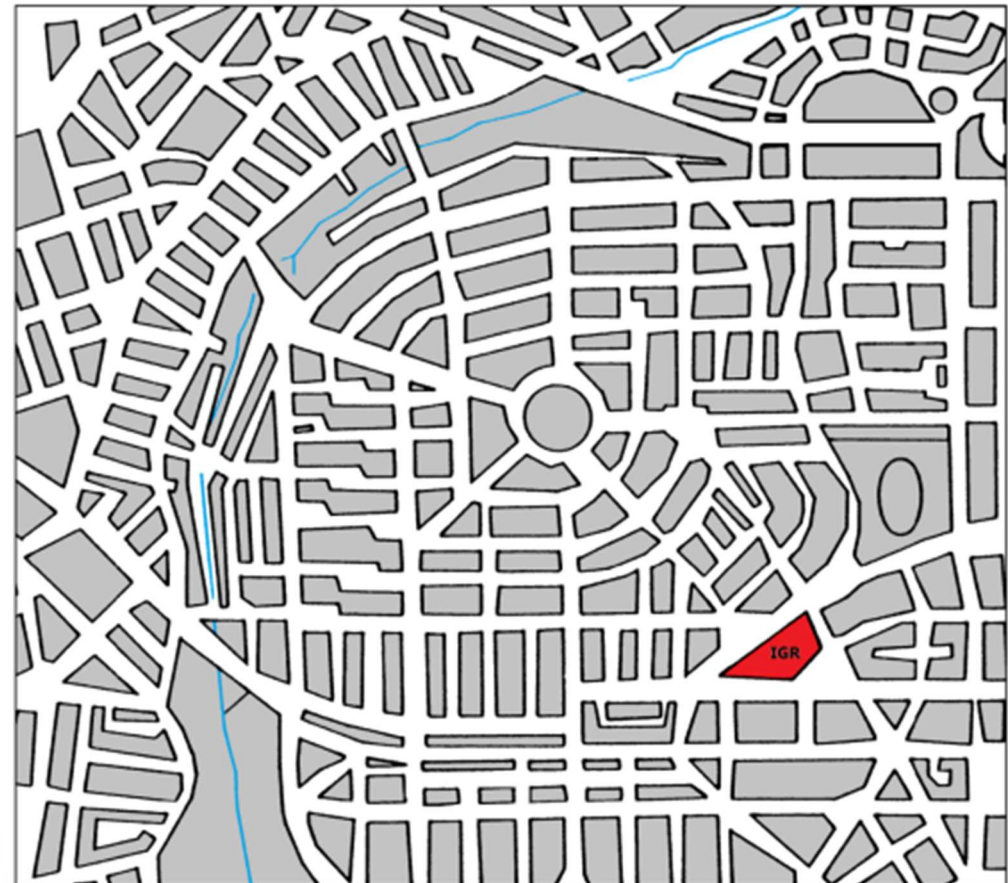
## 13 September 1987

### Removal of the source

- These two persons removed the source rotating assembly and carried it to Person A's house in a wheel barrow.
- In the evening, they both began to vomit.

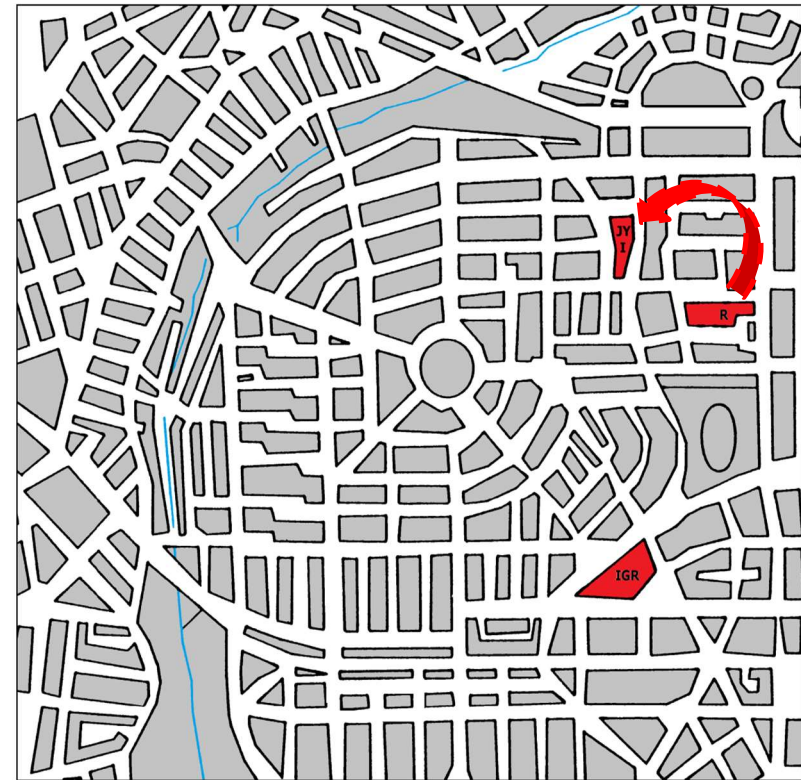
# 18 September 1987

## Source damage

- In his garden, Person A worked to remove the source wheel from the rotating shutter, accidentally punctured the source capsule with a screwdriver and removed some of the material.
- Person A sold the pieces of the rotating assembly to Person C, the owner of a junkyard (JY I).
