# Arrangements for the Termination of a Nuclear or Radiological Emergency

**Case Study:** Part 1. The Nuclear Incident in the Paks Nuclear Power Plant (NPP) in Hungary in 2003 and the Radiological Accident in Goiânia, Brazil in 1987

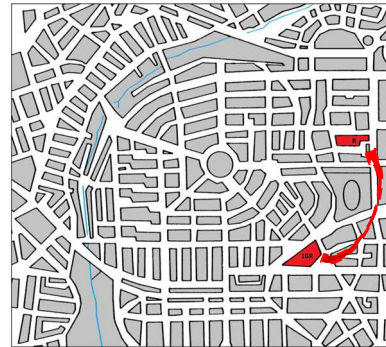
Image reproduced from 'The Radiological Accident in Goiânia', IAEA, Vienna (1988)

*FIG.: Map of Goiânia showing the movement of the source, International Atomic Energy Agency, The Radiological Accident in Goiânia, IAEA, Vienna (1988)*

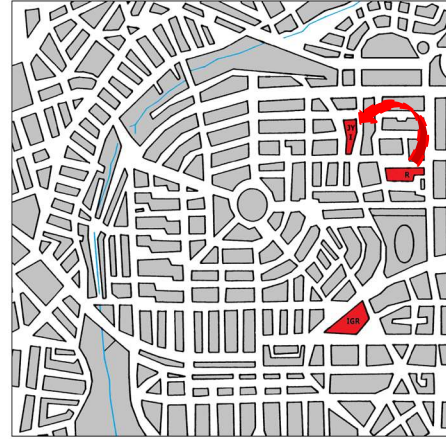
Image reproduced from 'The Radiological Accident in Goiânia', IAEA, Vienna (1988)

A couple of days later, the first person tried to remove the source wheel from the rotating shutter and accidentally punctured the source capsule with a screwdriver. He scooped out some of the material thinking that it was gunpowder and tried to ignite it, unsuccessfully of course.

*FIG.: Map of Goiânia showing the movement of the source, International Atomic Energy Agency, The Radiological Accident in Goiânia, IAEA, Vienna (1988)*
