# Arrangements for the Termination of a Nuclear or Radiological Emergency

**Case Study:** Part 3. The Radiological Incident in Hueypoxtle, Mexico in 2013

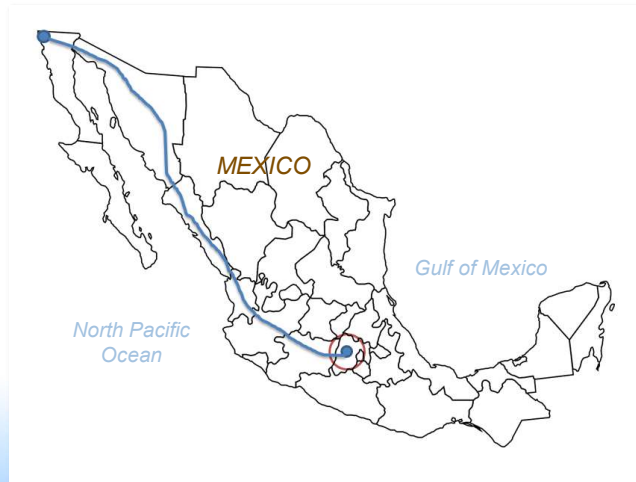
On 28 November 2013, a truck left the city of Tijuana (Baja California State) carrying a teletherapy unit head (about 3000 Ci or 100 TBq  $^{60}\text{Co}$ ) from the Hospital General Regional 20 (Instituto Mexicano del Seguro Social - IMSS).

The event has its start on 28 November 2013, when an old teletherapy unit was decommissioned in a hospital (Hospital General Regional 20) in Tijuana (Baja California), and the head with its cobalt-60 source had to be transported by road to a waste storage facility close to Mexico City. The residual activity of the source was estimated at about 100 TBq.

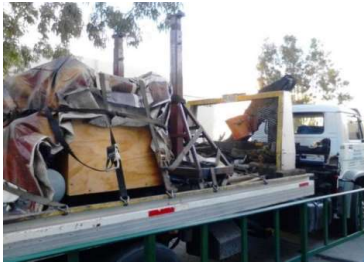
*Image courtesy of CNSNS*

Its final destination was a radioactive waste storage facility (Centro de Almacenamiento de Desechos Radiactivos - CADER), located near the town of Santa María Maquixco (Mexico State), a trip of 2800 km.

*FIG.: Vehicle transporting the teletherapy unit with Co-60, International Atomic Energy Agency, Arrangements for the Termination of a Nuclear or Radiological Emergency, IAEA Safety Standards Series No. GSG-11, IAEA, Vienna (2018)*

The truck with the radioactive parts had to cross some 2800 km to reach the waste storage facility near Santa Maria Maquixco.

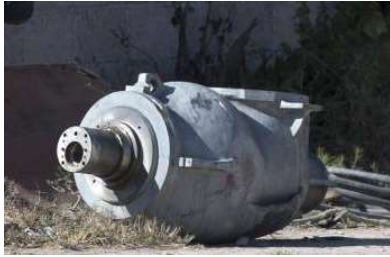
- The thieves were apparently only interested in the vehicle.
- Still, the teletherapy head was dismantled and the  $^{60}\text{Co}$  source was removed from its shielding.

However, it appeared later that the teletherapy head had been dismantled, and the Co -60 source removed from its shielding.

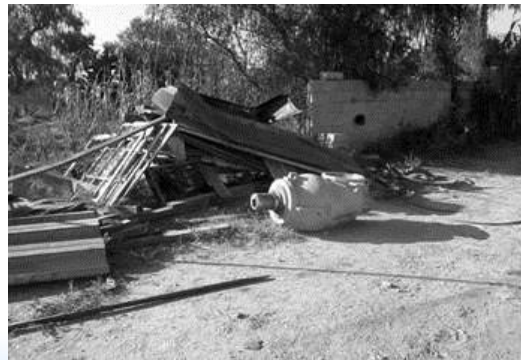
- The Federal Police located the teletherapy head in a local backyard and reported it to the CNSNS. The shielding casing was empty.
  - A local resident had brought the device home thinking that it was a water pump. He could not read English and therefore was not aware of a potential radiation hazard.

*FIG. on the right: The empty shielding of the radioactive source (courtesy of the CNSNS), International Atomic Energy Agency, Arrangements for the Termination of a Nuclear or Radiological Emergency, IAEA Safety Standards Series No. GSG-11, IAEA, Vienna (2018)*

Two days later, the police located the teletherapy head in the backyard of a local resident and reported the discovery to the CNSNS. The shielding was empty. Apparently, this person had brought the device home thinking that it was a water pump. In fact, he could not read English and did not understand the indications painted on the shielding and therefore was ignorant of a potential radiation threat.

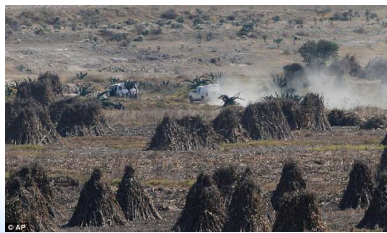
*Image courtesy of CNSNS*

- The federal police identified an area in the vicinity of Hueypoxtla, where the radiation level exceeded the normal background.
- In the evening, together with a specialized team from the CNSNS, the police located the source; it was lying among the crops in a field. A 500 m radius zone was cordoned off to prevent access.

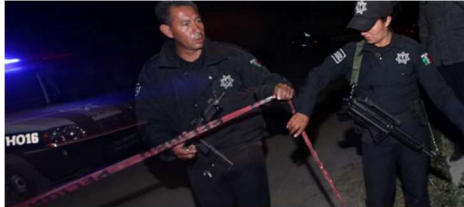
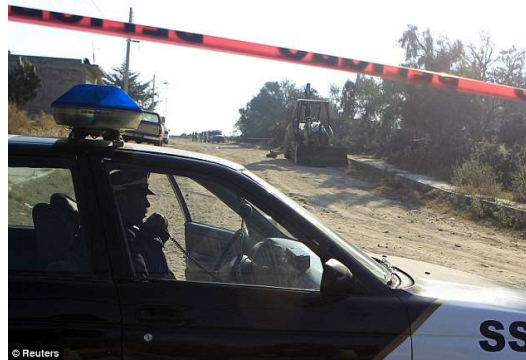
*Images courtesy of CNSNS*

- The activities to delineate the area and more accurately locate the position of the radioactive source continued.

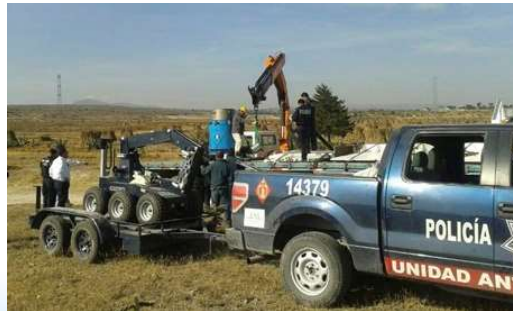
*Image courtesy of CNSNS*

- Experts from the Laguna Verde NPP entered the area previously delineated by CNSNS and determined the exact location of the source.
- A transport container was requested from the National Institute of Nuclear Research (ININ) for recovering the radioactive source. The container had to be adapted for the intended purpose.

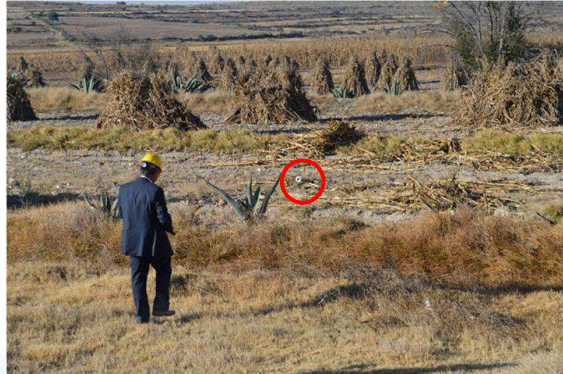
*FIG.: Exposed radioactive source (courtesy of Federal Commission for Electricity of Mexico), International Atomic Energy Agency, Arrangements for the Termination of a Nuclear or Radiological Emergency, IAEA Safety Standards Series No. GSG-11, IAEA, Vienna (2018)*

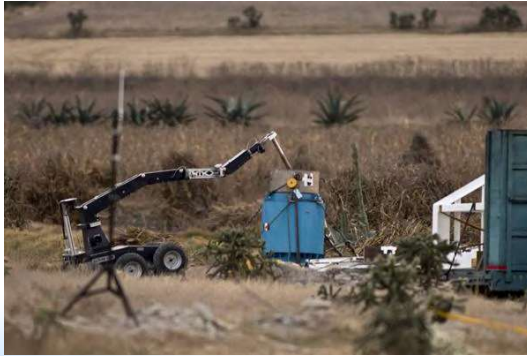
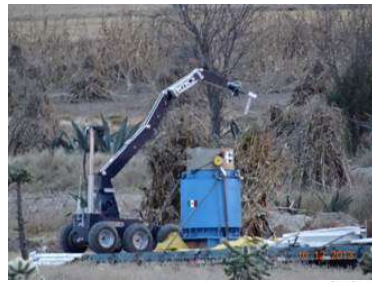
- The source was successfully recovered with the help of a robot, placed in a transport container and transported to the waste storage facility.

On 10 December, the source was successfully recovered with the help of a robot, placed in a transport container and transported to the waste storage facility.

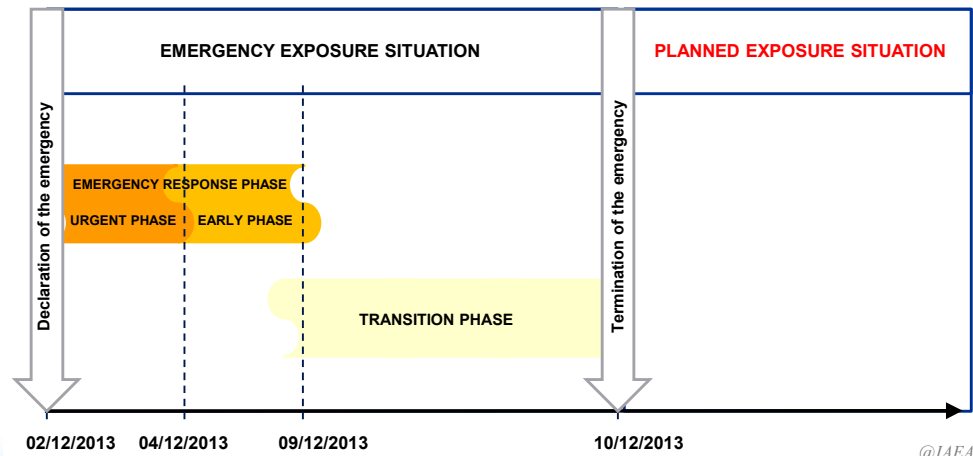
## Retrospective sequencing and milestones of the radiological incident in Hueypoxtlá

If we put the key milestones of the event on the general timeline of an emergency response, the declaration of the emergency occurred on 2 December 2013 with the notification to the CNSNS. The urgent phase lasted until 4 December, after the source had been located and the area was cordoned off to control access. The transition phase started on 9 December, after the integrity of the source had been confirmed. The emergency came to an end with the recovery of the source on 10 December.

- The emergency started on 2 December 2013, when the vehicle transporting a dangerous source was stolen (**urgent response phase**).
- Until 4 December 2013, the emergency response focused on locating the source and issuing warnings and information. On 4 December 2013, the source was located and the area cordoned off and secured (**early response phase**).
- Until 9 December 2013, emergency response focused on identifying the exact location of the source among the crops. On 9 December 2013, the source was isolated and its integrity confirmed (**end of emergency response phase**).
- Plans for recovery progressed in parallel, allowing the rapid recovery of the source on 10 December, by which time monitoring around the site had been completed and all exposed individuals had been identified for assessment and medical follow-up (**transition phase**).
