CONSEC
2019

9th INTERNATIONAL CONFERENCE ON CONCRETE
UNDER SEVERE CONDITIONS-ENVIRONMENT & LOADING

Durability of concretes produced with a mix of ornamental stone waste thermally treated and waste originating from glass stoning - A view to the corrosion resistance of the reinforcements

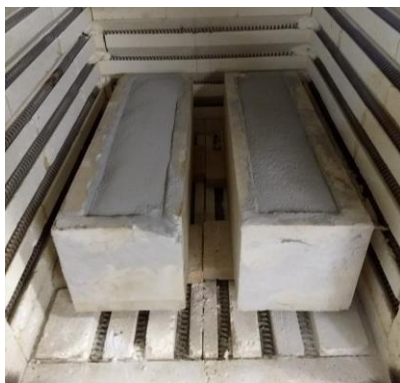
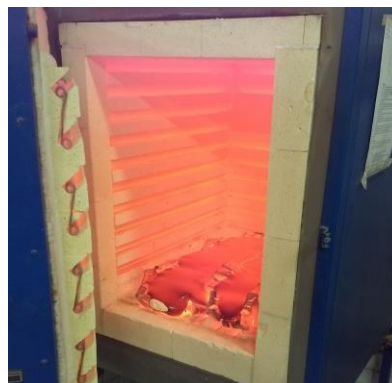
Fig. 2: OSWTT heat treatment process (before) Fig. 3: OSWTT heat treatment process (after)

The heat treatment process was carried out in the Mufla brand Linn High Therm, model KK 170, at an approximate rate of 10 ° C / min until reaching the programmed temperature of 1200 °C, after reaching the desired temperature the temperature was maintained constant for 2 hours and then the natural cooling process was started up to room temperature, as proposed by Degen [9] - Fig. (2) and Fig. (3).

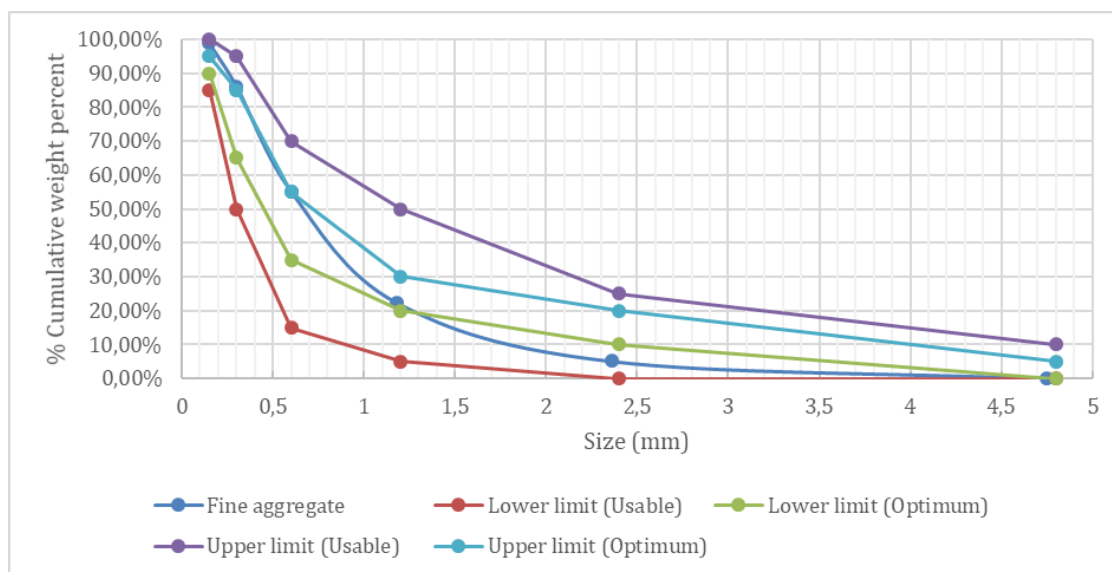
Fig. 3: Granulometric distribution of Fine aggregate

The fine aggregate used was sand, removal from Doce river, an important river on North Espírito Santo region. For the concreting, the sand was sifted to remove impurities, such as leaves and sticks and dried in the air so that its moisture does not interfere with the concrete's mix proportion. Table (1) below shows some properties of the fine aggregate and Fig. (3) shows its granulometric distribution.

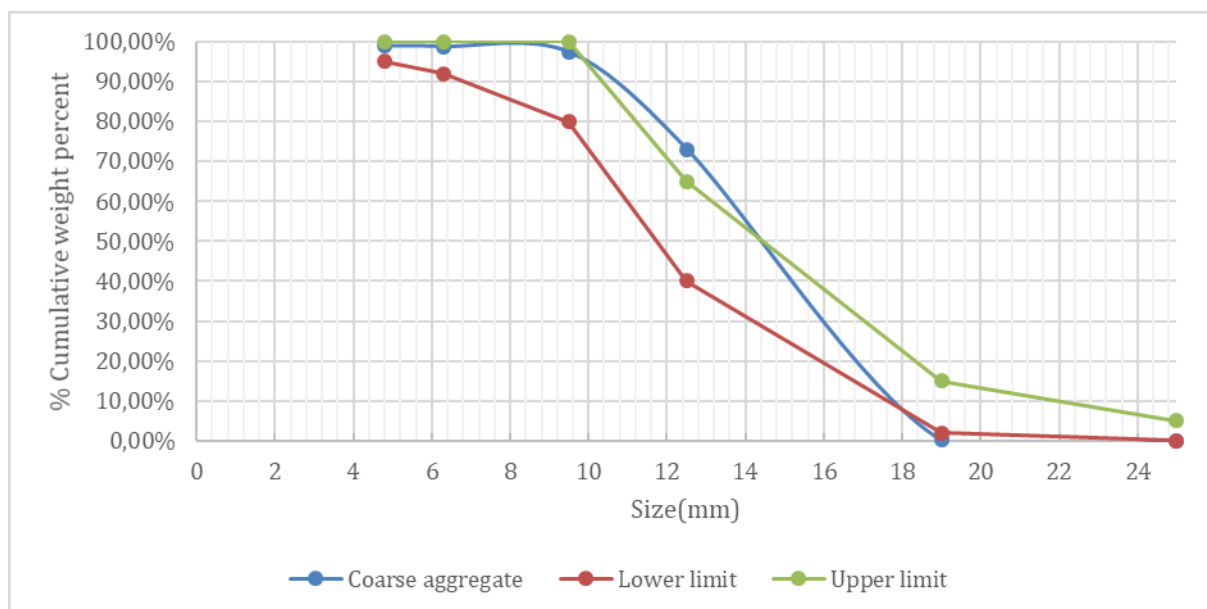
Fig. 4: Granulometric distribution of Coarse aggregate

Coarse aggregate was obtained in Vila Velha / ES/ Brazil. To perform the concreting, coarse aggregate was washed for removal of powdery materials and air dried. Table 2 below shows some properties of the coarse aggregate and Fig. (4) its granulometric distribution.

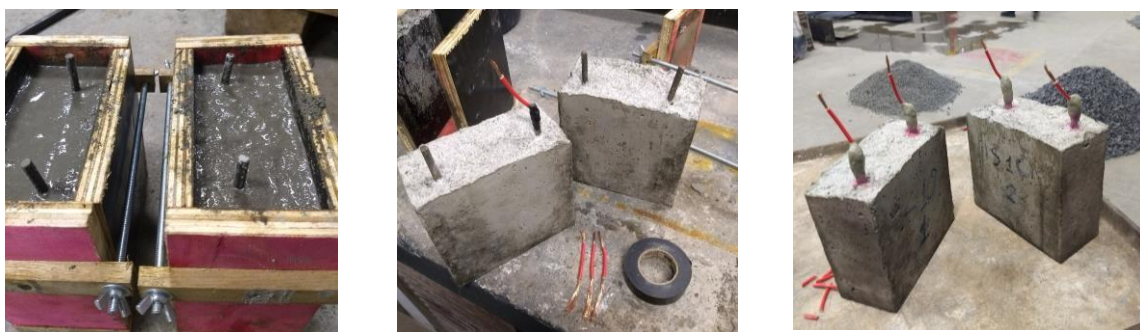
Fig. 6: Demonstration of specimens molding steps

For the molding of the prismatic specimens, two plywood shapes (with dimensions of 15 cm x 17 cm x 7 cm), containing 2 bars of CA - 50 steel of 6.3 mm diameter in each. Wood pieces were used to guarantee the thickness of cover of 2 cm as shown in Fig. (6). The 2 cm cover is the minimum nominal cover permitted in ABNT NBR 6118 [19].

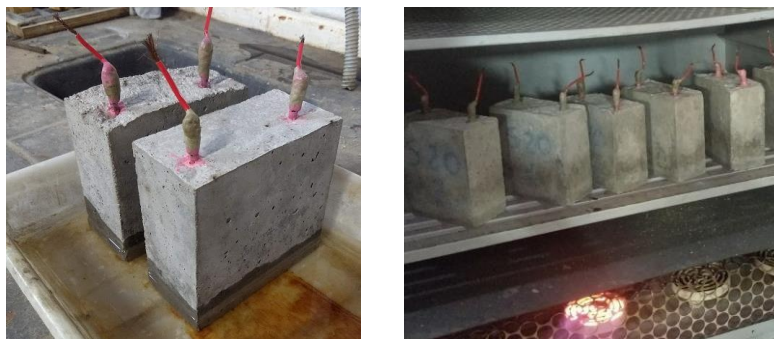
Fig. 7: Immersion in 5% NaCl solution and oven drying

In order to accelerate the process of deposition of the reinforcement, alternating cycles of immersion and drying of the test specimens were carried out in an aggressive solution of 5% NaCl, simulating a marine environment containing enough salts contents that could de-pass the steel bars of the concrete, shown in Fig. (7). These cycles accelerate the corrosion process, because when saturated the test pieces accumulate chlorides, when the drying process begins, there is oxygen inlet and diffusion, which is responsible for evaporating the water from the concrete pores, leaving only the free chlorides that reach the armature and destroy its passive layer, provoking the phenomenon of corrosion [22].

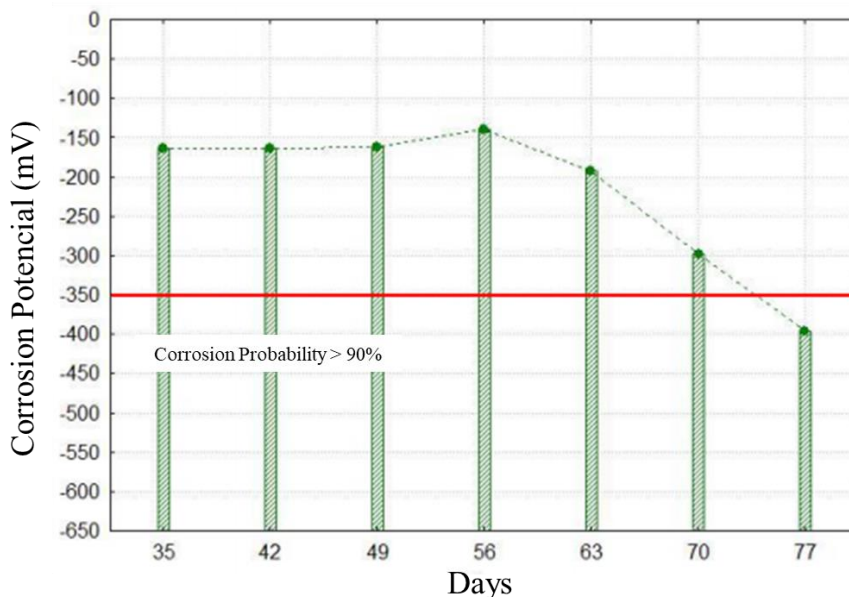
Fig 8. Graphic isolated effect of age variation on the average corrosion potential results

It can be seen from the graph of the corrosion potential in relation to age - Fig. (8) - that there is an increase in the potential difference between the armature and the reference electrode over time, this behavior is expected due to the increase of free chlorides in the as mentioned in item 2.3.

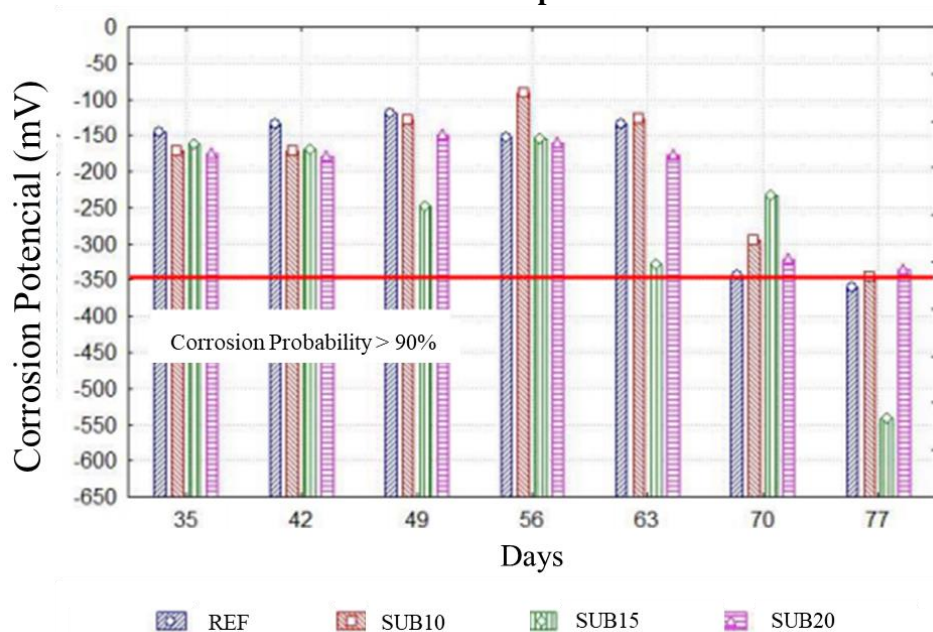
Fig 10. Graph of the effect of the interaction between the age and the percentage of OSWTT and WGS on corrosion potential

The graph of Fig. (10) shows the effect of the interaction between age and percentage of waste. It is observed that the concretes with contents of 10 and 20% presented better performance than the reference after the 6th immersion and drying cycle, in addition, the content of 10% was the one that presented better performance and the content of 20% was the one that stood out the most against the reduction of corrosion potential over time. In the reference concrete, S10 and S20 the dispassivation occurred in two of the four specimens with 6 cycles, the reference and the S15 already presented a bar with dispassivation to the 3rd cycle and to the 7th cycle all the bars presented a 90% chance of presenting corrosion.
