Prüfbericht - Nr.: 50003239 005
*Test Report No.:***Seite 24 von 29**
Page 24 of 29

6. Photographs of the Test Setup

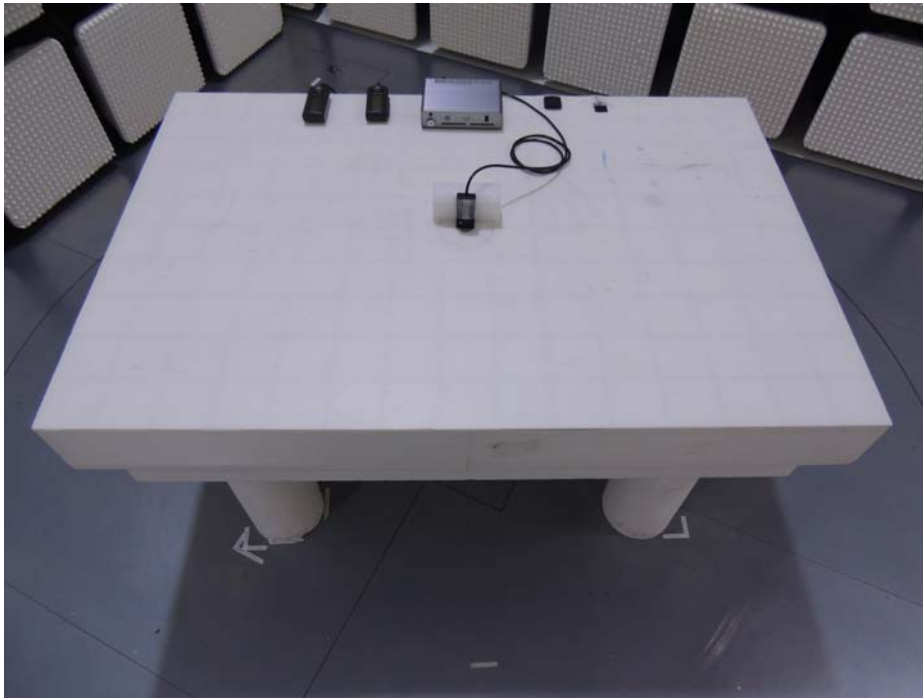
Photograph 1: Set-up for Radiated Emission of Transmitter, Front View

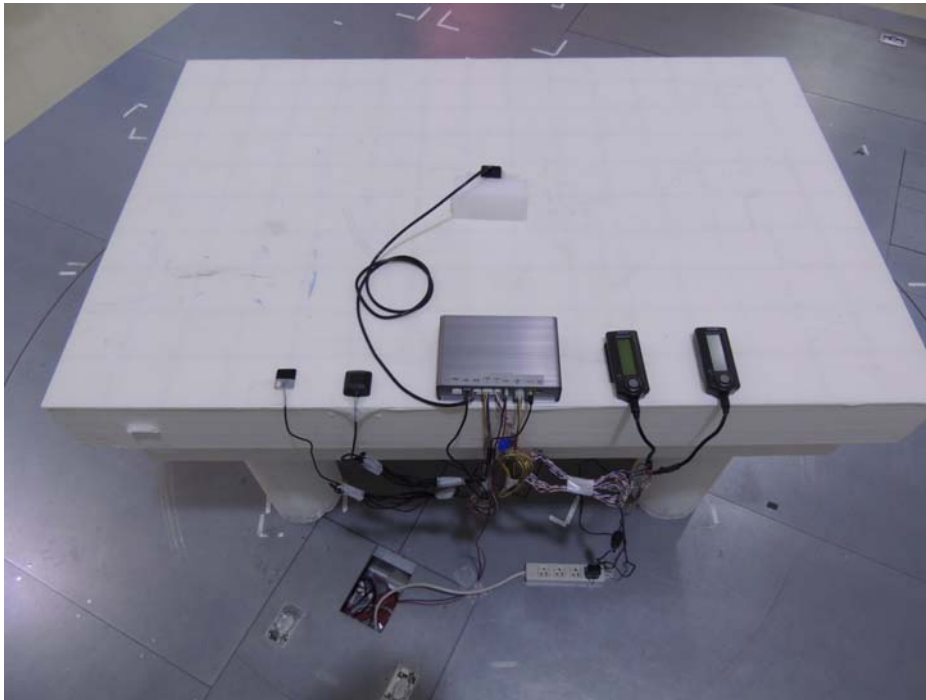
Prüfbericht - Nr.: 50003239 005
Test Report No.:Seite 25 von 29
Page 25 of 29**Photograph 2: Set-up for Radiated Emission of Transmitter, Rear View**

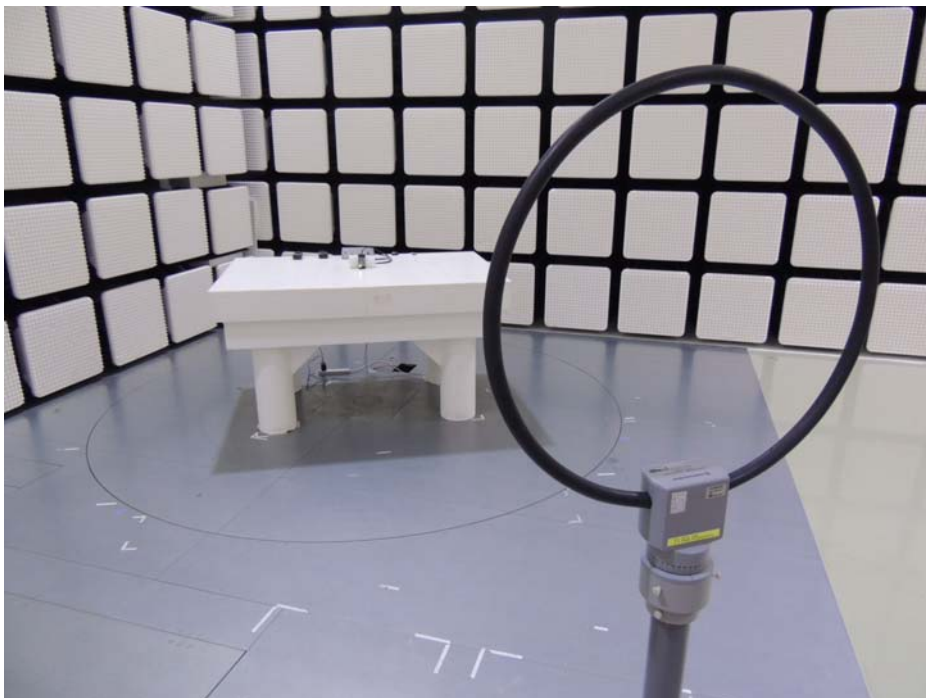
**Photograph 3: Set-up for Radiated Emission of Transmitter, below 30MHz**

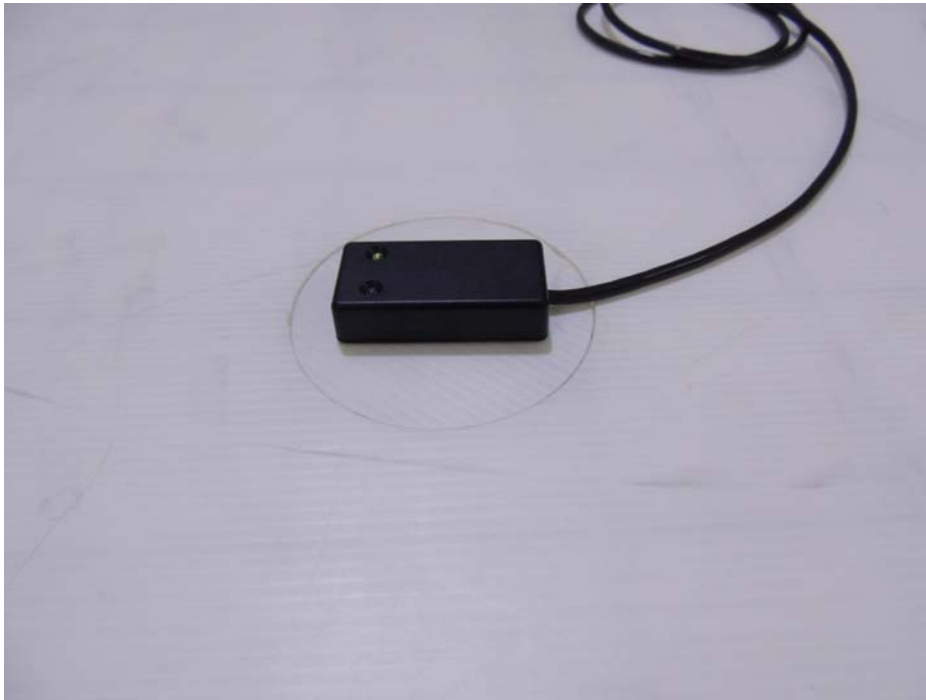
Prüfbericht - Nr.: 50003239 005
*Test Report No.:***Seite 26 von 29**
*Page 26 of 29***Photograph 4: Set-up for Radiated Emission, EUT Configuration X-Axis**

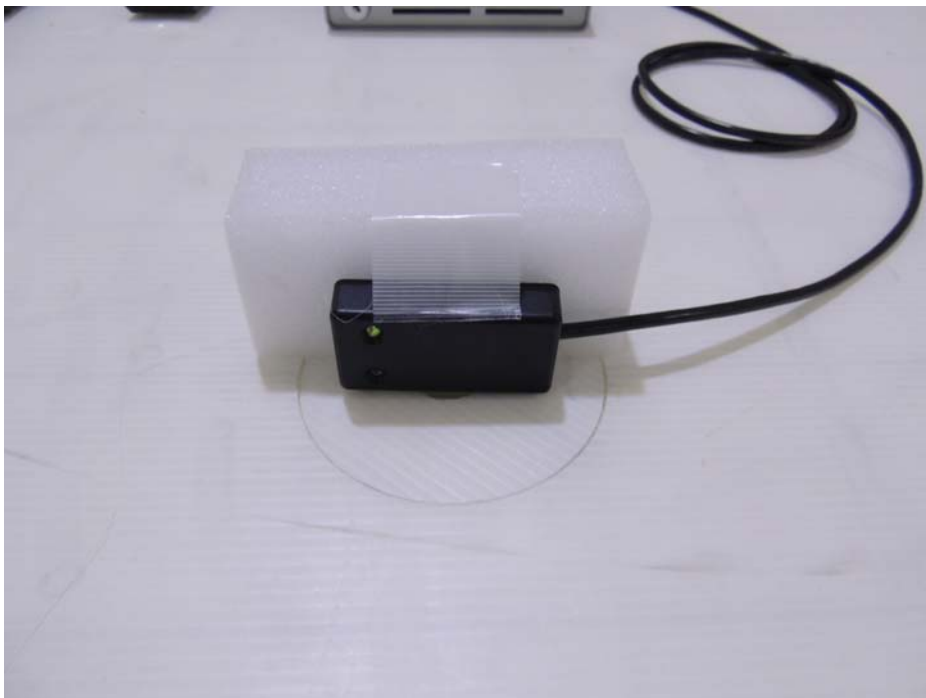
**Photograph 5: Set-up for Radiated Emission, EUT Configuration Y-Axis**

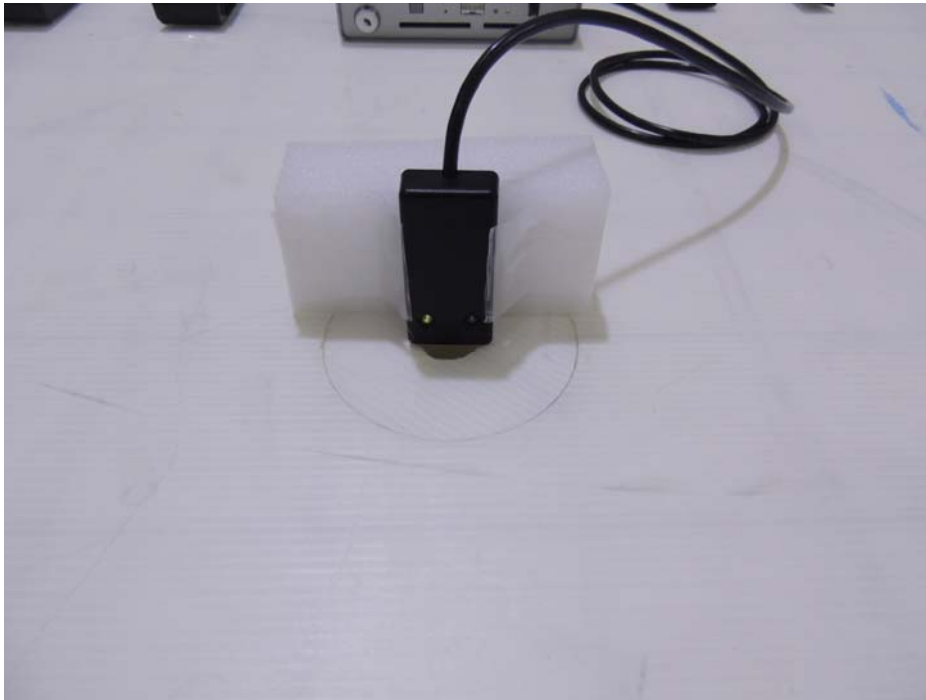
Prüfbericht - Nr.: 50003239 005
Test Report No.:Seite 27 von 29
Page 27 of 29**Photograph 6: Set-up for Radiated Emission, EUT Configuration Z-Axis**

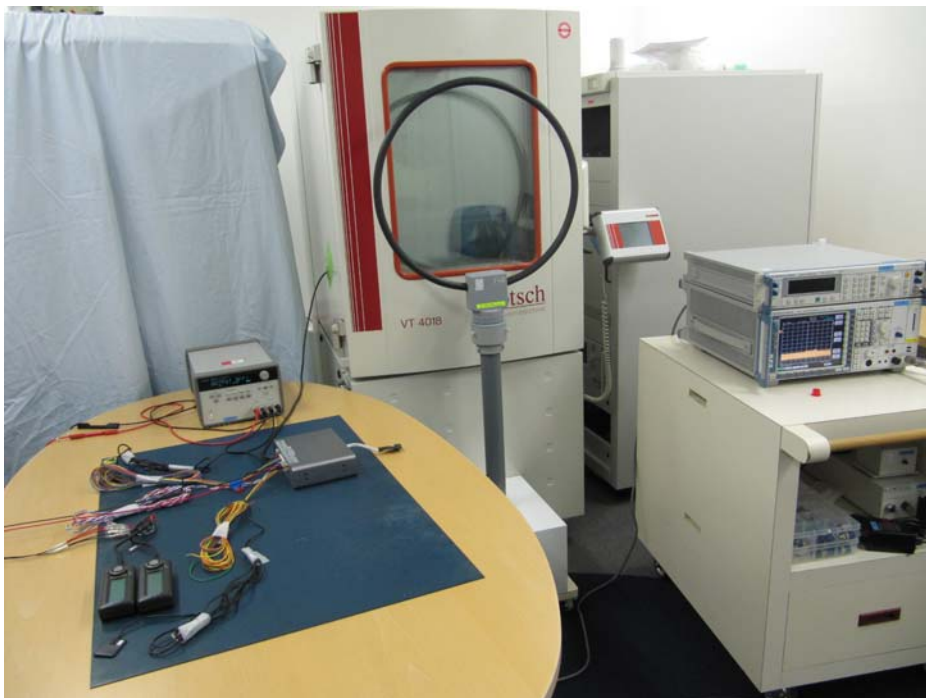
**Photograph 7: Set-up for Frequency Stability, General View**

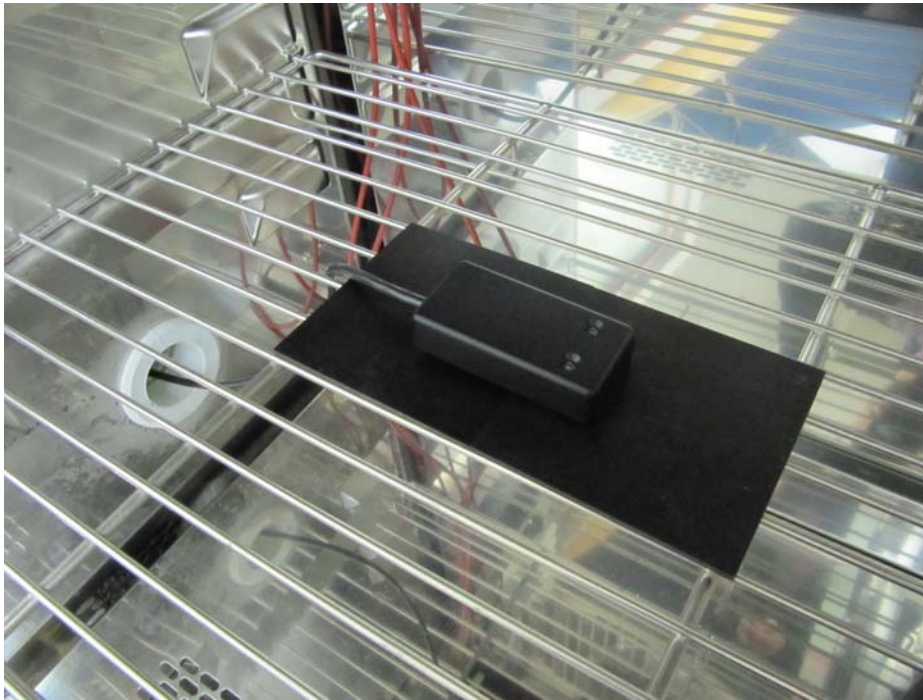
Photograph 8: Set-up for Frequency Stability, Inside Temperature Chamber
