Test Report

No: U142199E2

Designation of equipment under test: Sea Angel SA14

Type of test: Environmental test:
- Thermal Shock
- IP X7

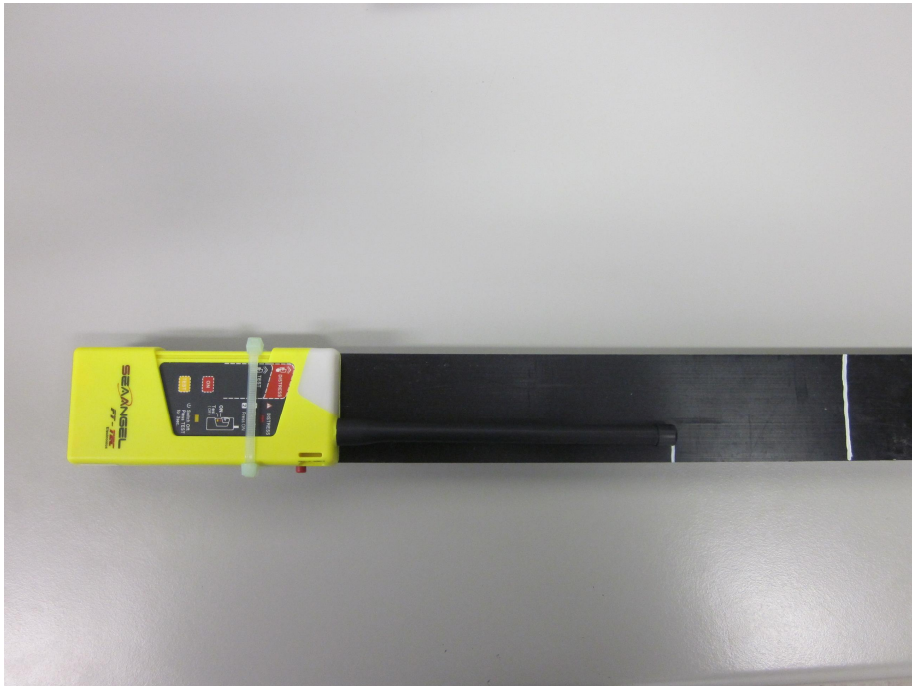
Picture 1: Test set-up Thermal Shock

The EUT shall be placed in an atmosphere of $+70\text{ °C} \pm 3\text{ °C}$ for 1 h. It shall then be immersed in water at $+25\text{ °C} \pm 3\text{ °C}$ to a depth of $100\text{ mm} \pm 5\text{ mm}$, measured from the highest point of the EUT to the surface of the water, for a period of 1 h. At the end of the test the EUT shall be subjected to a performance check, and shall then be examined for damage and for unwanted ingress of water. Following examination, the EUT shall be resealed in accordance with the manufacturer's instructions. Alternatively, if there are no external signs of unwanted ingress of water, an internal examination of the EUT, which involves disturbance to seals, may be carried out after all environmental tests have been completed.

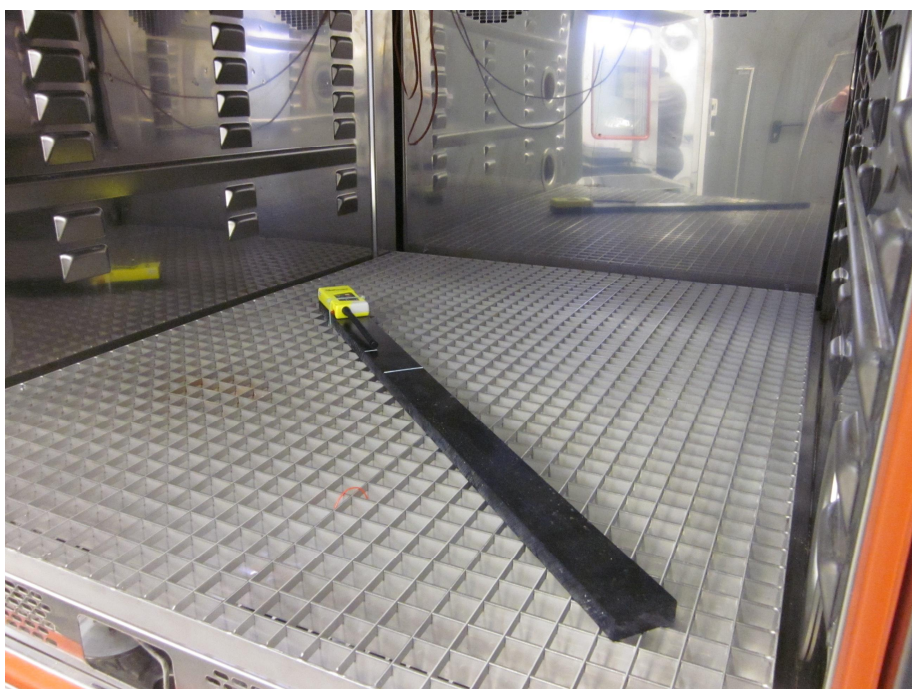
Picture 2: Test set-up Thermal Shock

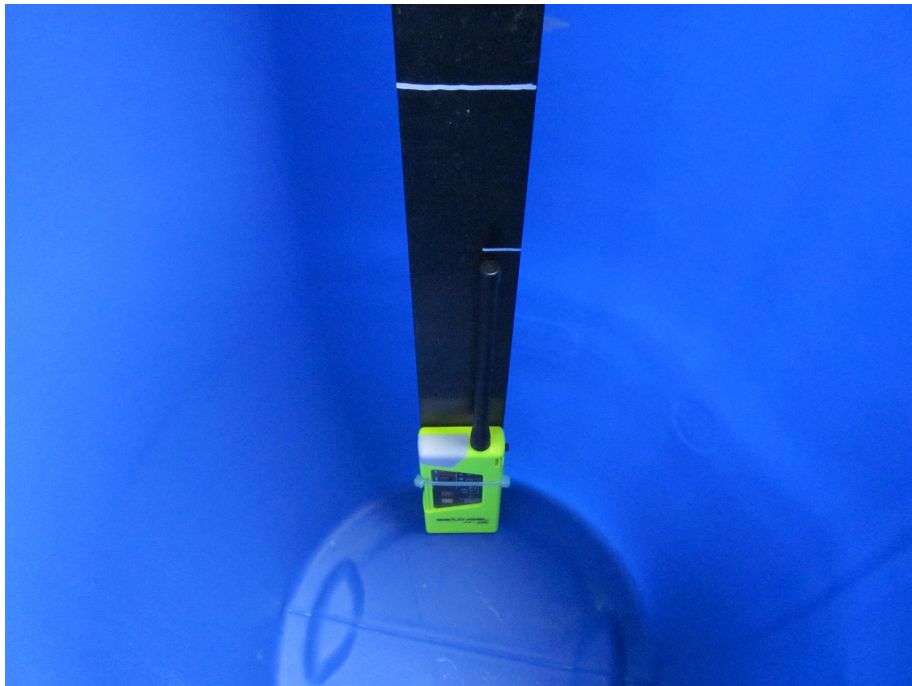
Picture 3: Test set-up Thermal Shock

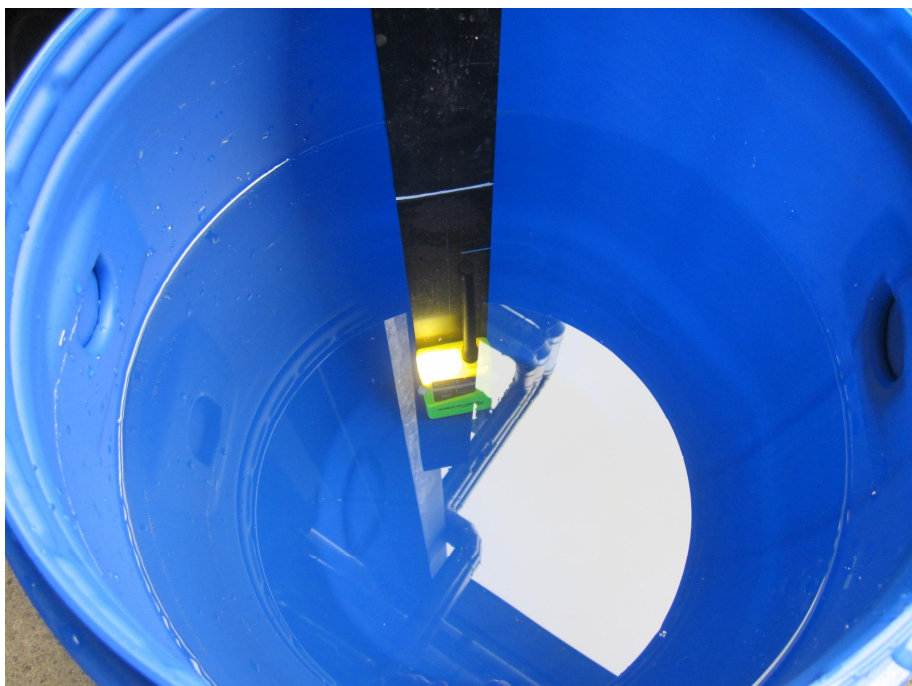
Picture 4: Thermal Shock

DUT	Temp.	Test duration	Visual damages	Performance check during the test	Requirements fulfilled
142199_310608	+ 70 °C	1 h	No	No	Yes
	+ 25°C water	1 h	No	Yes	Yes

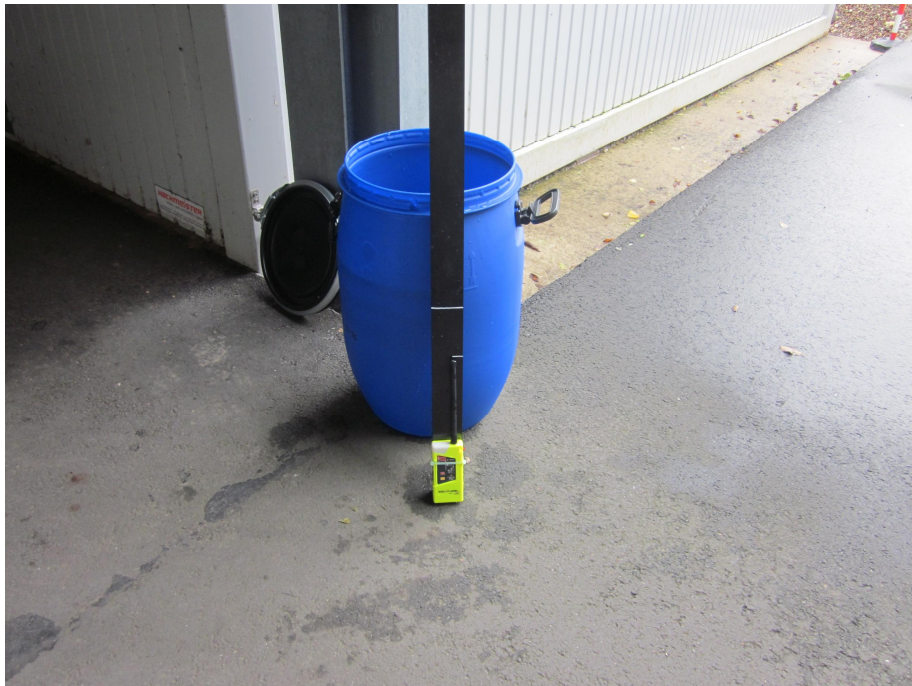
Picture 5: After Thermal Shock

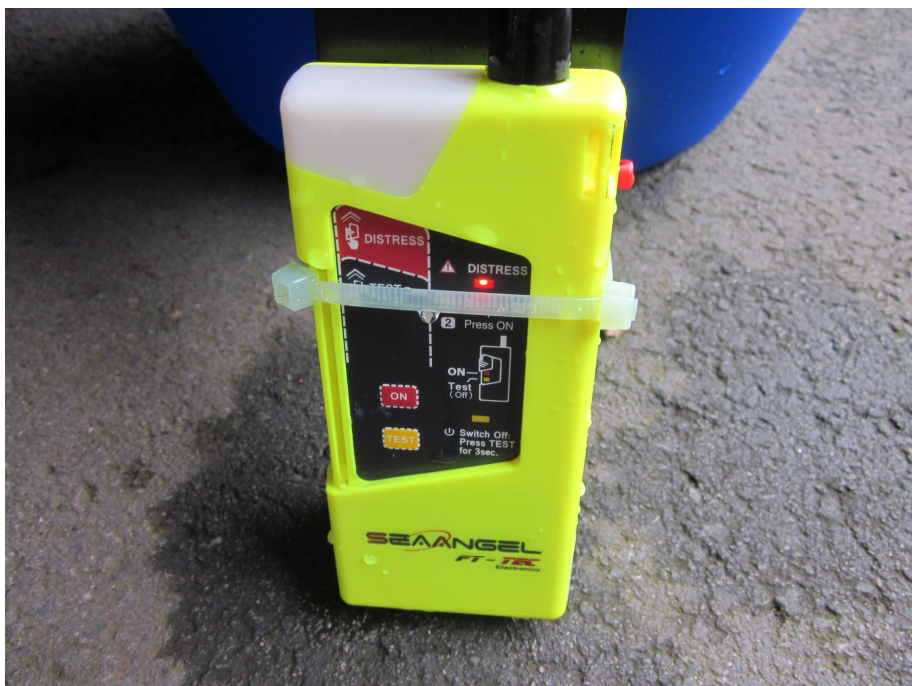
Picture 6: After Thermal Shock

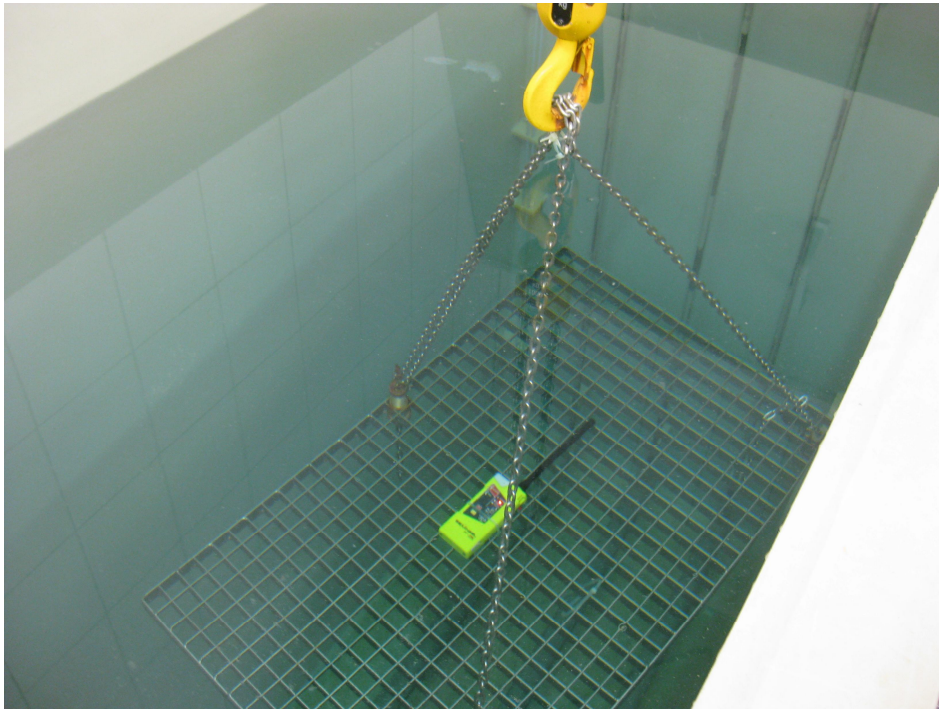
Picture 7: IP X7

The EUT shall be subject to the test corresponding to IEC 60529, table 3, second characteristic numeral 7: protected against the effects of temporary immersion in water.

- the highest point of the EUT is located 1 m below the surface of the water;
- the duration of the test is 5 min;
- the water temperature does not differ from that of the equipment by more than 5 K.

DUT	Deep.	Test duration	Visual damages	Performance check during the test	Requirements fulfilled
142199_310601	1 m	5 min	No	No	Yes

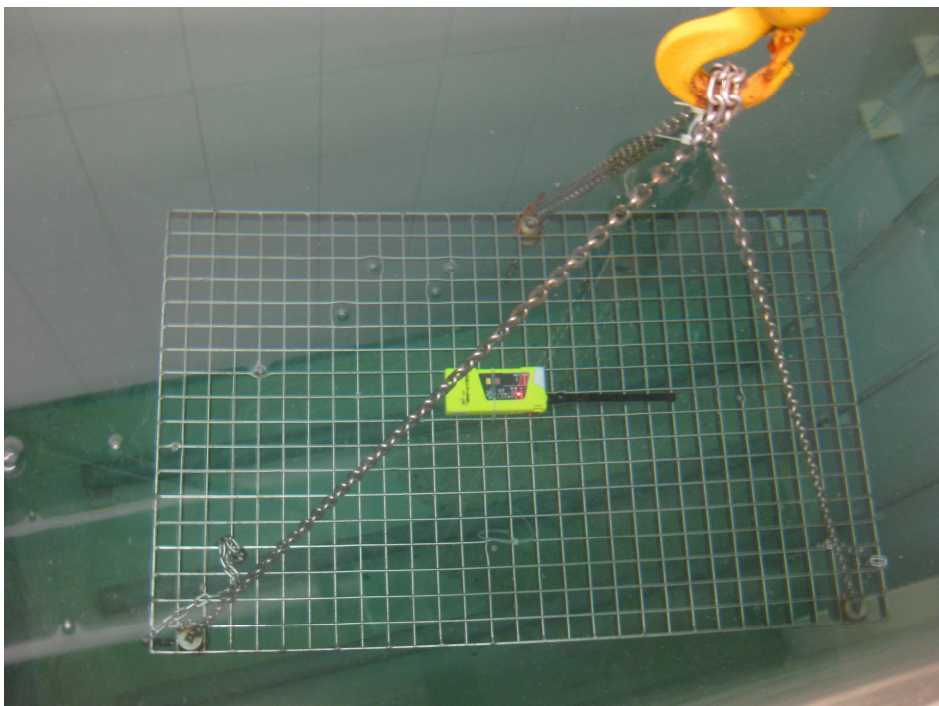
Picture 8: IP X7
