LATERAL WING-TO-FUSELAGE -FAIRING - EXTERNAL - INSPECTION/CHECK

2. LATERAL WING-TO-FUSELAGE FAIRING - EXTERNAL GENERAL VISUAL INSPECTION

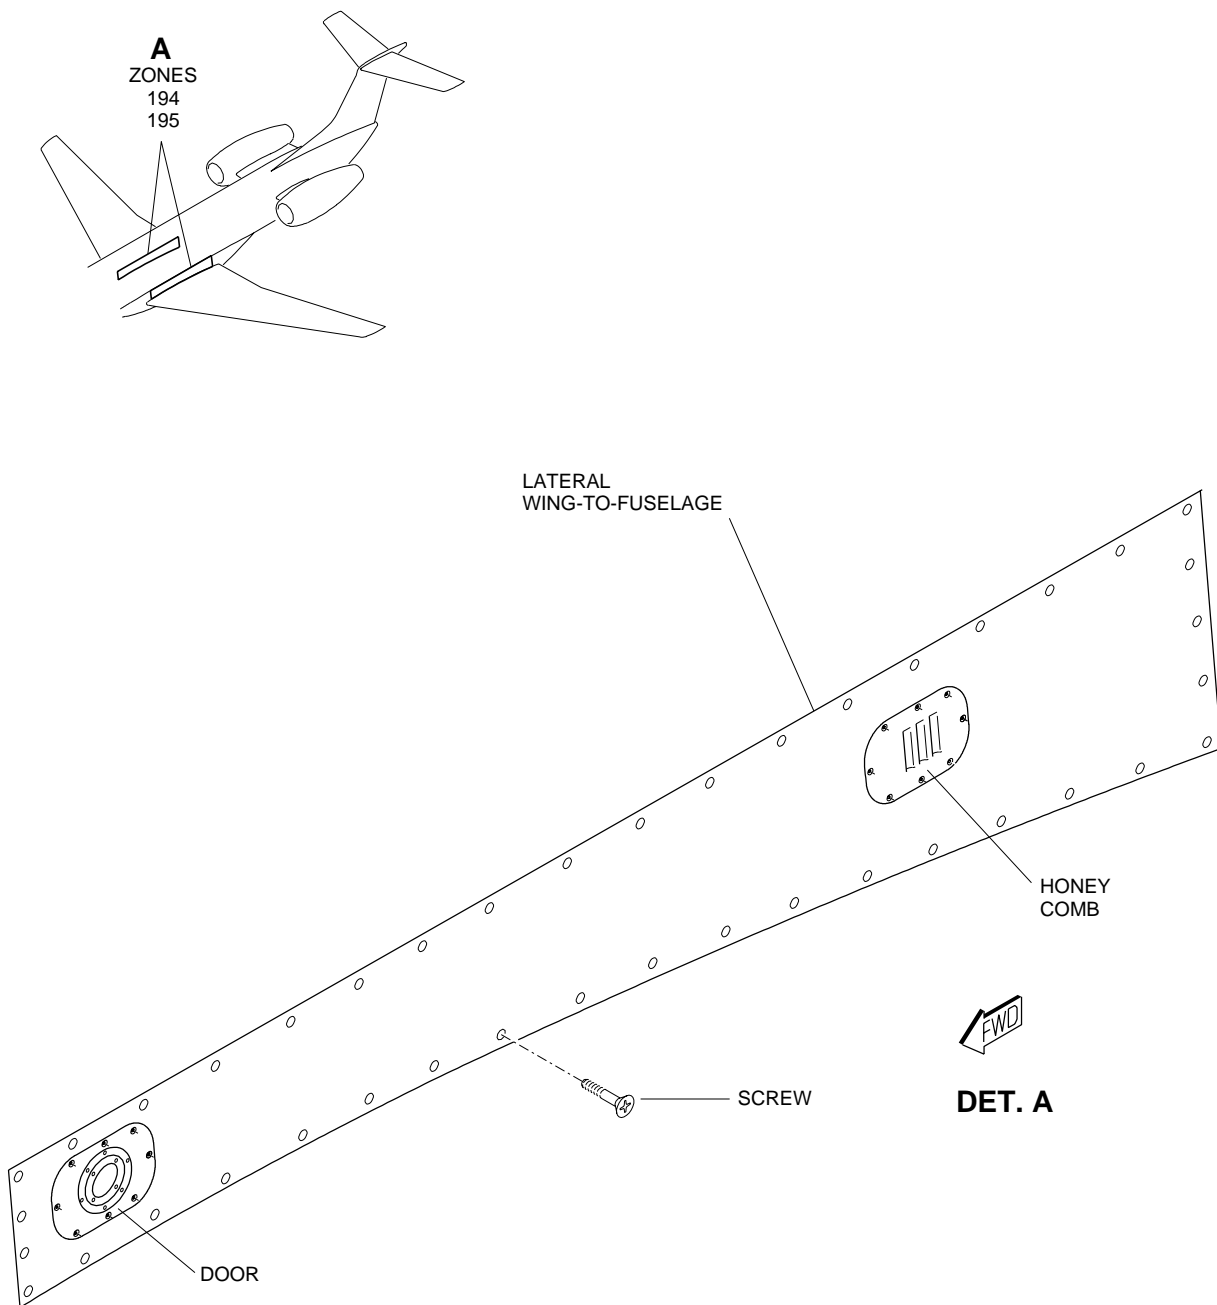
Figure 601

- (1) Examine the fuselage zone for loose screws, skin deformation, delaminations, sealant condition, scratches, nicks, cracks, dents, painting bad condition, erosion, and deteriorated protective treatment ([Figure 601](#)).
- (2) Examine the honeycomb, access door and emergency light for general condition.

Lateral Wing-to-Fuselage Fairing - External General Visual Inspection

J. External General Visual Inspection ([Figure 601](#))
