## BAGGAGE DOOR - INTERNAL - INSPECTION/CHECK

TASK 05-30-08-200-801-A

## 2. BAGGAGE DOOR - INTERNAL GENERAL VISUAL INSPECTION

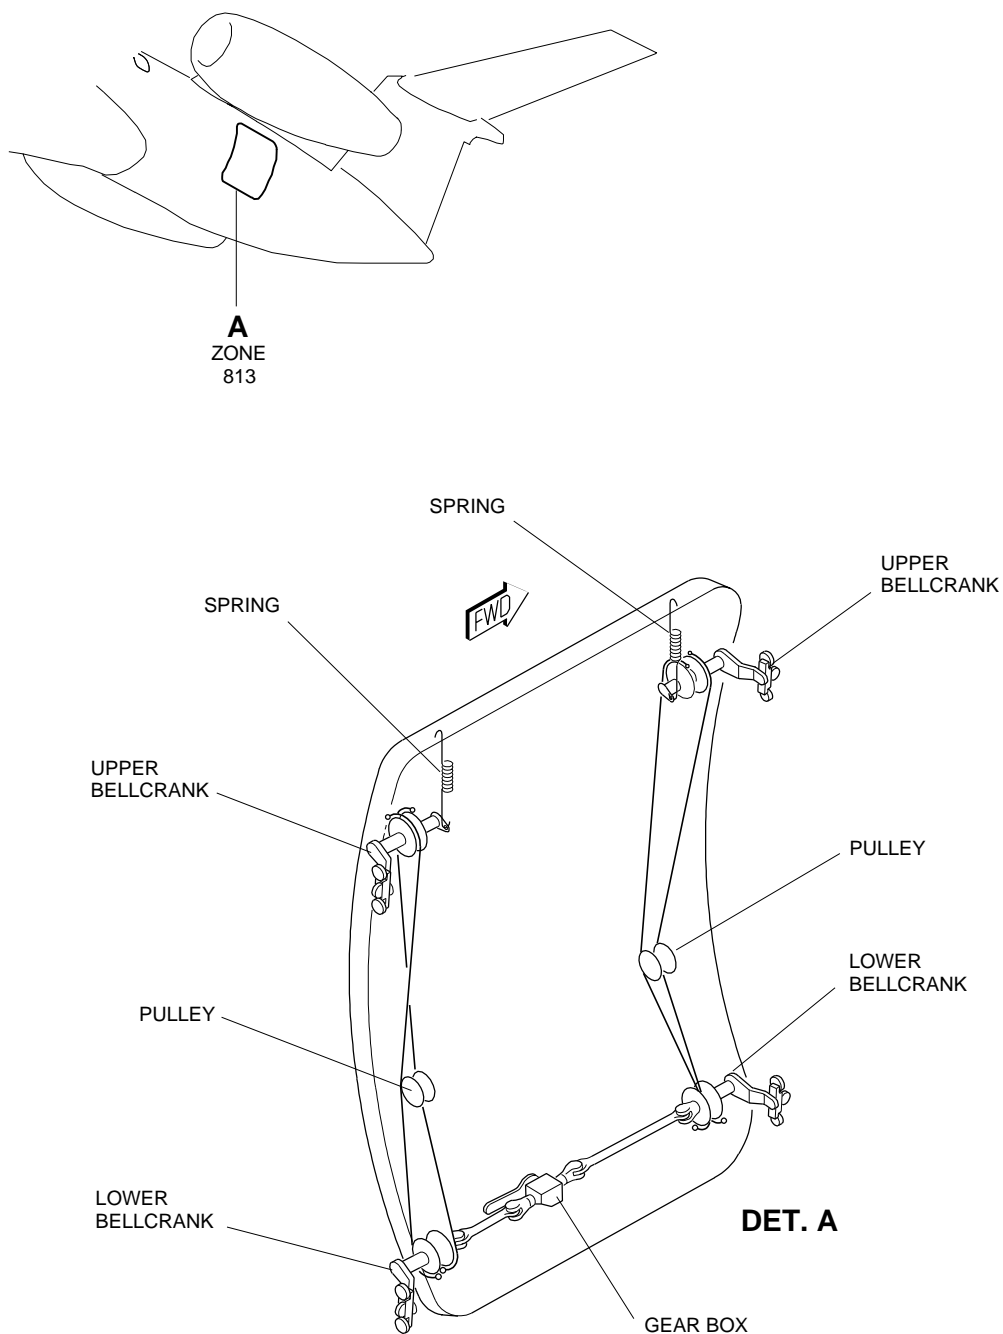
Figure 601

Baggage Door - Internal General Visual Inspection

- (1) Examine the baggage door actuating and locking mechanism ([Figure 601](#)).
- (2) Examine the upper and lower bellcrank springs ([Figure 601](#)).
- (3) Examine the cables for condition ([Figure 602](#)).
- (4) Examine the bellcrank rollers ([Figure 602](#)).
- (5) Examine the presence of any foreign objects.

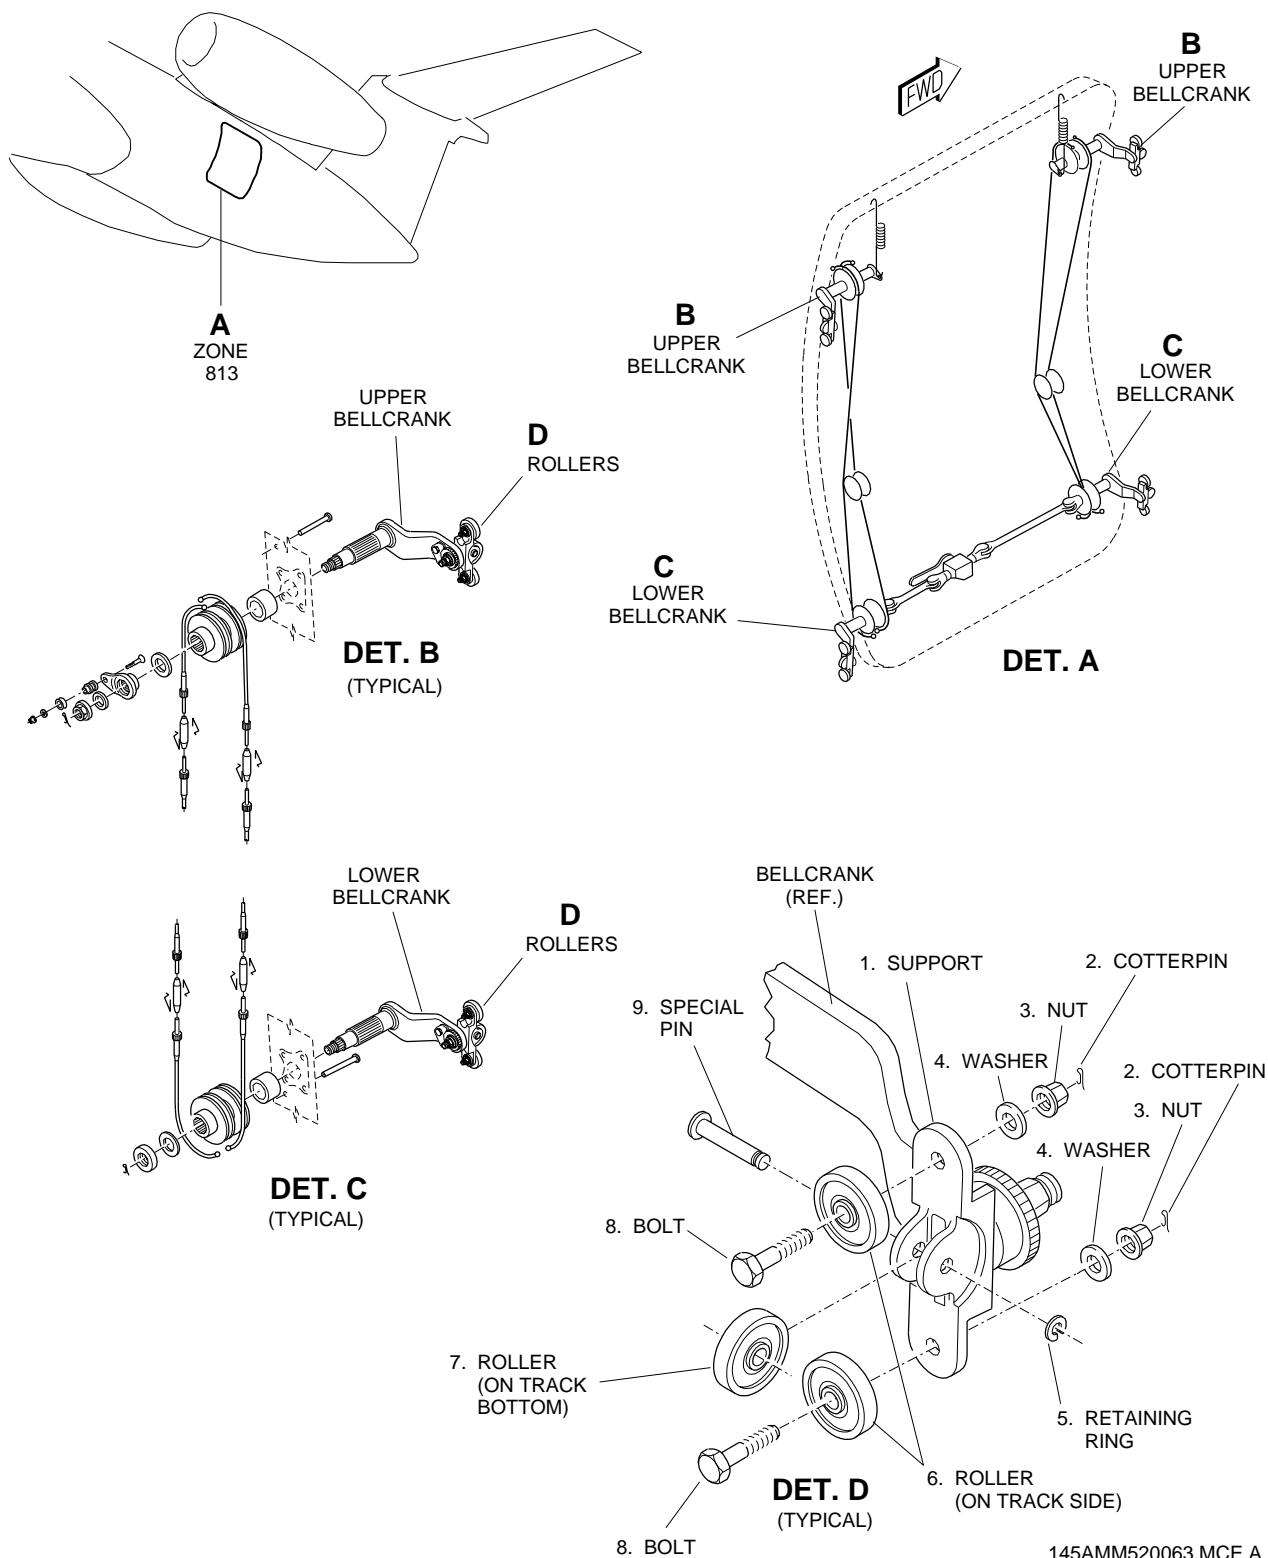
Figure 602

Baggage Door Bellcrank Rollers - Internal General Visual Inspection
