MAIN DOOR - EXTERNAL - INSPECTION/CHECK

TASK 05-30-03-200-801-A

2. MAIN DOOR - EXTERNAL GENERAL VISUAL INSPECTION

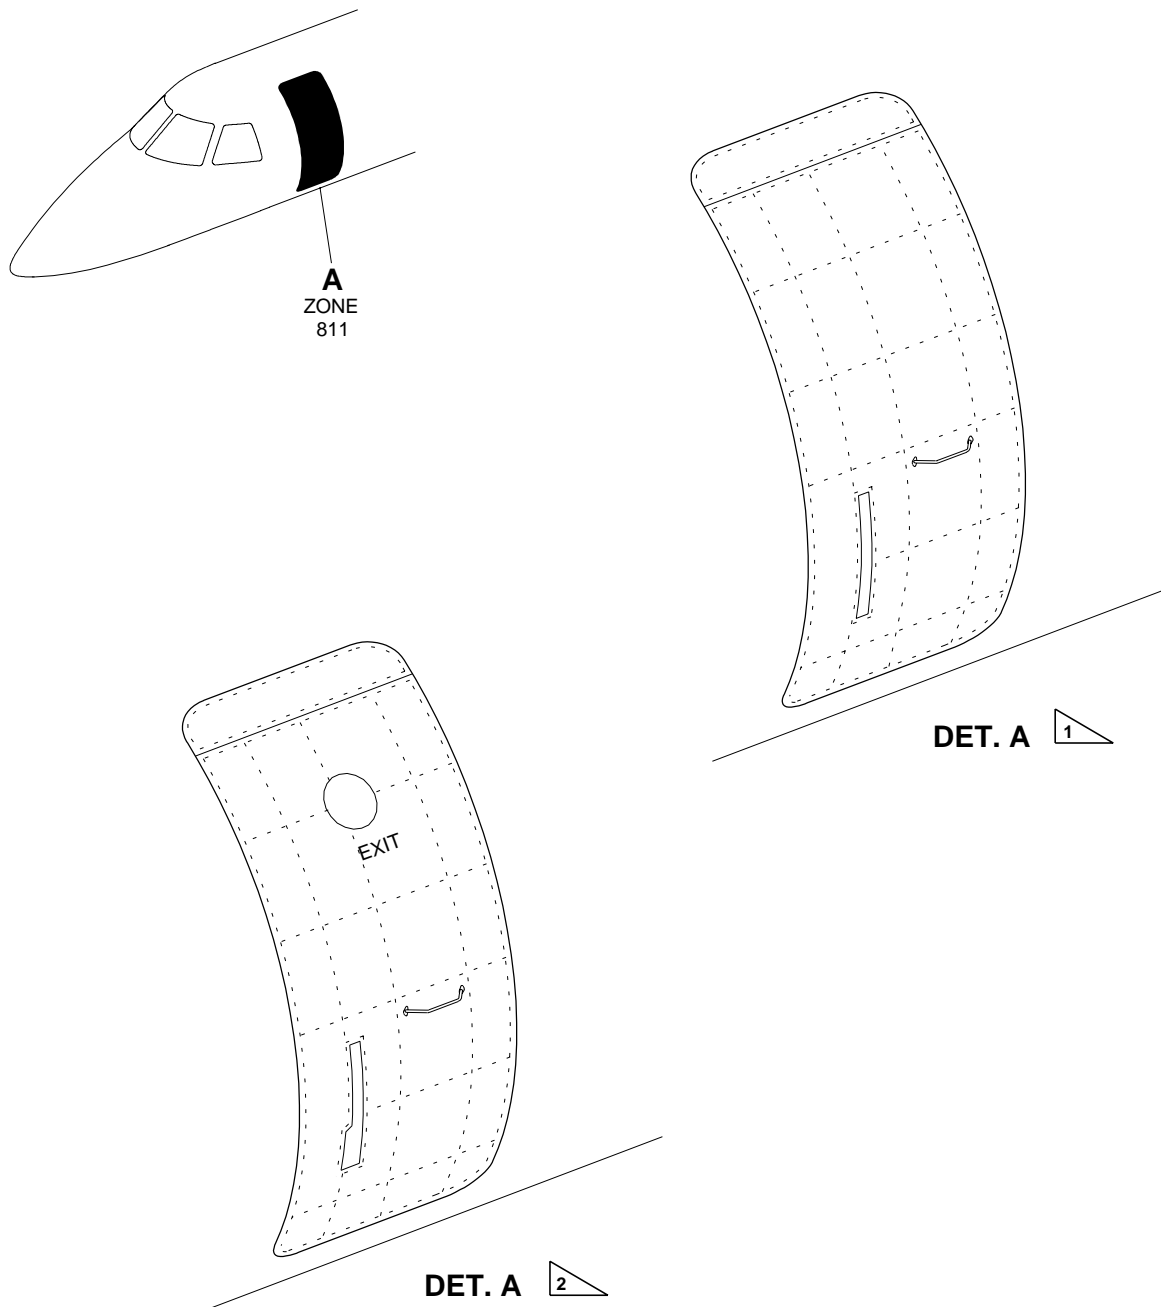
Figure 601

Main Door - External General Visual Inspection

AIRCRAFT WITH AIRSTAIRS MAIN DOOR.
-

AIRCRAFT WITH SIDE-HINGED MAIN DOOR.

- (1) Examine the main door for painting bad condition, loose rivets, skin deformation, rubber trim seal, sealant poor condition, scratches, gouges, creases, nicks, cracks, dents, erosion, corrosion, deformation, and deteriorated protective treatment.
