SERVICE DOOR - EXTERNAL - INSPECTION/CHECK

- A. This section gives SMRD Zonal Task 52-Z821-213-001-A00.
- B. Zone: 821.
- C. Zone Boundaries: STA X = 4514.0 thru STA X = 5292.0.
- D. The procedures in this section are given in the sequence below. The tasks identified with (♦) are part of the Scheduled Maintenance Requirements Document (SMRD).

2. SERVICE DOOR - EXTERNAL GENERAL VISUAL INSPECTION

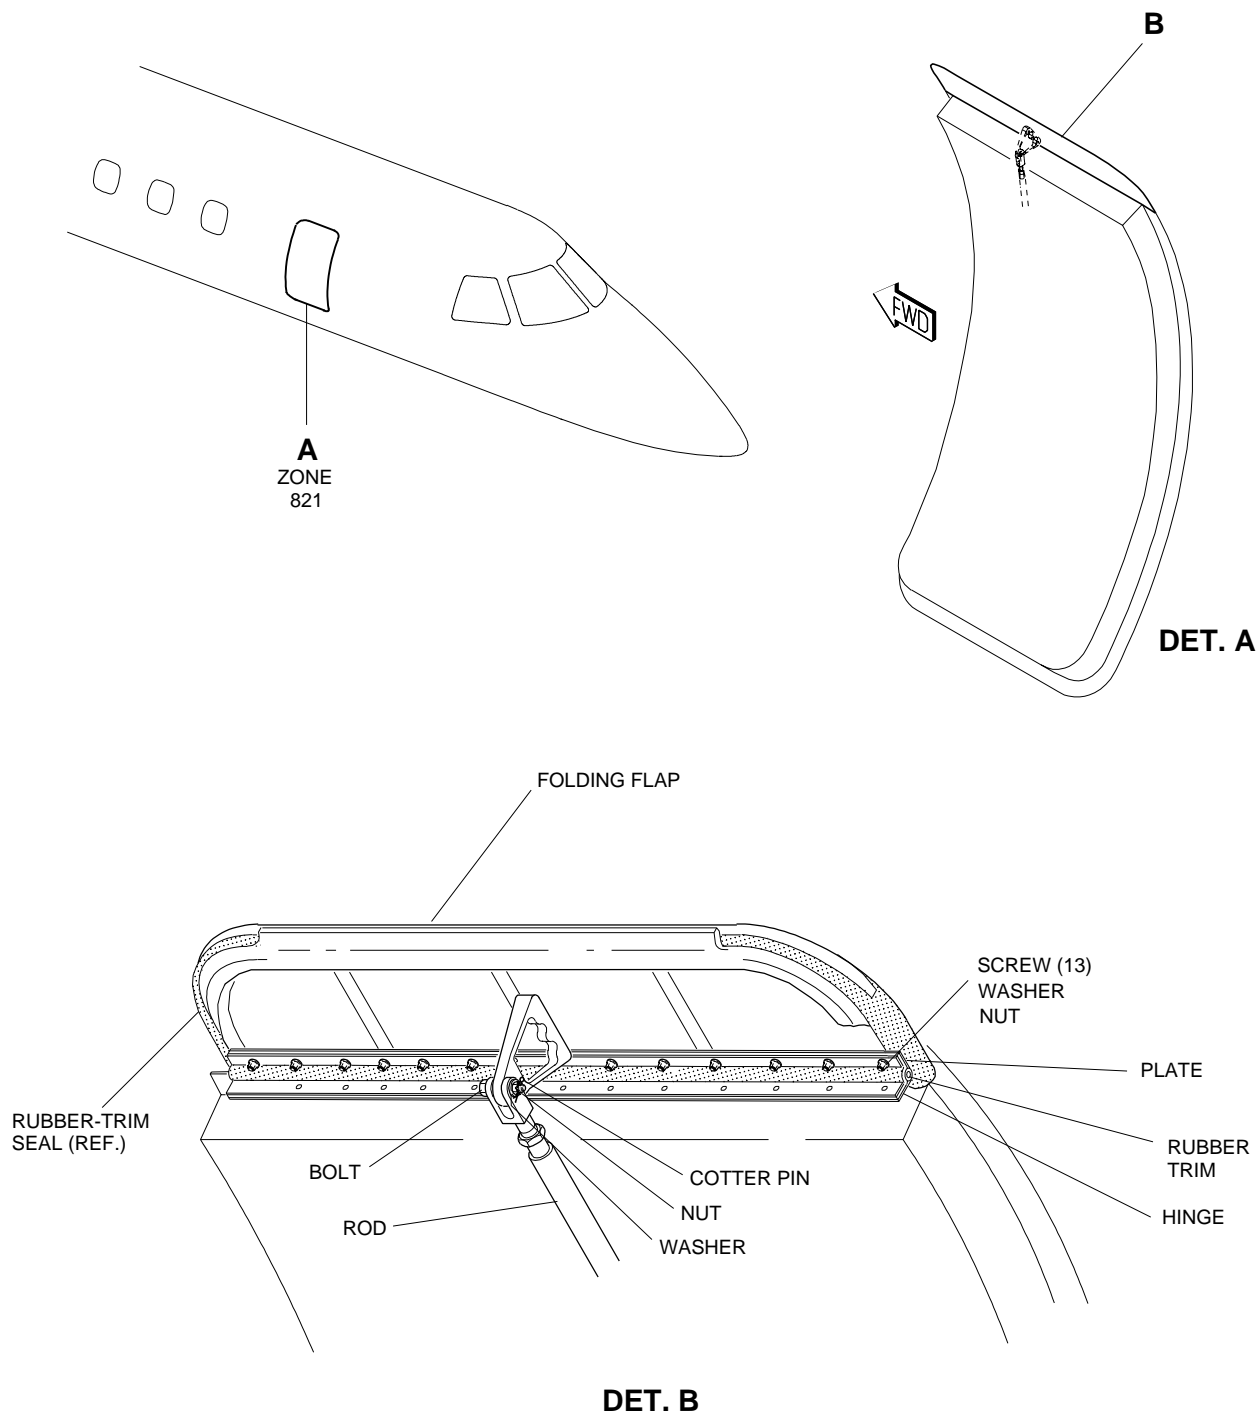
Figure 601

Service Door - External General Visual Inspection

- (1) Examine the service door zone for loose rivets, screws, nicks, cracks, dents, erosion, corrosion, deteriorated protective treatment, or deformation ([Figure 601](#)).
- (2) Examine the service door folding flap structure for condition.
- (3) Examine the service door folding flap/rod mechanical linkage.
