CENTER FUSELAGE III - PASSENGER CABIN TOP - EXTERNAL - INSPECTION/CHECK

2. CENTER FUSELAGE III - PASSENGER CABIN TOP - EXTERNAL GENERAL VISUAL INSPECTION

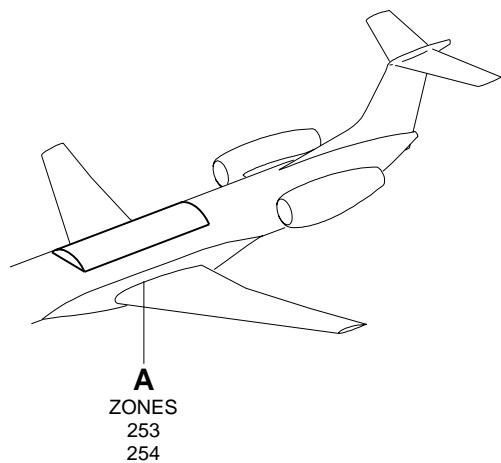
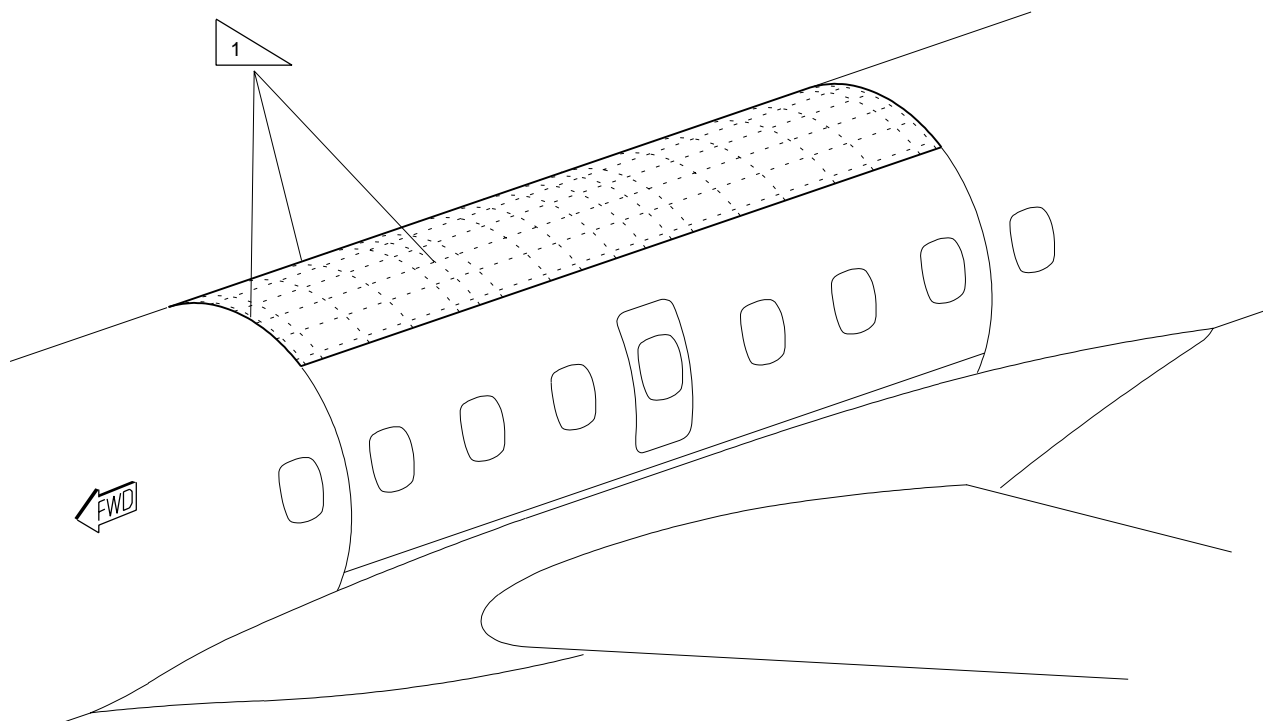
Figure 601

Center Fuselage III - Passenger Cabin Top - External General Visual Inspection

EXTERNALLY INSPECT FUSELAGE SKIN PANEL,
SKIN LONGITUDINAL AND CIRCUMFERENTIAL SPLICES

- (1) Examine the fuselage zone for loose rivets, skin deformation, fillet sealant condition, nicks, cracks, dents, erosion, corrosion, and deteriorated protective treatment ([Figure 601](#)).
- (2) Examine the fuselage skin longitudinal splices for loose rivets, nicks, cracks, dents, erosion, corrosion, and deteriorated protective treatment ([Figure 601](#)).
- (3) Examine the fuselage skin circumferential splices for loose rivets, nicks, cracks, dents, erosion, corrosion, and deteriorated protective treatment ([Figure 601](#)).
