**CENTER FUSELAGE IV - PASSENGER CABIN TOP - EXTERNAL - INSPECTION/CHECK**

## 2. CENTER FUSELAGE IV - PASSENGER CABIN TOP - EXTERNAL GENERAL VISUAL INSPECTION

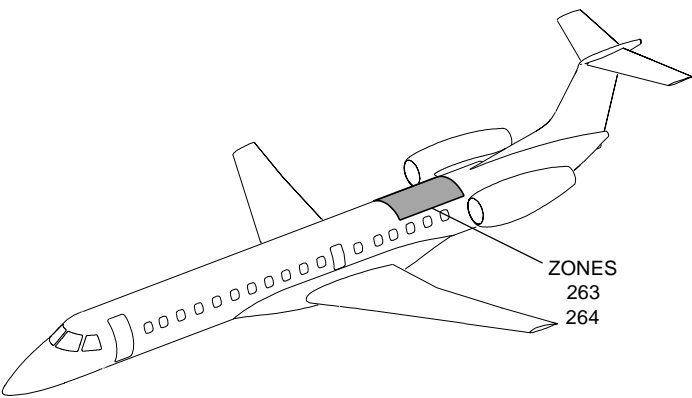
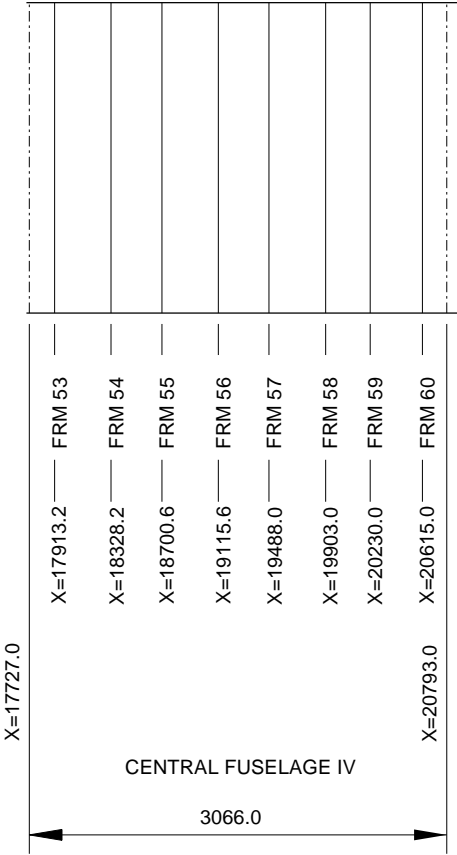
EFFECTIVITY: EMB-145 ( ) models  
Center Fuselage IV - Passenger Cabin Top - External General Visual Inspection  
Figure 601

INSPECTION AREA

- (1) Examine the fuselage zone for loose rivets, nicks, cracks, dents, erosion, corrosion, and deteriorated protective treatment (Figure 601) or (Figure 602) as applicable.
- (2) Examine the fuselage skin longitudinal splices for loose rivets, nicks, cracks, dents, erosion, corrosion, and deteriorated protective treatment (Figure 601) or (Figure 602) as applicable.
- (3) Examine the fuselage skin circumferential splices for loose rivets, nicks, cracks, dents, erosion, corrosion, and deteriorated protective treatment (Figure 601) or (Figure 602) as applicable.
- (4) Examine the antennas for general condition and aerodynamic sealing condition.

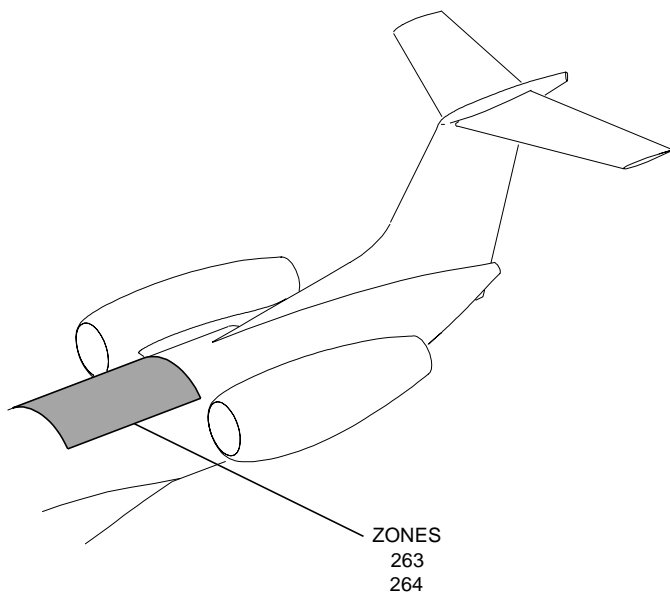
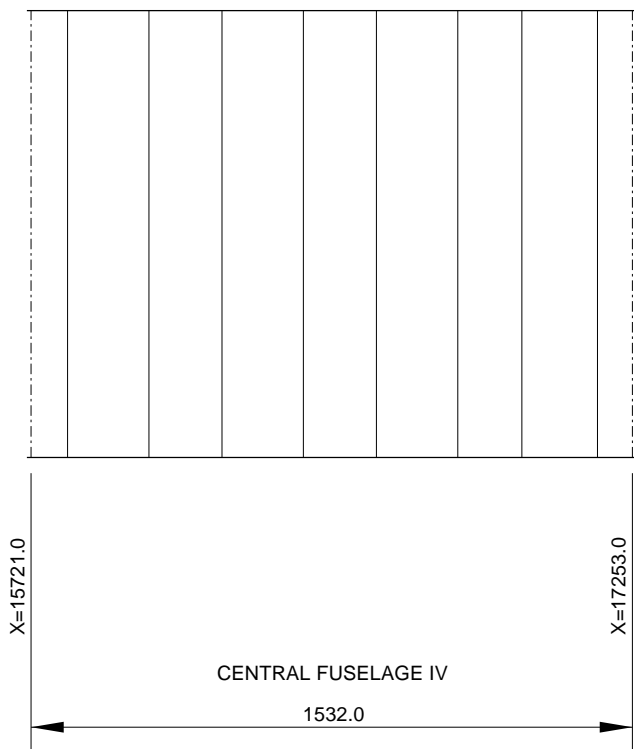
Figure 602

Center Fuselage IV - Passenger Cabin Top - External General Visual Inspection

INSPECTION AREA
