Baker Rd Properties Project, Beach Observations, 27 March 2023

by John R. Harper, P.Geo., Ph.D.

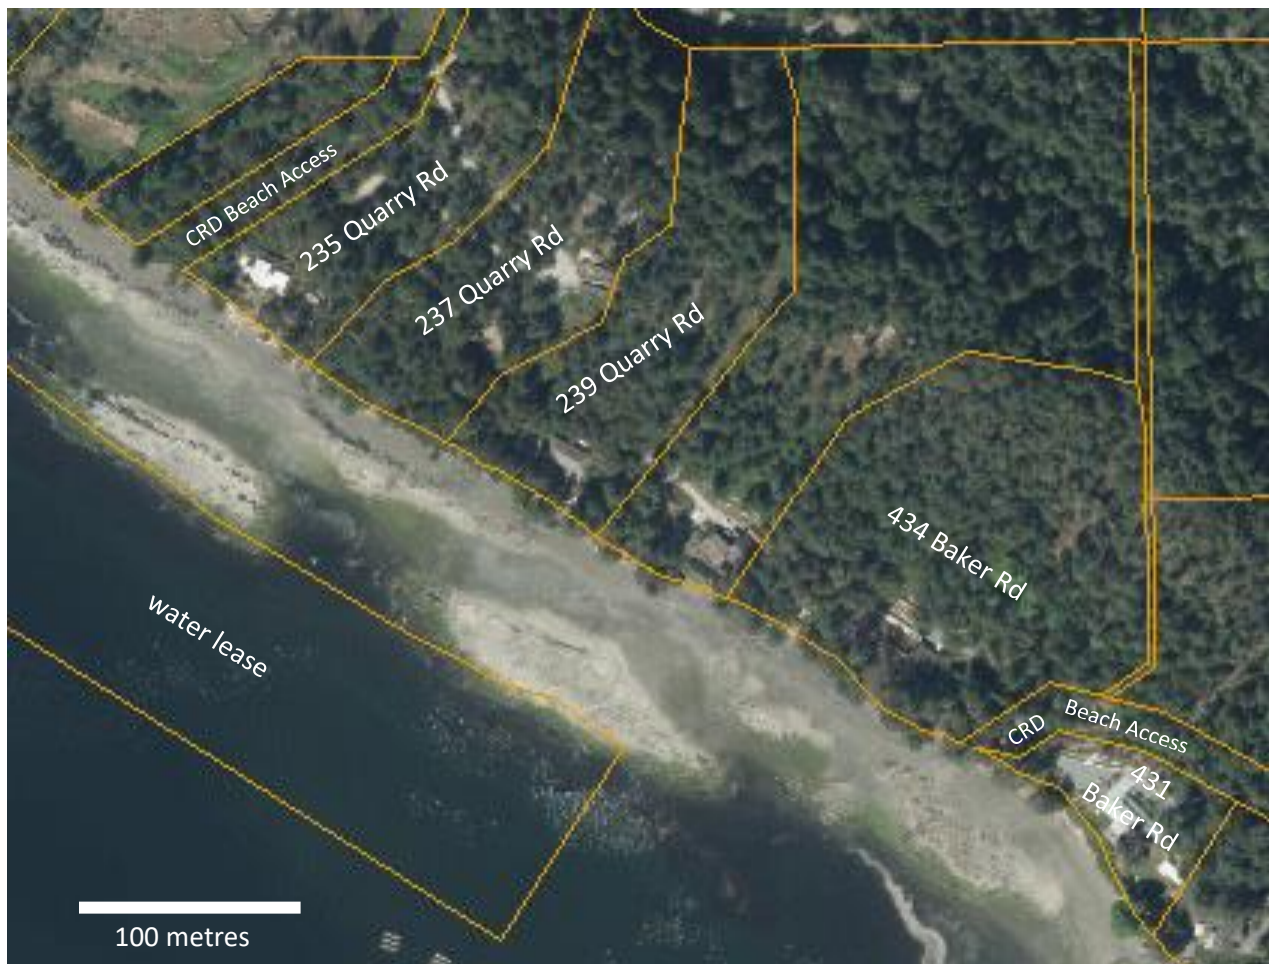
Figure 1. A 2021 aerial photo of the Baker Rd Properties showing property boundaries and general intertidal morphology. (source: *CRD Natural Areas Atlas*)

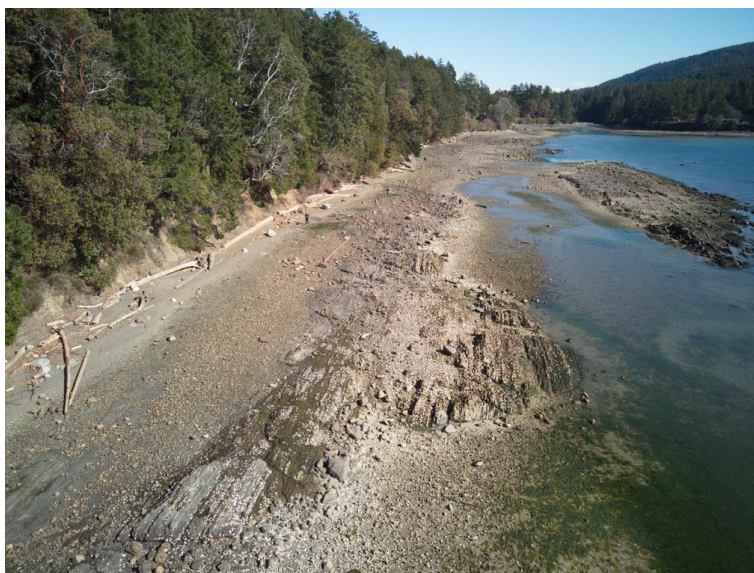
The shoreline orientation is controlled by the bedrock structure and is exposed to the west and northwest. Wave fetches to the northwest are in the order of 20 km (10 n mi) making this a *semi-protected* shoreline. The shoreline is a combination of rock and sediment (Fig 2). The bedrock is shale and siltstone (Nanaimo Group; Muller 1980). A wave-cut rock platform has been cut into the bedrock leaving a relatively gradual foreshore slope and a steep bedrock cliff in the backshore. The bedrock platform has a discontinuous veneer of pebbles, cobbles, and boulders (Fig 3). There is a continuous beach (~5 m in width) in the upper intertidal at the base of the cliff; sediments on the beach are pebble to sand-sized, shale fragments that have weathered off the cliff face (Fig. 4). There are two large intertidal siltstone reefs offshore that provide shelter so that muddy sand has accumulated in the wave shadow of the lower intertidal zone landward of these reefs (Fig. 1, 2).

Figure 2. Drone photo of the Baker Road Properties foreshore looking to the southeast. From left to right, there is (a) a cliff in the supratidal zone, (b) a narrow sand beach with logs, (c) a rock platform with a discontinuous cover of pebbles, cobbles and boulders, and (d) a sand flat inside of (d) the two offshore reefs.

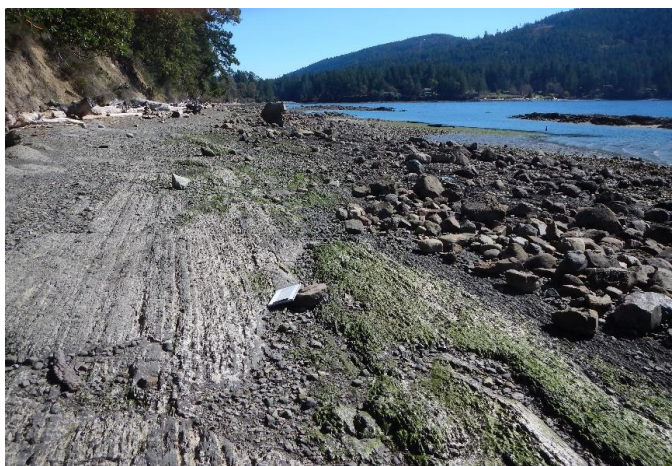
Figure 3. Ground photo of the Baker Road Properties foreshore looking to the southeast. The siltstone bedrock is very prominent.

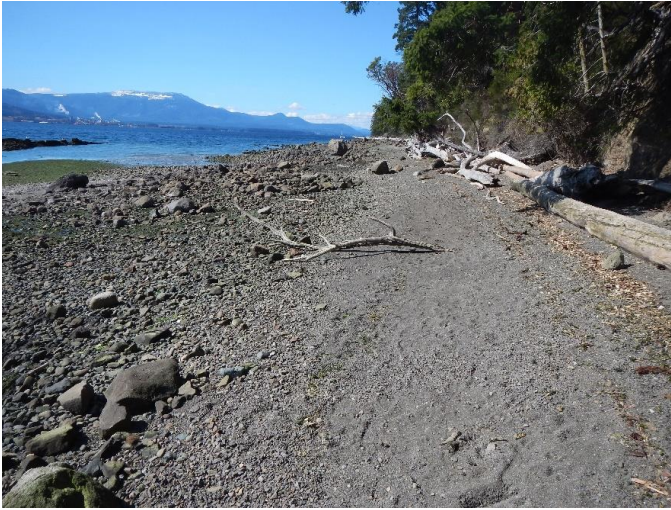
Figure 4. A narrow (~5m-wide) pebbly sand beach just below the high-water line and seaward of the cliffs (looking NW). Much of this beach is comprised of *plate-like* shale fragments eroded from the cliff face.

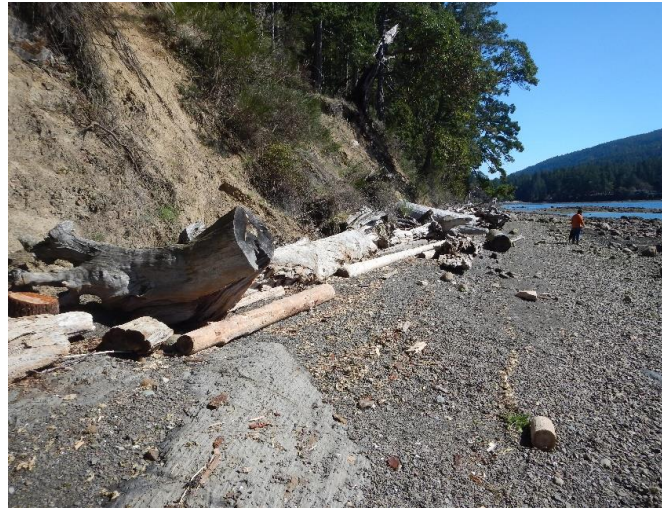
Erosion on the cliff varies along the shore with some segments showing more stability due to resistant bedrock and some segments showing less stability where the siltstone is *friable*¹. On friable sections, one can scrape off sediment by hand (Fig. 5). Stability is indirectly indicated by growth of vegetation on the cliff face. For example, the cliff at 431 Baker Rd is almost completely vegetation covered (Fig. 6), indicating greater stability. The rate of cliff erosion has not been documented.

Figure 5. The cliff at the 235 Quarry Rd property is mostly bare of vegetation and material can easily be scrapped off the cliff face.

1. Reducing toe erosion at the base of the cliffs will contribute to reducing the retreat rate of cliffs. This may be achieved by a combination of a *protection strategy* (using rip rap) and *ecosystem adaptation strategy* (using placement of a beach berm against the base of the cliff).
2. Another *ecosystem adaptation strategy* would be to pull back the upper portion of the cliff, where possible, to reduce the cliff-face slope. A lower gradient slope would provide for a better riparian habitat to establish vegetation on the cliff face. Implementation of a *riparian planting strategy* with drought-resistant vegetation (a mix of understory plants and trees) would also contribute to cliff stability.

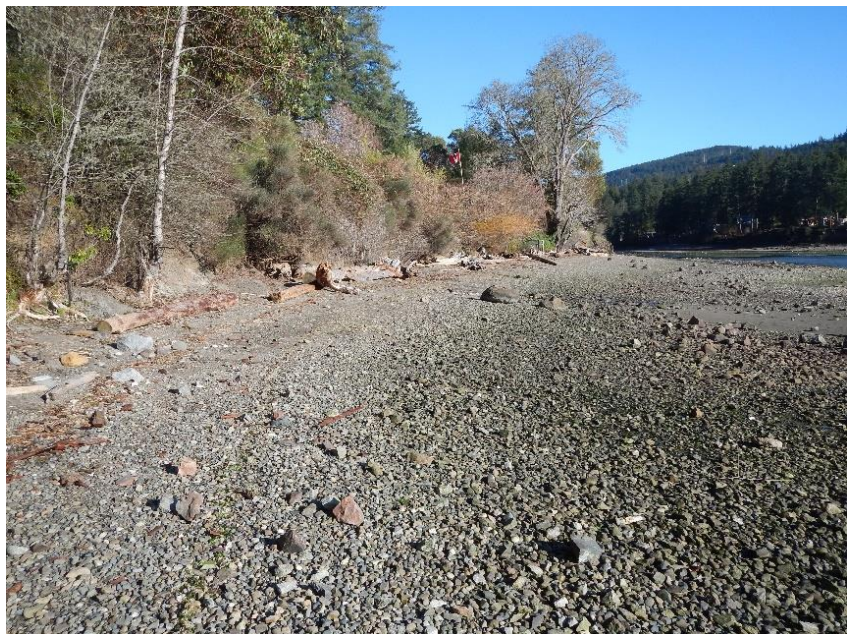
Figure 6. The cliff at the 431 Baker Rd property is almost totally vegetated, suggesting greater stability than sections further to the northwest.

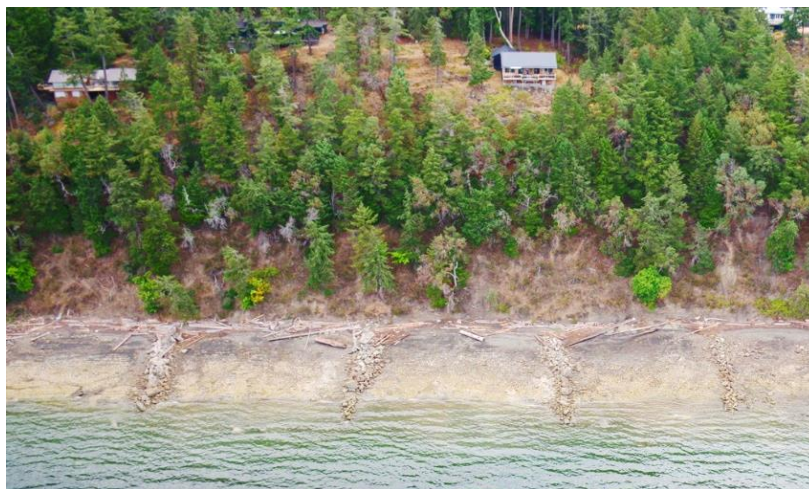
The Baker Rd of section of properties are in a near natural state. But to the north, a bulldozer has scraped boulders into linear, groyne-like features in the intertidal zone at the 183 to 205 Quarry Rd properties; these features have not been effective at catching sediment. Between the 234 Quarry Rd and 431 Baker Rd properties, there are three sections of rip-rap (large boulders) placed in the upper intertidal zone at (a) the NW CRD access stairs (10m alongshore length), (b) a private residence at 241 Quarry Rd (30m of along length) and (c) the SE CRD beach access stairs (30m of alongshore length). A total of 70m of rip-rap presently exist along 500m of shoreline (14%).

Figure 7. Aerial photo of the shoreline near 201 Quarry Rd showing groyne-like features created from beach boulders. There is no strong indication of sediment accumulation within these groyne or longshore transport direction. (August 2021 *ShoreZone* photo)
