1. Inspection Test

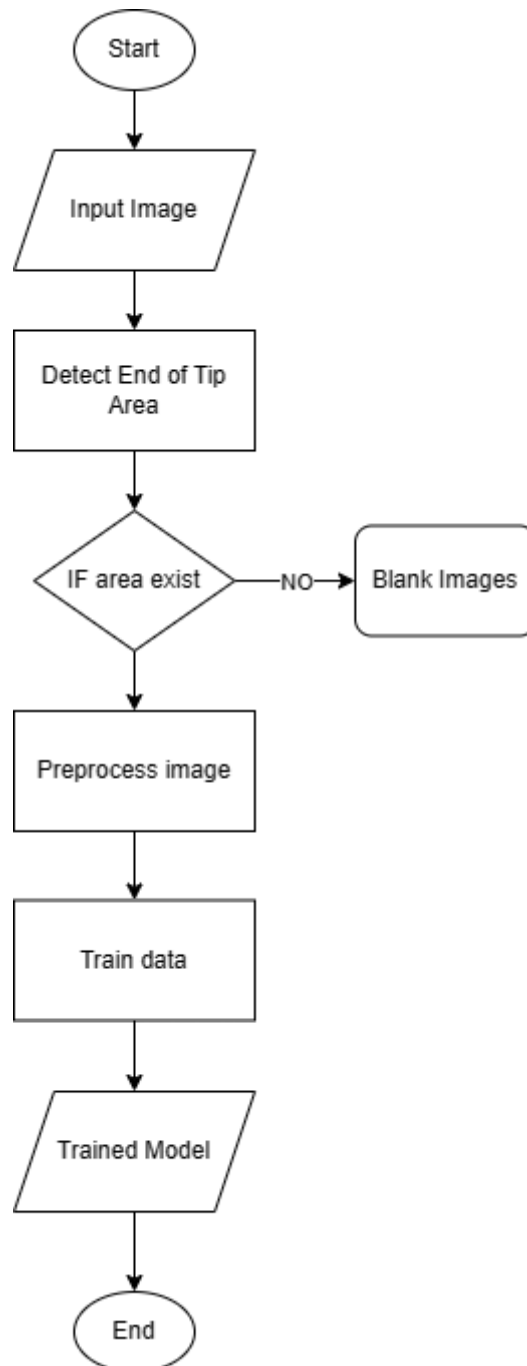
Based on the context provided, the task involves classifying images of the end of tip into three categories: "OK," "ARGUABLY OK," and "NO GO." An SVM classifier is being used due to the limited quantity of image data. To aid in classification, the VGG16 model is used to extract features from the images. Before extracting these features, the end of the tip is located using the HoughCircle technique.
