## **ISSB SAMPLE SHELTER CONSTRUCTION IN IFO SAVE HAVEN**

NRC together with DRC was tasked to carry out construction of sample ISSB shelter in save haven in IFO. The purpose of the exercise was to determine cost and sustainability of ISSB shelters in dadaab as a way of addressing environmental concerns raised by host community. NRC specifically was tasked with providing budget to meet the cost of materials and labor and DRC to take a lead role in supervision of the construction. The process involved;

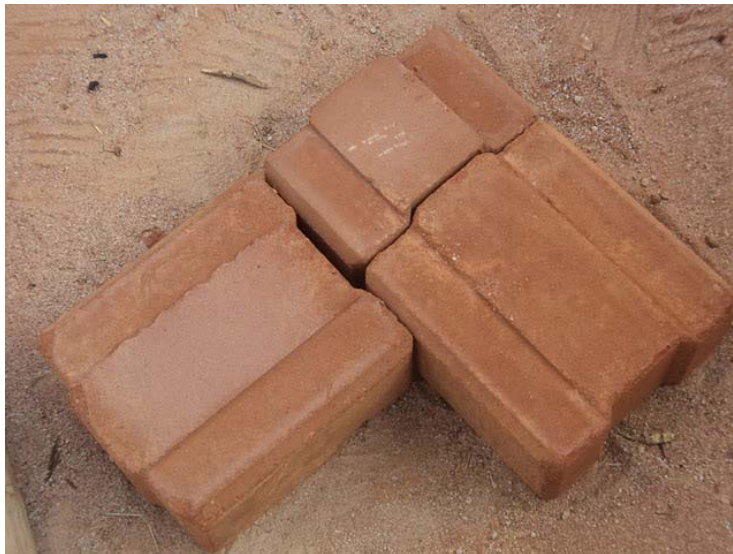
Determination of number of bricks required was done in consultation with DRC and a specialist who had experience in ISSB construction. The total number of bricks per unit was calculated to 1700 and 25% extra to take care of breakage. The total number of bricks procured was 4400 of two different sizes to address different issues (corners and Joints) i.e. 220x115x280mm and 140x115x280mm for the two structures.

The two sizes of blocks used at the corners

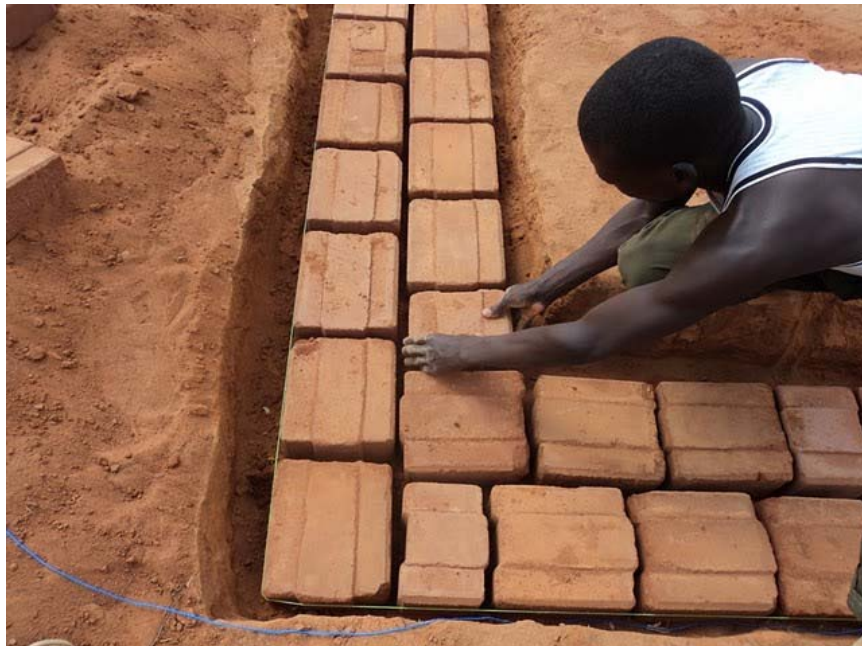
Foundation works

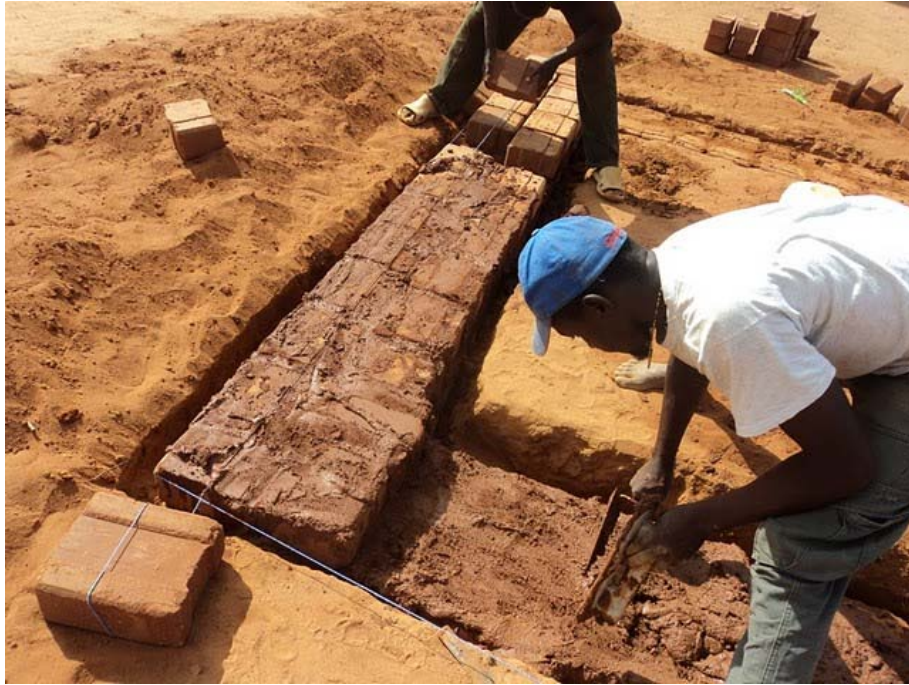
Soil paste used to bond the foundation bricks

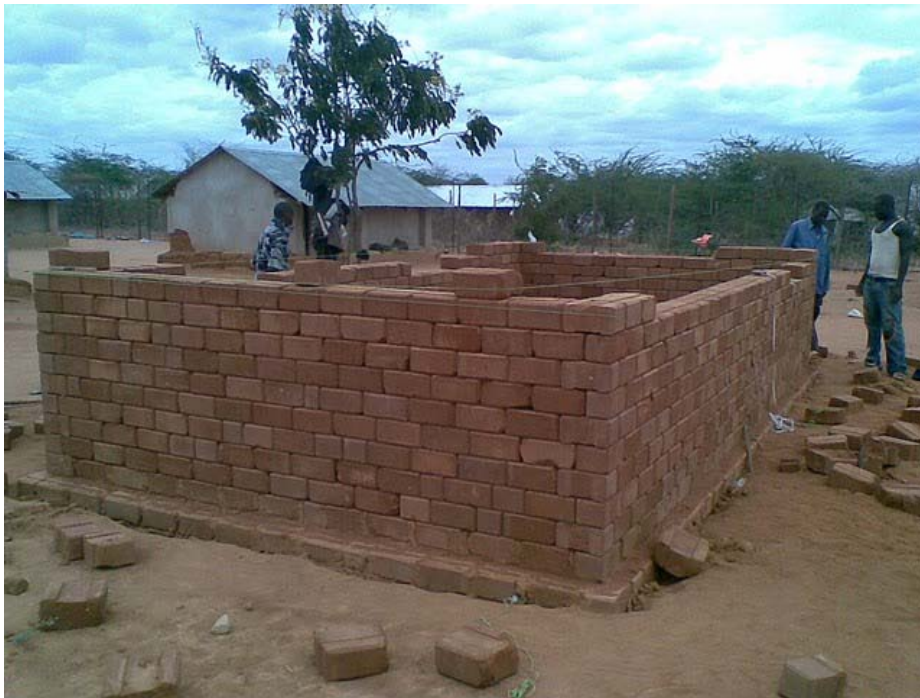
Due to the fact that this was a new skill in the area NRC together with DRC decided to hire an expert outside Dadaab who was to guide other skilled and unskilled labor to accomplish the task. The expert was hired together with 3 other skilled labor and 4 unskilled laborers. The construction took one week for the two structures up to the lintel. Two courses of double brick wall was laid below ground level and bonded with soil paste. Walling was done by interlocking of bricks using different sizes to ensure that straight joints are not created. To strengthen the structure, binding wire was used at the four corners of the structure after every alternate course.

Wall construction by interlocking of bricks

1. The ISSB used (220mm thick ) have a small groove making it difficult to interlock. This makes the structure weak and with slight push then the wall can collapse.
2. Procurement of the bricks took time ( looking for suppliers with readymade bricks)
3. High breakage rate during transportation
4. Weak structure after lintel level hence need for use of cement or some bonding material. ISSB structure has to be joined together at lintel level. In this case there was no provision for lintel and it made it difficult to fix the gable. By fixing lintel also, it makes fixing of window easier and to the recommended height for better aeration. Currently it was very difficult to fit windows and we ended up having window opening at a higher level than recommended.
