Conference Paper · July 2021

Alternative Prosthetic Treatment of Anterior Teeth with Root Canal Treatment: Different CAD/CAM Desing

R.Kara

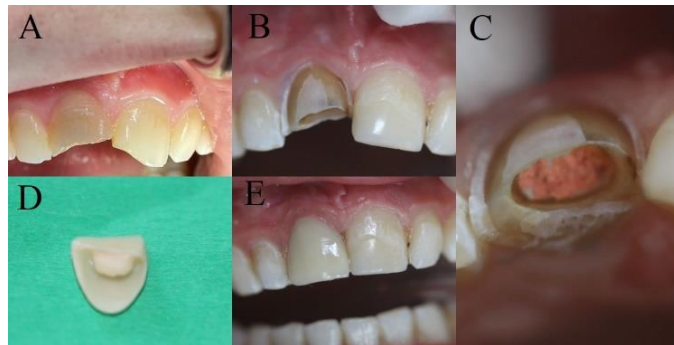
Fig. 2 A: Fractured teeth, B: Facial view of the preparation, C: Incisal view of the preparation, D: Fabricated restoration, E: Cemented CAD/CAM restoration

speed diamond round bur. The pulp chamber was prepared to a depth of 4 mm, with cavity walls at 6-10 degrees. (Fig. 1 and Fig. 2B, C). The cavity base was sealed with high viscosity glass ionomer cement (Equia, GC Europe, Tokyo, Japan).

For dental preparation, a 1mm chamfer-shaped step was prepared in the vestibular cervical of the tooth and the pulp chamber cavity was included in the preparation. All sharp corners on the inner walls were rounded (Fig. 2B, C). The restoration was designed in CAD/CAM software (Cerec 4.2.4, Dentsply / Sirona, Germany) by taking the digital measure of the preparation (Cerec Omnicam, Dentsply / Sirona, Germany). To reduce the monochromatic appearance of the CAD/CAM restoration and increase its aesthetics, the incisal trio of the tooth was abraded in the form of a cut-back. The areas reduced by enamel porcelain were restored. The designed restoration was etched using an E-max block (Lava Ultimate A2 LT, 3M Espe, Seefeld, Germany) (Cerec MC XL, Dentsply / Sirona, Germany) (Fig. 2D). After rehearsing the milled restoration, its inner surface was sandblasted with 50 μ sized aluminum oxide particles. After cleaning the sand particles with alcohol and air, the inner surface of the restoration was silanized (Monobond Plus, Ivoclar, Liechtenstein), the adhesive bonding resin was applied with a brush-type applicator, (Scotchbond Universal, 3M Espe, St Paul, USA) air-dried and opaque until bonding kept in a bowl. After the application of local anesthesia, the relevant teeth were isolated with a rubber dam.

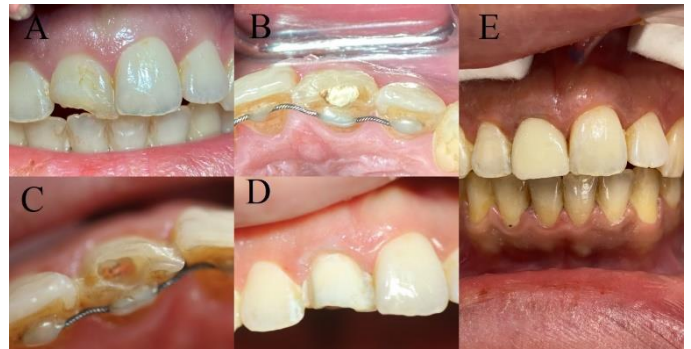
Fig. 3 A: Fractured tooth, B: Root-treated tooth, C: Incisal view of the design, D: Facial view of the design, E: Cemented CAD/CAM restoration.

no root or alveolar fracture. Since the patient was receiving orthodontic treatment, there was a splint wire behind the teeth. As in the first case report, considering the size of exposure in the pulp, the amount of hard tissue lost, the degree of root development, and the time between trauma and treatment, it was decided to treat the relevant tooth with root canal treatment. All steps from the preparation of the restoration to its completion were carried out as in the first case (Fig. 3C, D).

In the controls on the 12th and 24th months of the patient, it was observed that there were no symptoms in the teeth, and aesthetic, functional, and gingival harmony was good (Fig. 3E). As a result of the patient's inadequate oral hygiene, coloration was observed on the marginal of the restoration. The coloration area was polished with diamond-containing polishing paste (Diamond Gloss, TDV Dental, Santa Catarina, BRAZIL).

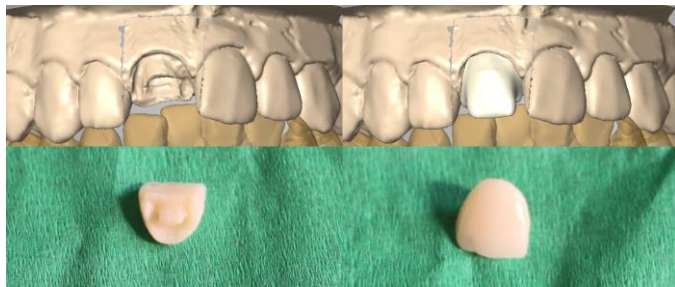
Fig. 4 : CAD/CAM desing and fabricated restoration

As in the steps in case 1, the design and fabrication of the CAD/CAM restoration were done (Fig. 4). Clinical controls were made in the same way and duration. There were no complications (Fig. 5D).

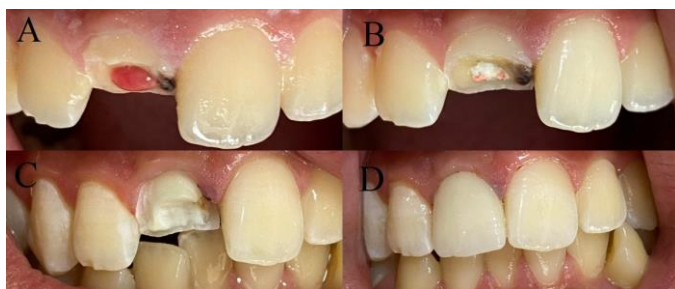
Fig. 5 A: Fracted tooth, B: Root-treated tooth, C: Prepared tooth, D:Cemented CAD/CAM restoration

Switzerland) and gutta-percha. (Fig. 5B).
