Politecnico di Milano - Courses on Photogrammetry

Laboratory report

| Lab Topic: | 02 - Drone Survey in Cassano d'Adda | | |

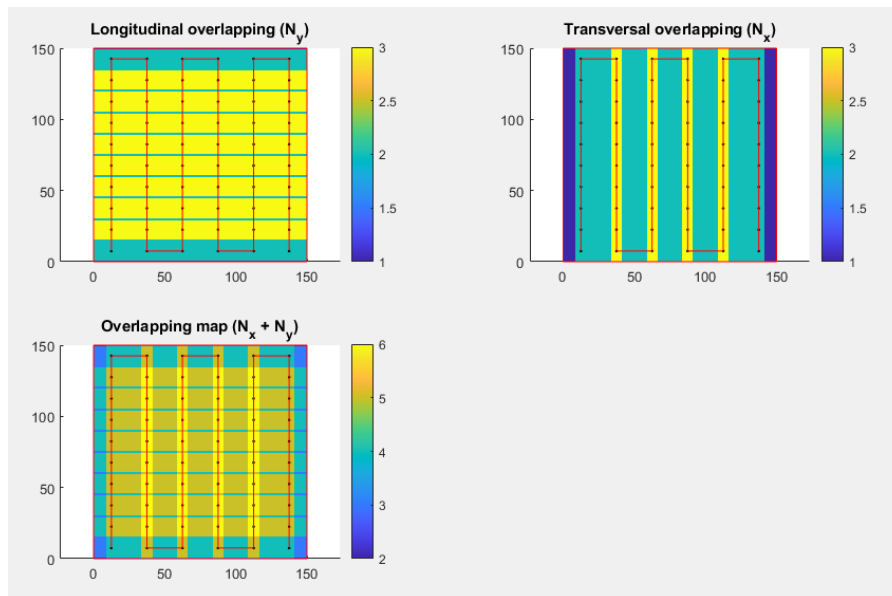
Fig. 1

The main goal of this lab was to create the DEM (Digital Elevation Model) and the orthophoto of a fluvial area in the proximity of Cassano d'Adda to perform further analysis; this was accomplished with an UAS, which was also one of the main reasons behind the location choice. Indeed, to fly the UAS, a location further away enough from any flight zone had to be picked. For what concerns the survey planning part of the lab, the flight had to be planned to reach the best accuracy possible for this type of survey; this was accomplished through the acquisition of photos in a almost nadiral direction parallel to the terrain's surface. The flight also had to be planned and calibrated, which entailed the calculations of the GSD (0.01 m), the overlapping % in longitudinally and laterally (50% and 65% respectively), the flight parameters such as height of flight (50 m) and the actual path to be followed by the drone. The parameters were chosen in order to achieve a reasonable value of GSD and a higher overlapping, which also means to achieve better results later on during the BBA procedure. Obviously, a larger overlapping also means a higher number of images that needs to be acquired, thus leading to higher computational costs. See the results of the MATLAB computation in *fig.1-2*. (12)

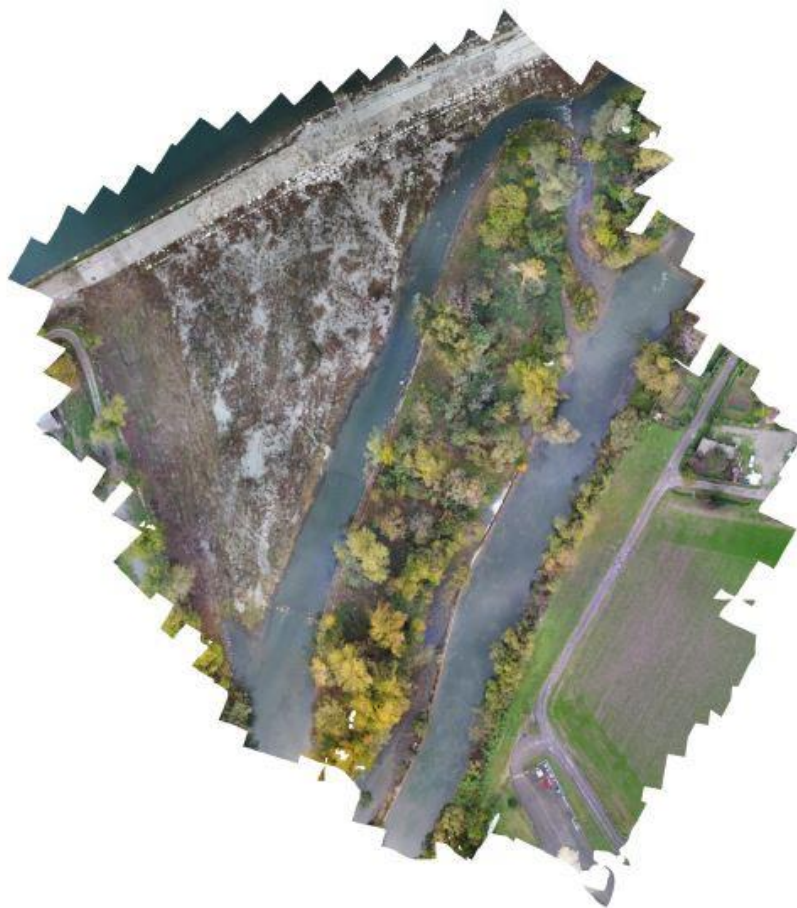
Fig. 3

Later, after all the necessary images were acquired, they were imported, together with the relative GCP (Ground Control Points) into Metashape. The whole procedure was done with images acquired by the first group, because the second group's acquisition yielded problems in the image calibration. After a first low-accuracy BBA, the upload of some earlier-computed camera calibration parameters, and the subsequent collimation of the GCP on all images, a higher accuracy BBA was performed, but not before having unchecked ca. 20% of the GCP to keep as check points. These were picked from places where GCP were more densely distributed and avoiding as much as possible the borders of the image. After this step was performed, not all the images were oriented; this happened mostly for images taken above the central island that can be seen in *fig.3*, because of the presence of things easily moved by wind, such as water and trees. To overcome this issue, although not a most pressing one per se, two markers were added over objects not affected by the presence of wind. It is worthy of notice that this could also be solved by a flatter terrain (not achievable here) and by increasing the overlap of the photos, albeit, as mentioned above, correspondingly increasing the number of photos and computational cost of the process. After a first round of re-collimation of suspected outliers, and a second round of yet another BBA, we checked the accuracies retrieved against the target accuracy, which was supposed to be of around 10 cm. This should have given a fairly good idea of the actual achievable accuracy. As it can be seen in *fig. 4*, both the categories achieved comparable results, with the control points faring better than the check points (0.01m vs 0.08m). A comment that could be made is that higher errors in the z-direction, could be imputed to the accuracy of the camera mounted to the UAV, while higher errors in the XY plane would probably entail a wrong collimation by the user. (19)
