ADA Curb Ramp New Construction Inspection Form (Perpendicular)

Nw 313th ave

24952.54

Nw. Brooking st

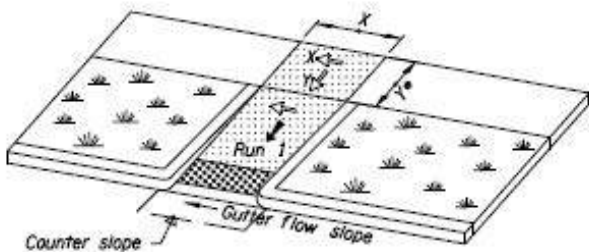
PERPENDICULAR RAMP (PR)

- Pedestrian Access Route (to measure Clear Width)
- Detectable Warning Surface
- Cross Slope (2.0% max.)
- Running Slope (8.3% max.)
- Counter Slope (5.0% max.)
- Turning Space (X & Y) (2.0% max. / 4' x 4' min.)*
* If constrained at back of walk, min. Y length is 5'.
- Gutter Flow Slope (as directed)
