ADA Curb Ramp New Construction Inspection Form (Perpendicular)

Nw 292nd

23885.56

Nw Fair

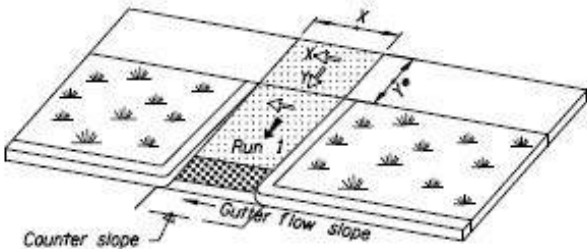
PERPENDICULAR RAMP (PR)

Pedestrian Access Route (to measure Clear Width)

Detectable Warning Surface

Cross Slope (2.0% max.)

Running Slope (8.3% max.)

Counter Slope (5.0% max.)

Turning Space (X & Y) (2.0% max. / 4' x 4' min.)*

* If constrained at back of walk, min. Y length is 5'.

Gutter Flow Slope (as directed)

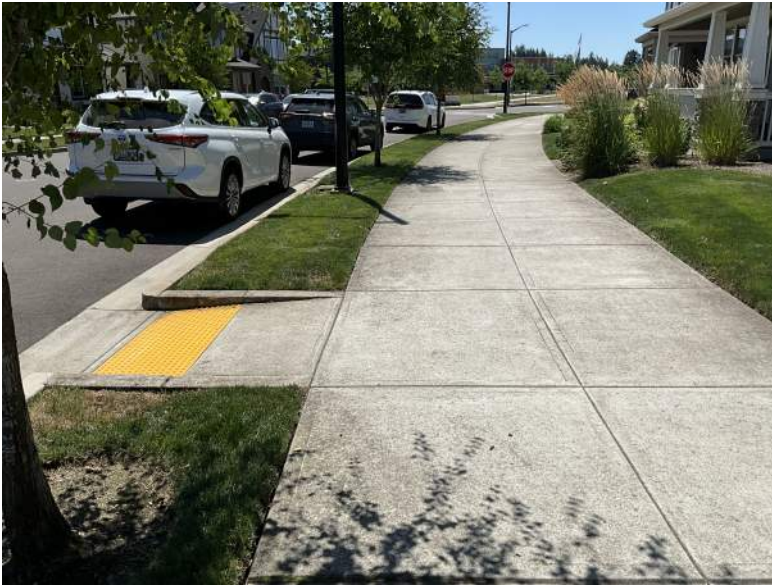
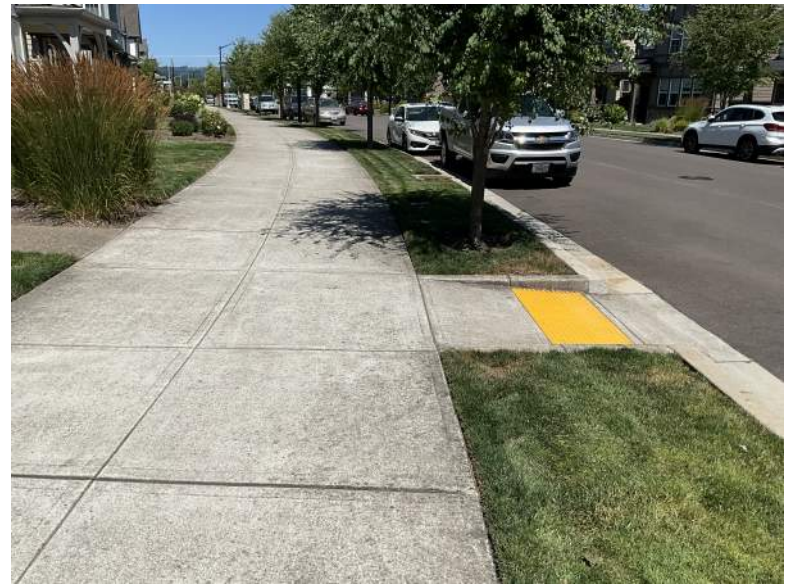
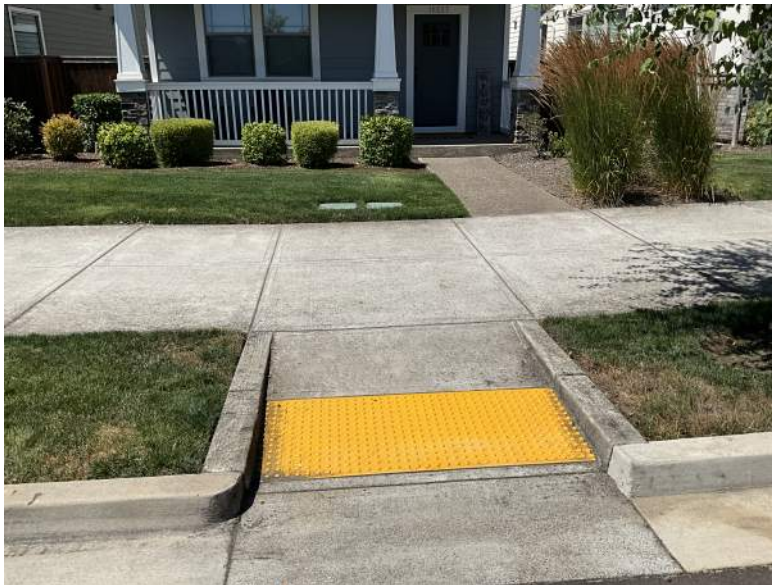
ADA Curb Ramp Images

IITD RR1 Fails
