ADA Curb Ramp New Construction Inspection Form (Blended Transition)

NW MAIN ST

24953

NW NORTH AVE

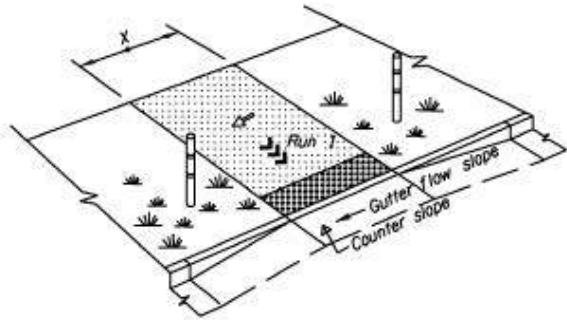
BLENDING TRANSITION (BT)

Pedestrian access route (To measure clear width)

Detectable warning surface

Cross slope (2.0% finish grade max.)

Running slope ($<5.0\%$ finish grade max.)
(If running slope $\geq 5.0\%$, this is a curb ramp, not a blended transition.)

Counter slope (5.0% finish grade max.)

Gutter flow slope (as required)

Edge of Gutter Pan
