# ADA Curb Ramp New Construction Inspection Form (Blended Transition)

NW. 314TH AVE

24953

NW. COMMERCIAL ST.

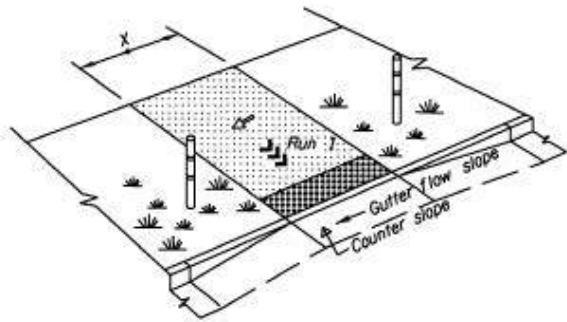
BLENDING TRANSITION (BT)

Pedestrian access route (To measure clear width)

Detectable warning surface

Cross slope (2.0% finish grade max.)

Running slope ( $<5.0\%$  finish grade max.)  
(If running slope  $\geq 5.0\%$ , this is a curb ramp, not a blended transition.)

Counter slope (5.0% finish grade max.)

Gutter flow slope (as required)

Edge of Gutter Pan

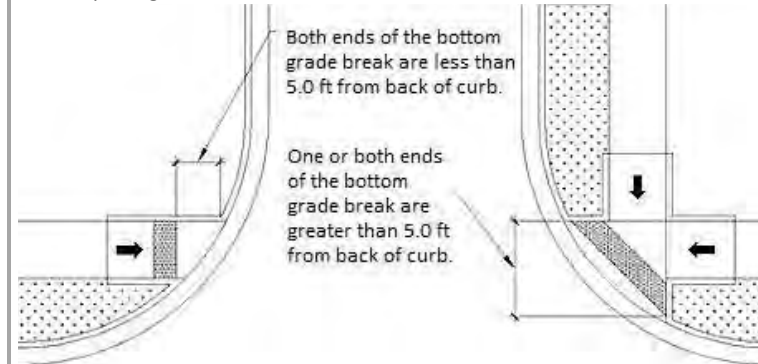
1  
Corner Position

Both ends of the bottom grade break are less than 5.0 ft from back of curb.

One or both ends of the bottom grade break are greater than 5.0 ft from back of curb.

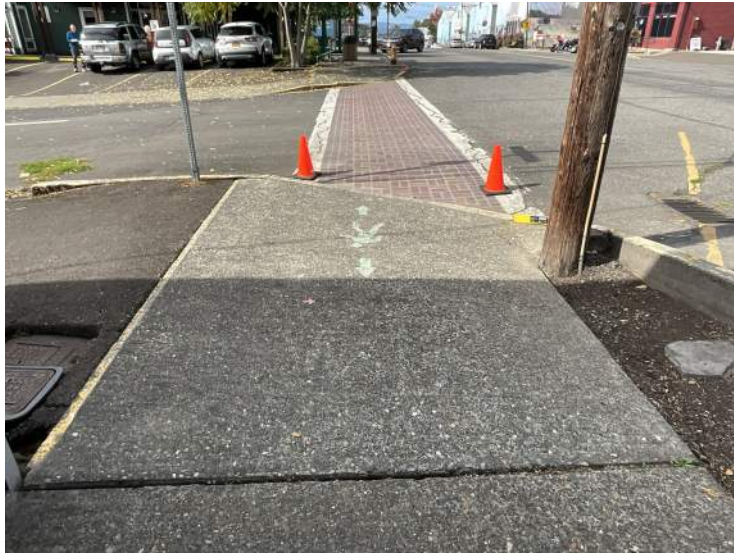
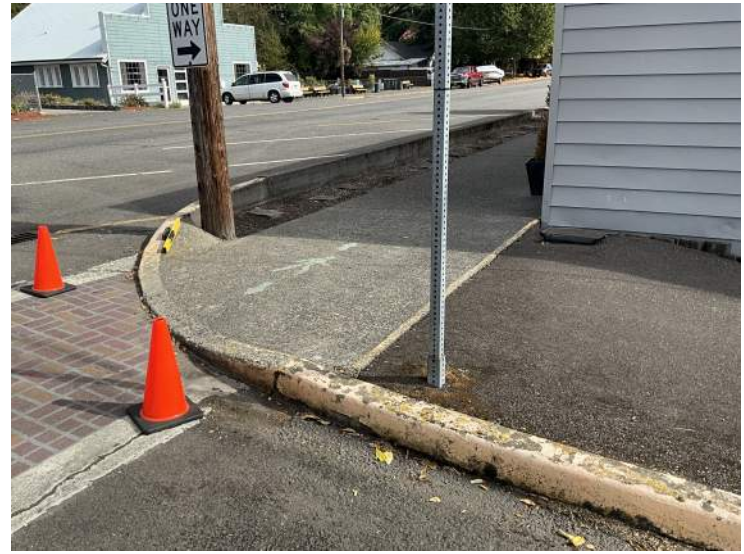
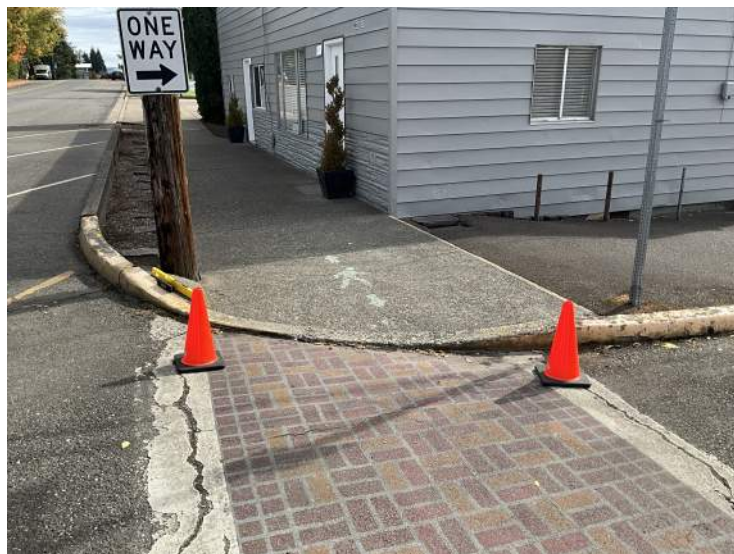
## ADA Curb Ramp Images

No dome
