ADA Curb Ramp New Construction Inspection Form (Blended Transition)

NW MAIN ST

24953

NW NORTH AVE

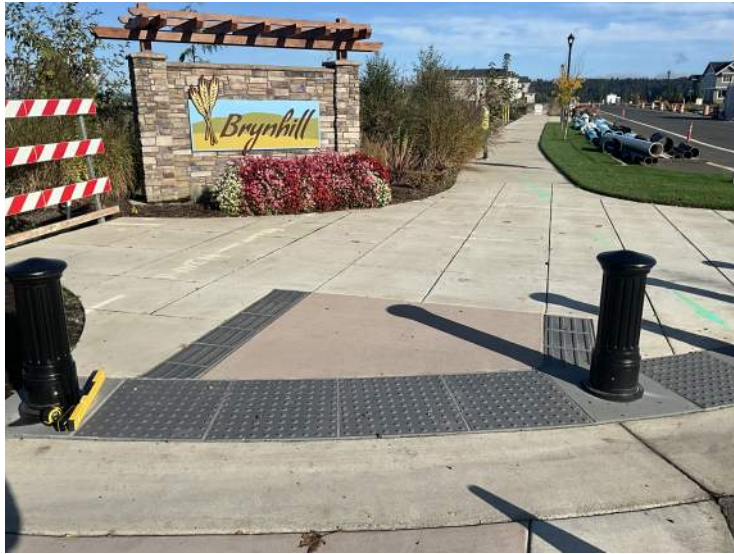
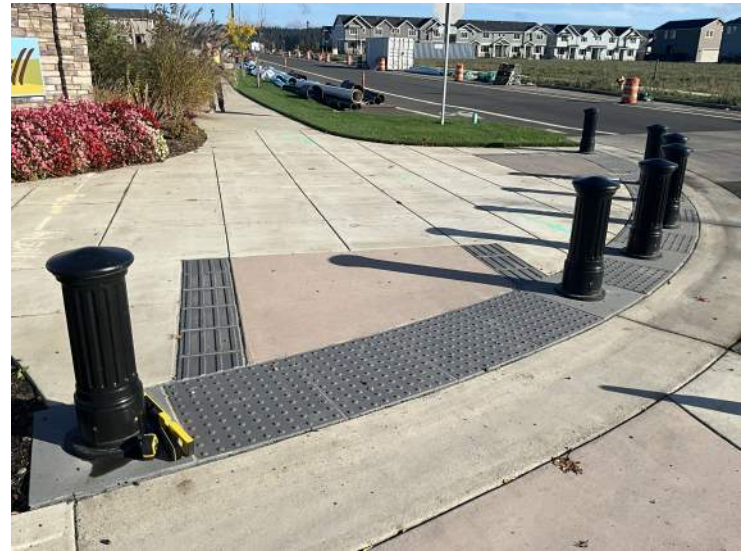
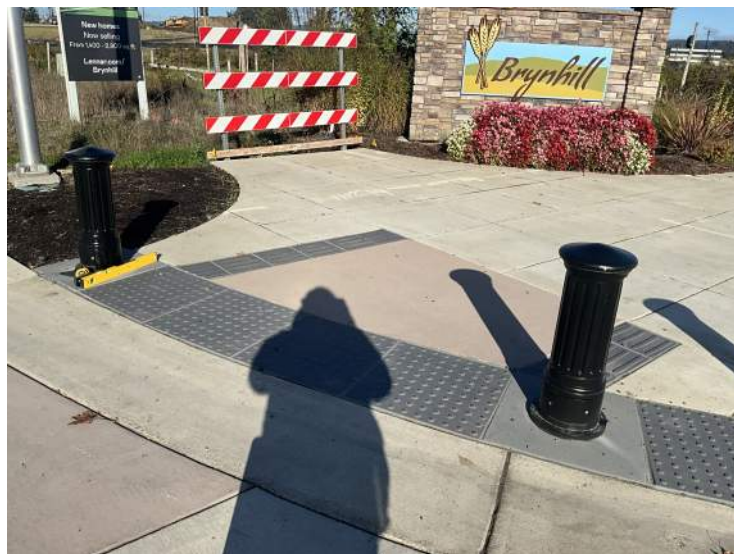
ADA Curb Ramp Images

GFS fail workmanship
