ADA Curb Ramp New Construction Inspection Form (Blended Transition)

NW MAIN ST

24953

NW NORTH AVE

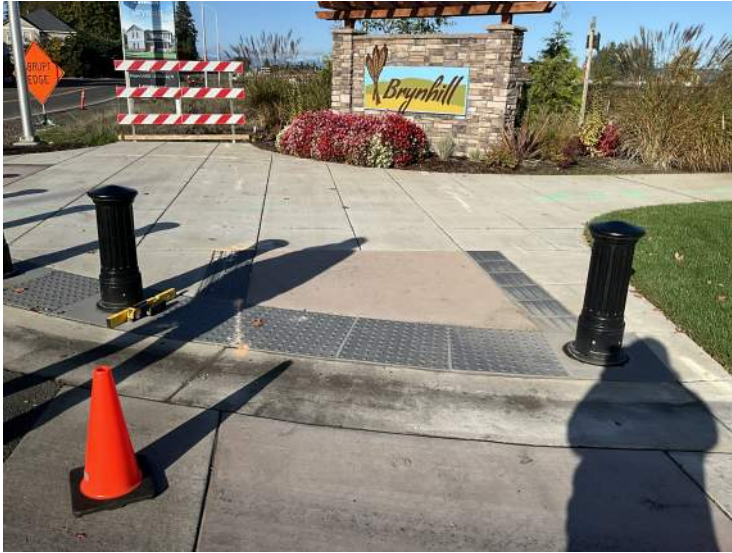
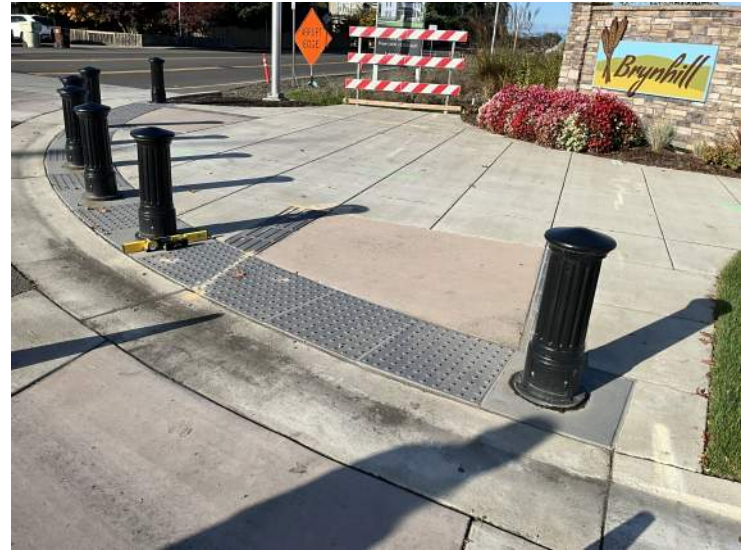
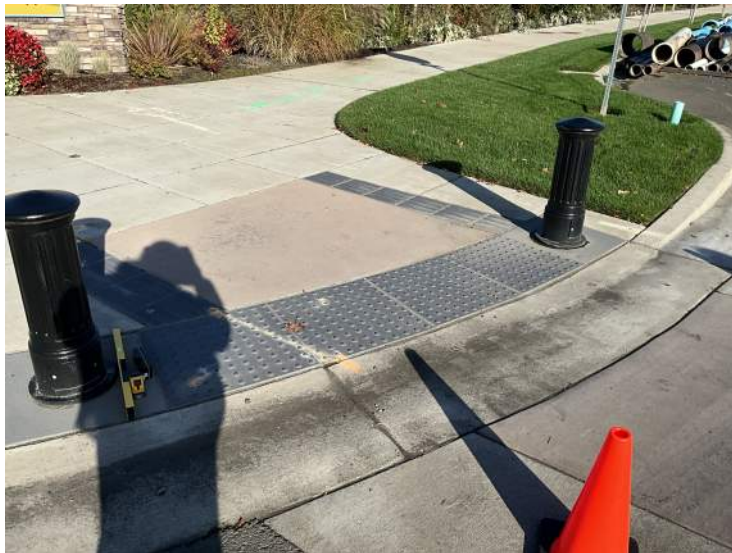
ADA Curb Ramp Images

Crack through curb and gutter
