ADA Curb Ramp New Construction Inspection Form (Blended Transition)

NW MAIN ST

24953

NW NORTH AVE

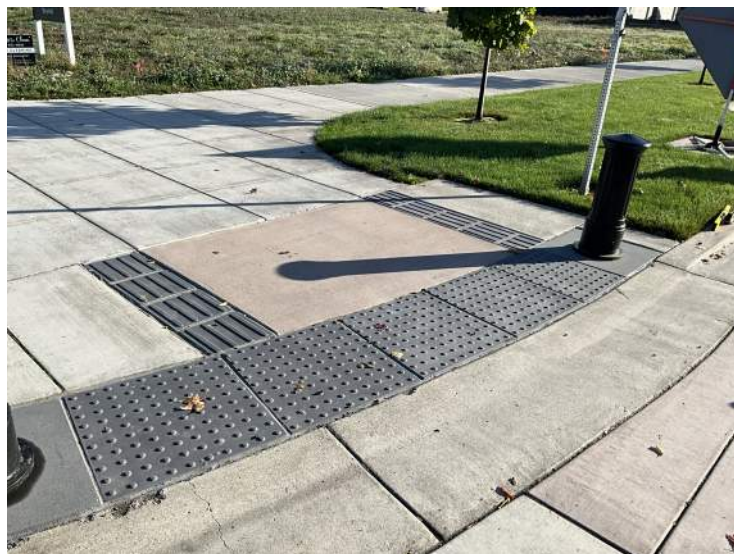
ADA Curb Ramp Images

Large crack through gutter and curb
