# ADA Curb Ramp New Construction Inspection Form (Perpendicular)

NW Kaye

24952.54

NW Fair

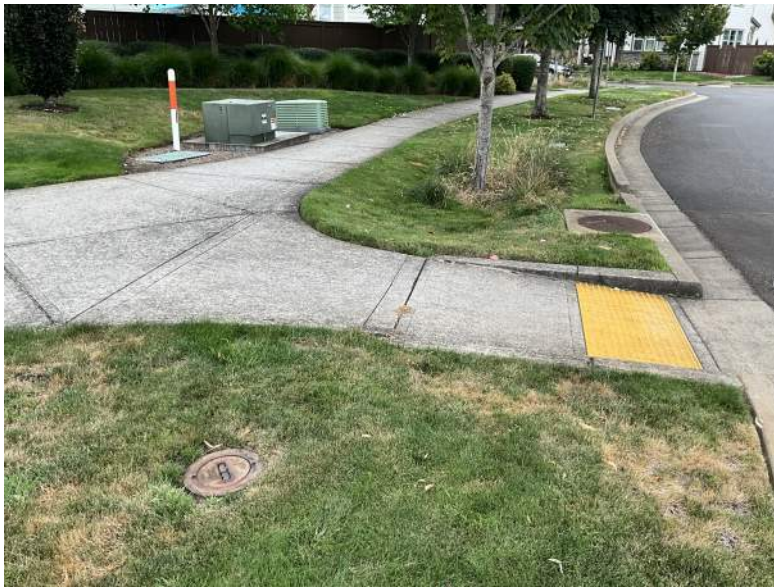
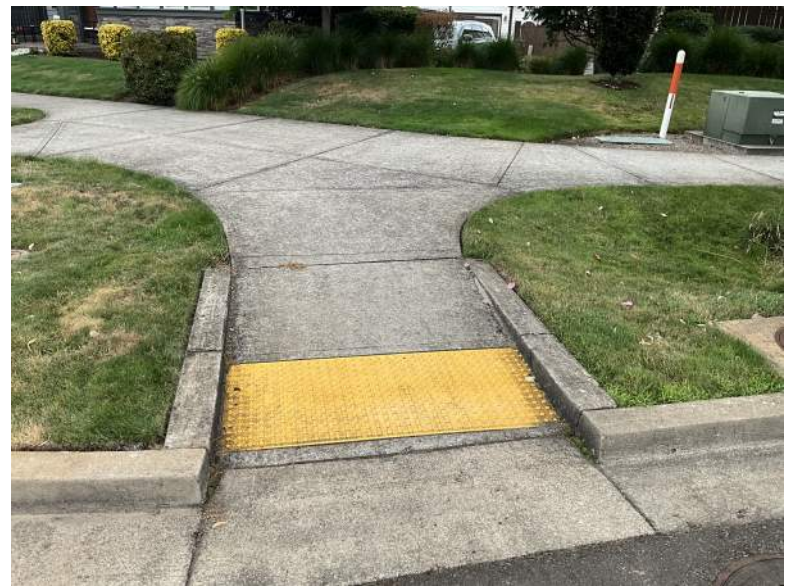
## ADA Curb Ramp Images

Counter Slope (+/-) \*2

6.1

> |5.0%|

Comments:

IITD, RR1 ICRR
