ADA Curb Ramp New Construction Inspection Form (Blended Transition)

NW. 314TH AVE

24953

NW. COMMERCIAL ST.

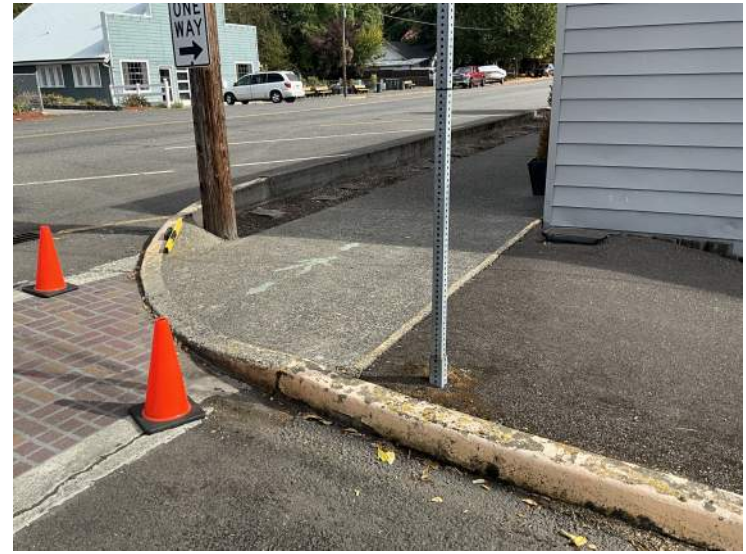
ADA Curb Ramp Images

Running Slope 1

5.8

Curb Running Slope (avg)

10.77

Counter Slope (+/-) *1

7.4

No dome

Flare Slope 2

21.5
