ADA Curb Ramp New Construction Inspection Form (Perpendicular)

NW Cami Pl

24952.54

NW North Ave

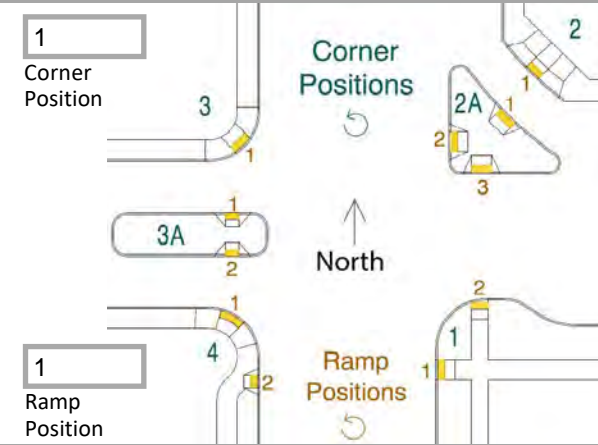
PERPENDICULAR RAMP (PR)

- Pedestrian Access Route (to measure Clear Width)
- Detectable Warning Surface
- Cross Slope (2.0% max.)
- Running Slope (8.3% max.)
- Counter Slope (5.0% max.)
- Turning Space (X & Y) (2.0% max. / 4' x 4' min.)*
* If constrained at back of walk, min. Y length is 5'.
- Gutter Flow Slope (as directed)
