ADA Curb Ramp New Construction Inspection Form (Perpendicular)

Nw 293rd

23885.56

Nw King

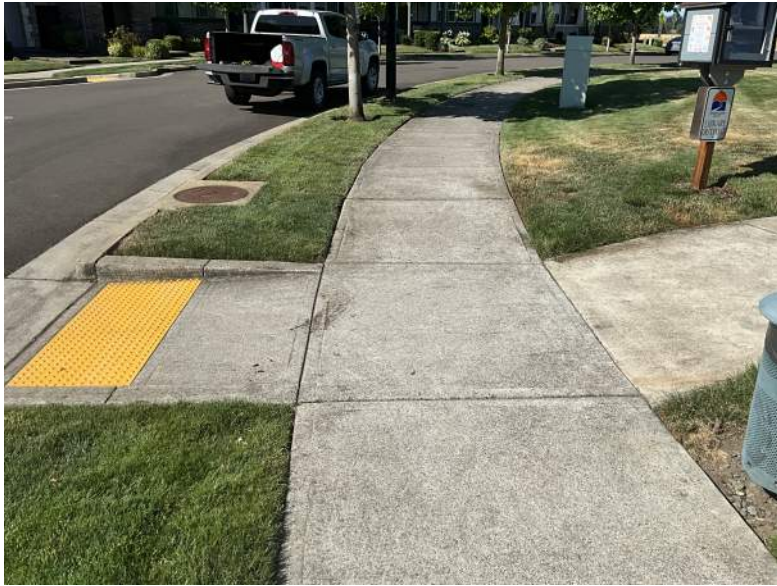
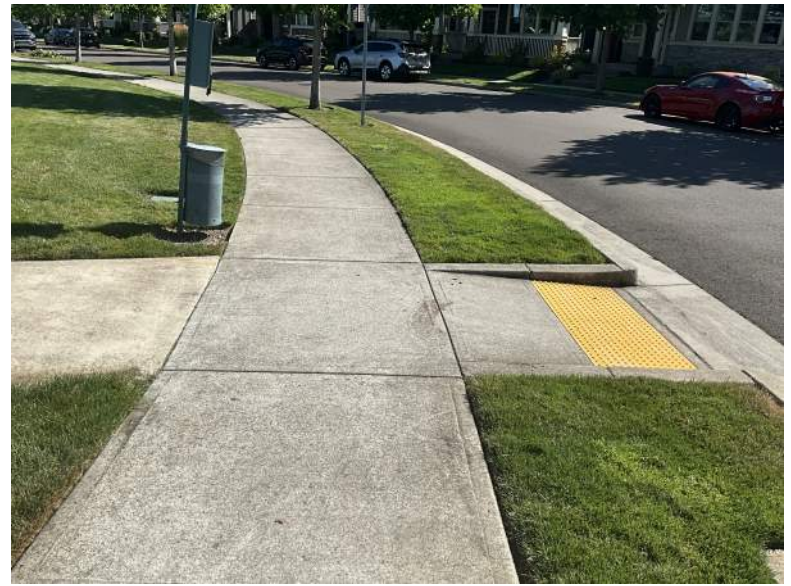
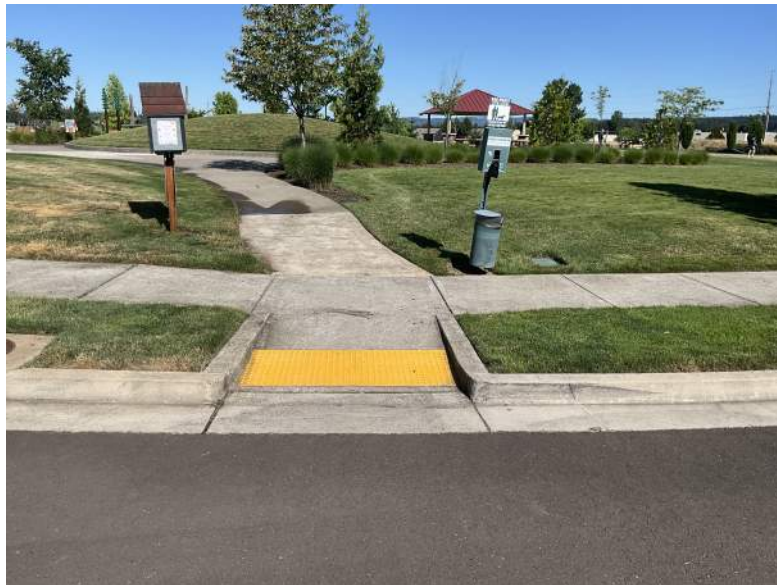
ADA Curb Ramp Images

IITD RR 1 fails
