Re-engineering a stacker truck to decommission a 30-year old vitrification cell

ANS Sixth
Topical Meeting
on Robotics and
Remote Systems
February 5-10,
1995 Monterey,
California

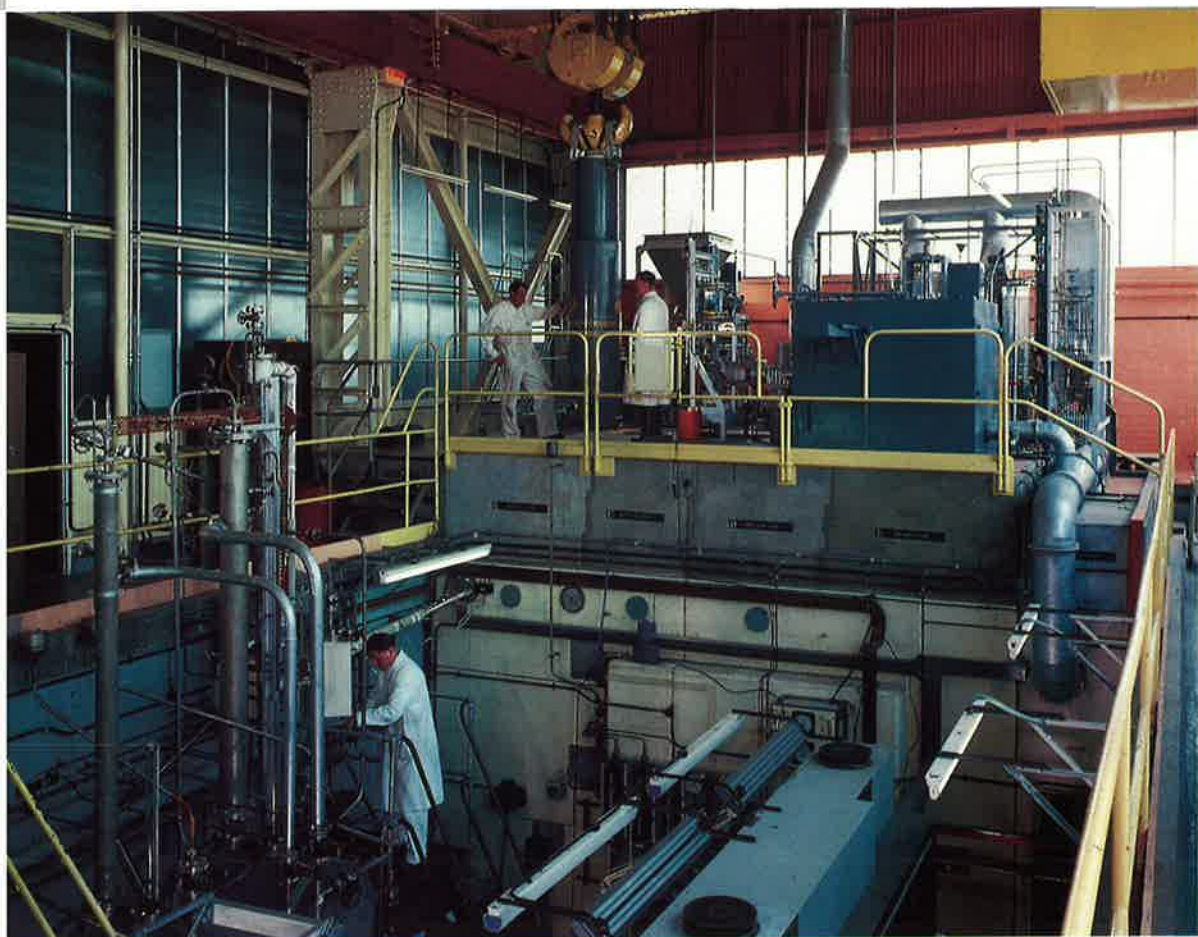
Figure 1. The FINGAL
Cell in operation

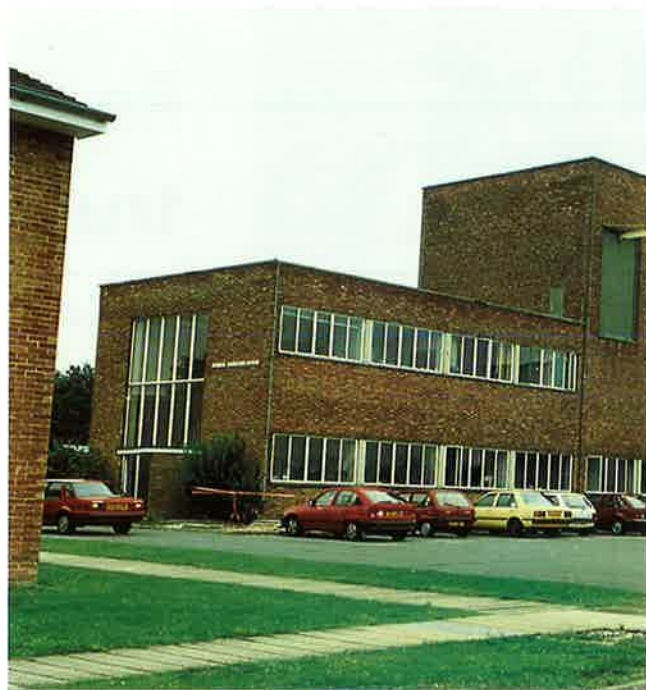
Figure 2. The Chemical Engineering Building

The FINGAL cell is situated at the end of a 36 m long storage pit in the old Chemical Engineering Building (Figure 2). This building is the subject of a decommissioning programme with a scheduled green field end point in 1998.⁽²⁾ Initial tasks have been to strip the building of the multitude of redundant chemically and radiologically contaminated process plant, rigs, laboratories and stores. The building fabric is being decontaminated so that near-conventional demolition techniques can be employed. The FINGAL cell had to be decommissioned to allow access to the pit which must also be extensively decontaminated. Even after 30 years of abandonment, FINGAL represented one of the largest single inventories in the building. Later experimental and near-production scale vitrification facilities such as HARVEST were not heavily contaminated and were relatively easy to decommission.

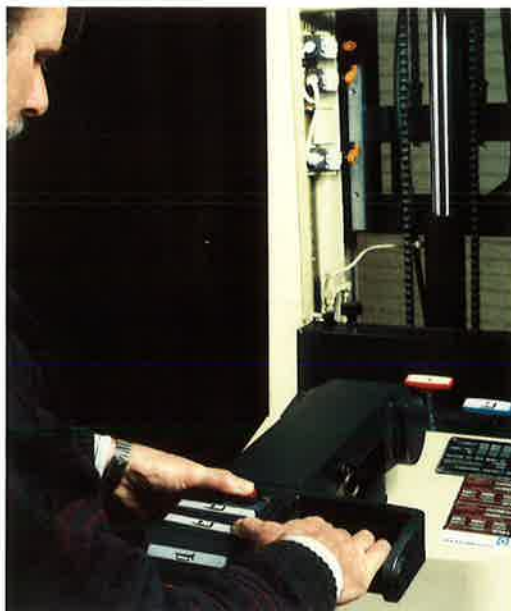
Figure 8. Creep control
for inching near the roof
