- The Complete Decommissioning of a Chemical Engineering Building

Ed Abel and Clive Hamblin
Harwell Projects Department
Southern Division

International Conference on Nuclear Decommissioning '98,
London, 2-3 December 1998

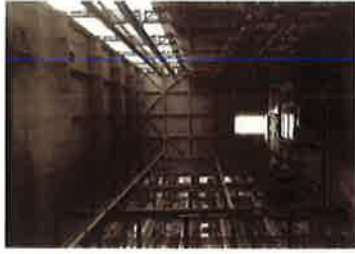
Background (i)

- Design began in 1946
- New design in 1948, built 1950-1952
- Galleries + big shielded cells & large Storage Pit
- Experimental, not Pre-production (Windscale)

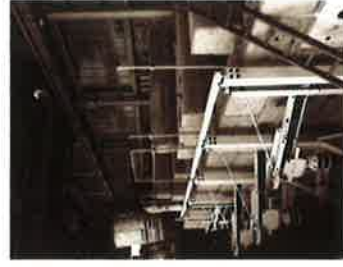
Background (ii)

- The Large Cells became cannibalised for the ^{233}U Pilot Plant Six
- The Pit was used for fuel cutting, breakdown & dissolution as well as highly active effluents

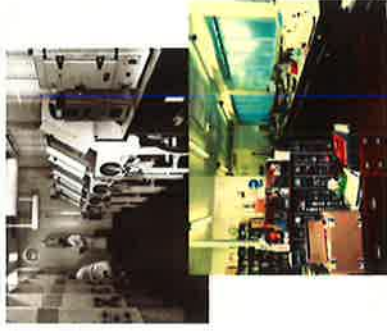
Analytical Laboratory (i)

- Refurbished in 1957
- Chemical & radioactive hazards
- Dedicated ventilation
- Legacy contamination
- Asbestos in roof spaces & voids
- Unsafe hidden wiring

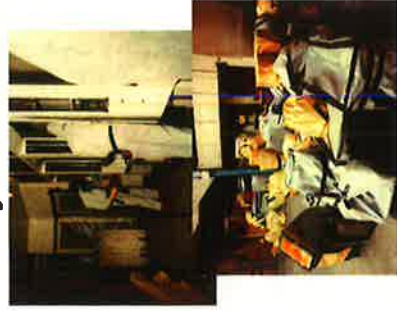
Analytical Laboratory (ii)

- Mix of in-house & competitive tender
- Archive research
- Cautious, piecewise approach to reduce risks
- Ductwork wrapped for local size reduction
- Segregation of wastes

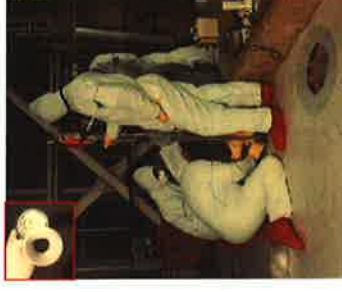
FINGAL (ii)

- FINGAL Flask, active block and γ gate removed
- Several controlled in-cell inspections + surveys
- Unproductive search of records for as-built details
- Intrusive survey from roof with cctv and telescopic β/γ probe
- Planned approach to tackle decommissioning

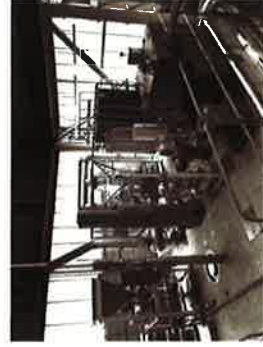
FINGAL- abandoned vitrification cell (i)

- Early 1960s plant
- Used active liquors from Windscale (10^{15} Bq)
- Built into Storage Pit with shielded roof blocks
- Incidents led to cell and roof contamination
- Abandoned in mid-60s in favour of Harvest and rotary calciners

- Cell contained Pb wall >2.5m high with ~800 150kg blocks
- Modular Containment built to give extra space
- Access limited to narrow corridor and 0.75m door
- Ventilation system contaminated and decrepit
- No way to deal with large quantities of LLW

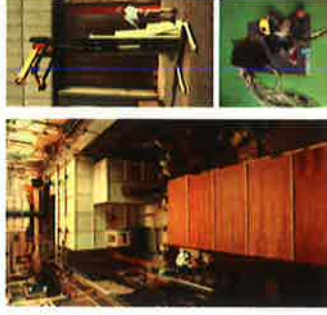
FINGAL (iv)

- Mobile Filtration Unit (4000 cfm) fitted to RDP
- HISO facility built in Pit using 50 ton crane
- Modified stacker truck and folding cranes used to aid manual handling
- Improved tooling, audio & cctv communications

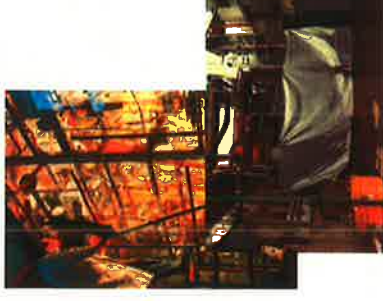
Mkl Gel Precipitation Lab (i)

- Used to prepare U/Th spheres for fuel studies
- Simple construction, could still use building ventilation system
- additional hazards of nitric acid, organic solvents and ammonia
- adjacent structures and equipment contaminated

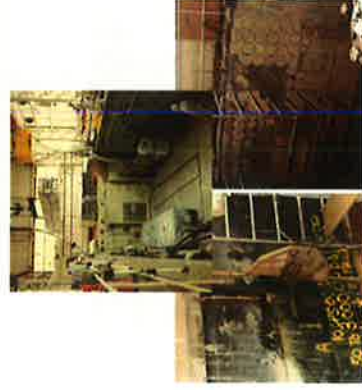
FINGAL & Pit Concrete

- Cell decontamination attempted and concrete sampled (hollow drill)
- Roof blocks removed, cored & decontaminated
- Support walls broken down and disposed of
- Wall bulk removal trials
- Remaining areas cleaned and scabbled/scarified

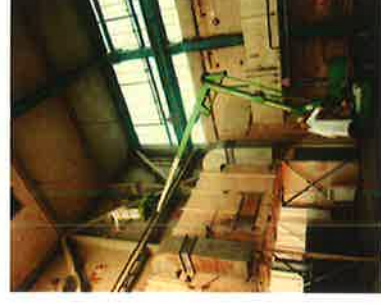
Mkl Gel Precipitation Lab (ii)

- Was U storage area and High Temperature Lab
- Catch tray floor and main wall (14m x 14m) contaminated
- Temporary walls hid old contaminated items
- Remote low-loss cabled cctv used to monitor work
- Cherry-picker for survey

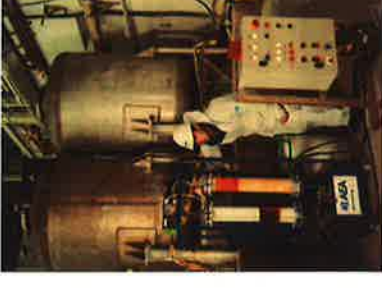
SEPP & the Uranium Evaporator (iii)

- No easy disposal route for contaminated solvents
- Contaminated pipework packed into larger vessels and placed in HISOs
- Solvent drained to two SEPP tanks until process options determined
- Ion-exchange process developed for TBP/OK

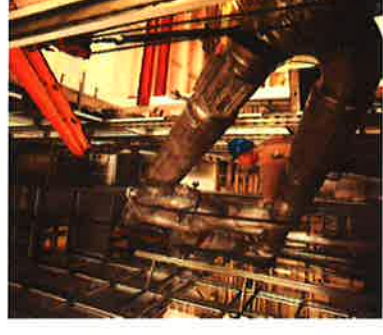
The CDFR Dissolver (i)

- Studies of dissolution of spent fast reactor breeder fuel in various dissolvers
- 100m³ ventilated cubicle with off-gas treatment
- Large storage tanks for liquors (conc. HNO₃, NaOH, uranyl nitrate)
- Substantial stainless steel dissolver

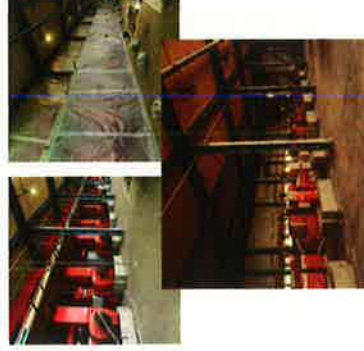
Main Active Ventilation System (i)

- Mainly mild steel ducts (~4km and up to 3m x 3m) through building to two Plant Rooms
- Most with HEPA filters
- Competitively Tendered
- Runs tented to allow safe dismantling
- Old ducts insulated with cork and asbestos cement

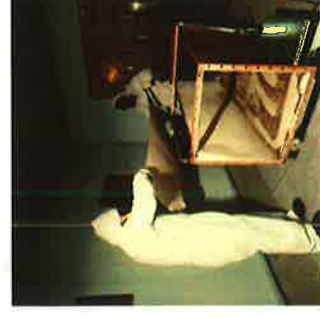
Main Active Ventilation System (iii)

- All ductwork, fans and housings size reduced in special facility in B351
- Decontamination used when beneficial
- Cold cutting techniques developed and used (band saws, nibblers, etc)
- Flat-packed waste sent to B351 HISOs for disposal

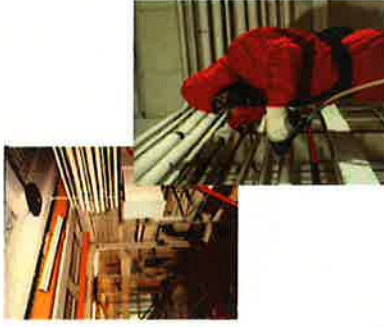
Building Demolition - West Wing (i)

- Used as "safe" trial for main building
- Services disconnected & asbestos removed
- All equipment, cubicles, floor coverings, partitions, fume cupboards and duct-work removed
- Floor plates and joists surveyed, decontaminated and removed

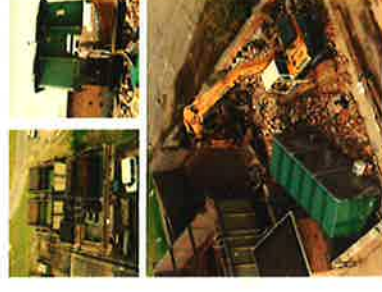
Building Demolition - Delay Tanks (i)

- North Delay Tank Complex to green field
- High pressure water jetting removed most of contamination
- Up-ended tanks allowed non-confined space decontamination work
- Mass size reduction of tank by hydraulic shear

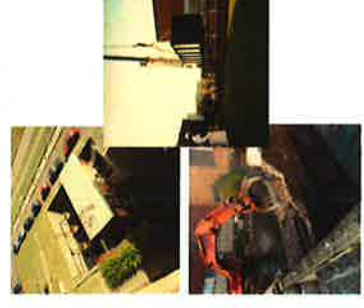
Building Demolition - Delay Tanks (ii)

- South Delay Tank Pit Complex totally cleared, eventually backfilled with B351 rubble and capped
- Tanks also cleaned (by HP water jetting and selective flame cutting) to free release and special precautions burial levels
- Pump house demolished

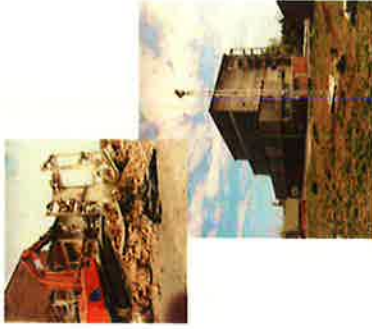
Main Building Demolition (i)

- Competitively Tendered
- Environmental Impact Assessment (B351 was 11m from Site Boundary)
- Vibration, noise and dust control measures in ITT
- Surveillance cctv installed on masts, relayed to new Project Offices close to site

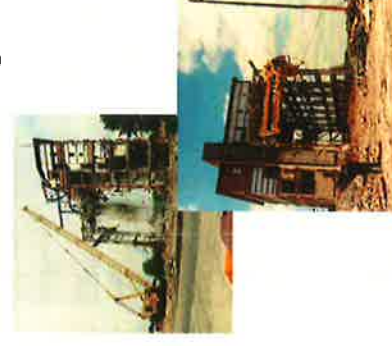
Main Building Demolition (iii)

- Main steel/concrete structures collapsed using wrecking ball and progressive cutting of steel
- Continuous radiological surveys and environmental monitoring
- Demolition completed in August 1997 but basemat and capped Pit on C&M

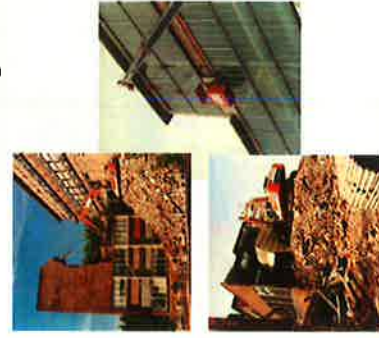
Main Building Demolition (ii)

- Demolition began in April 1997 with brick built Office and Analytical Lab Wings
- Storage Pit backfilled with this rubble to allow close, load-bearing access to North Side of building
- Asbestos cement panels removed from cladding frames via scaffolding and cages

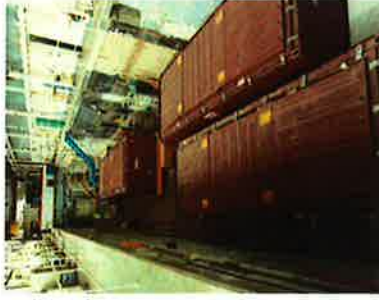
Waste Management (i)

- Radiation monitoring and sampling rigorously applied to help segregation and minimise volumes
- Waste fingerprints determined before work
- gross activity with β analysis and α - and γ -spectrometry identified isotopes and checked compliance for Drigg

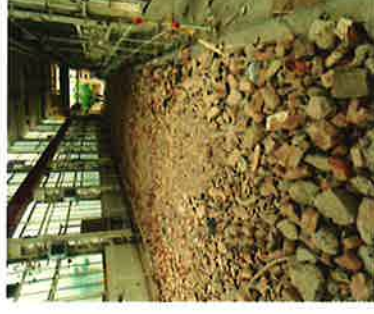
Waste Management (iii)

- Materials recycled on the B351 site (backfill of ducts and Delay and Storage Pits)
- Chemical waste sentenced through AEAT's HDS
- Non-hazardous wastes sold or to landfill via skips
- LLW volumes close to estimates but decontamination techniques failed to scale up adequately

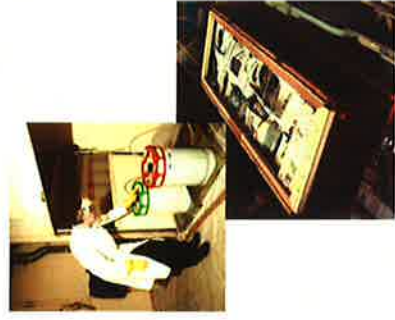
Waste Management (ii)

- 200l bins (compactable), HISOs (non-compactable)
- ~1 tonne of nuclear material (U + Th) as contact handled ILW
- FINGAL block as 540l ILW in own flask
- 1000's of chemical analyses on ~5ml to tonne quantity bulk materials
- Audited disposals
