DIDO Operators Meeting, 16-17 April 2008, Roskilde, Denmark

Replacement of the PLUTO reactor top shield plug in 1983 – a lesson in pre-decommissioning, decommissioning

Dr Ed Abel

Harwell Reactors Decommissioning Manager
UKAEA, 404 Rutherford Avenue
Harwell Science and Innovation Campus
DIDCOT, Oxfordshire, OX11 0DF
United Kingdom
+44 1235 434168
ed.abel@ukaea.org.uk

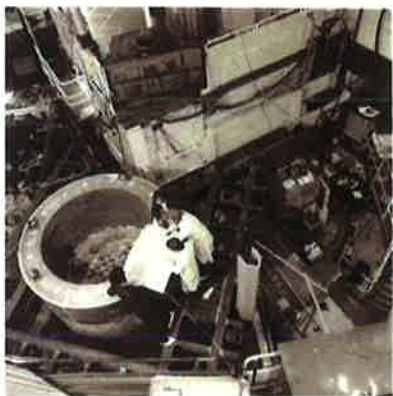
Installing the new Rigs Storage Block (RSB) that would accommodate the old top shield plug

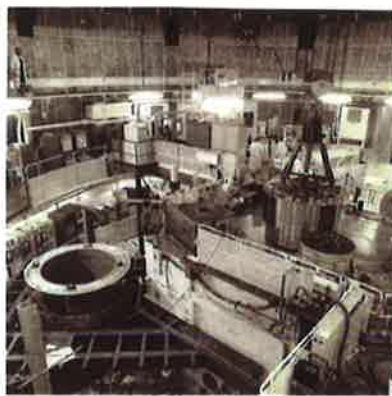
Extra structural steelwork around the RSB would support the 0.6 m x 0.6 m concrete shielding blocks

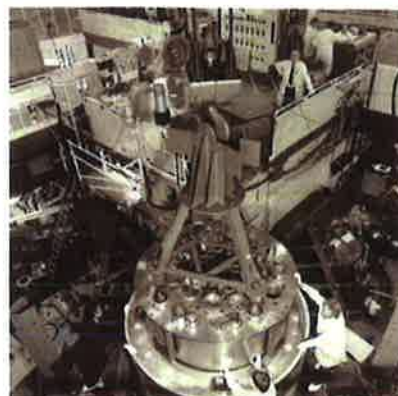
Checking the new plug fits in the RSB. Side-wall stools are attached so the plug is not fully lowered

Rehearsals used the new top shield plug and demonstrated that the plug could be inserted into the Rigs Storage Block and onto its stools. The two lifting frames had features at their top to guide the crane hook into position and the engagement and disengagement was practised. The rehearsals also allowed repositioning of cameras and other equipment to ensure the best views were available to a crane operator in the Emergency Control Room. An arrangement of guide rollers would be fitted to the top flanges of the RAT and RSB so that the crane driver could manoeuvre the plugs without damaging the RAT walls if the alignment was not precise.

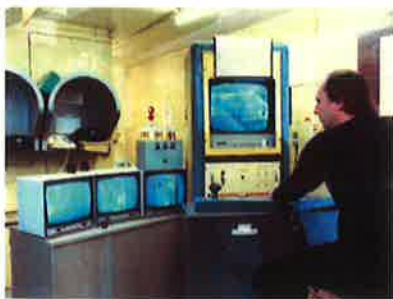
The ECR: Crane Operator's CCTV and remote controls

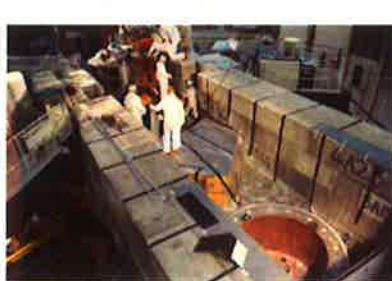
View from auto-camera - old top shield plug is prepared

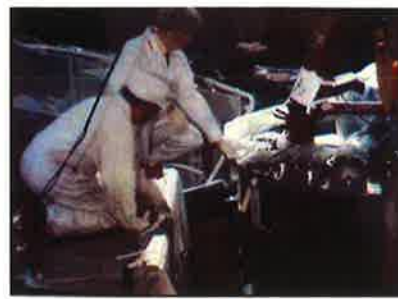
Video link screen-shot - old top shield plug is prepared

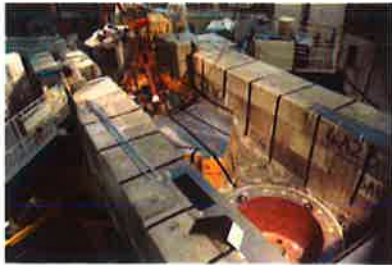
10:30
Lift of plug from RAT begins

The replacement was achieved without any serious set-backs. There was no need for any emergency intervention. The old plug was lifted until white paint markers on the crane ropes were level, indicating a correct traversing height. As the plug moved along the shielded trough towards the RSB, it passed over two high-level radiation monitor chambers, one on the edge of the reactor well, the other on top of the shielding towards the RSB. Their amplifiers could be read by CCTV. The maximum radiation level detected (at a distance of 1 metre) from the plug was 11 Gy h⁻¹. Peak levels measured on the crane gantry walkway next to the Shell wall were 2 mGy h⁻¹.

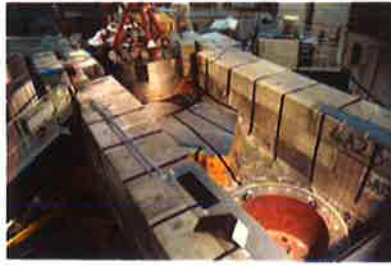
10:31
Top shield plug is clear

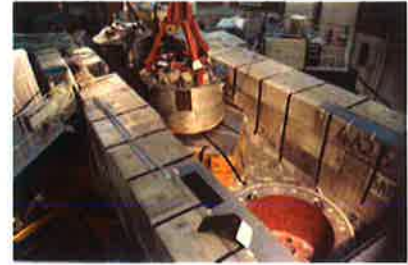
10:32
Traverse to RSB

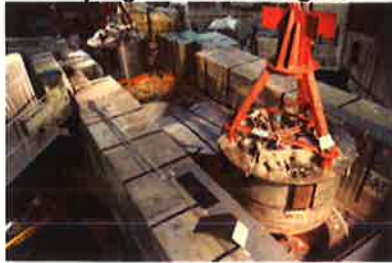
10:33
Positioned over RSB

The three cameras on the lifting frame were useful in helping the crane operator position the old plug above the RSB by equalising the gaps around the base. Minor adjustment was required but the plug was set down on the stools in the RSB. At this point, the crane gantry gamma monitor directly above the RAT only read 200 µGy h⁻¹, showing the increased water level had successfully reduced the radiation. The assumptions on cobalt content of the aluminium were considerably lower than the most pessimistic prediction or the activation had not reached as far up the RAT or shield plug as assumed. The maximum at the nearest section of Site fence was 3 µGy h⁻¹.

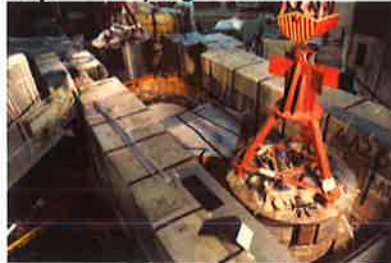
10:34
Lowering into RSB

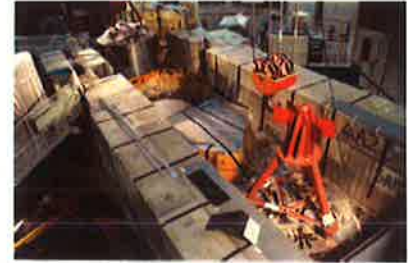
10:36
Installed & crane hook clear

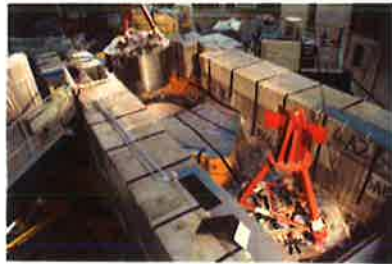
10:40
New plug lifted over RAT

The crane was remotely unhooked from the old top shield plug frame and hooked onto the frame for the new plug. It was positioned over the RAT and was lowered slowly, using the 120° cameras and guide rollers to attempt to centralise itself. The new plug did tip sidewise and then was slightly

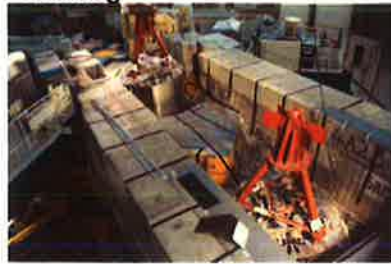
10:43
Lowering into RAT

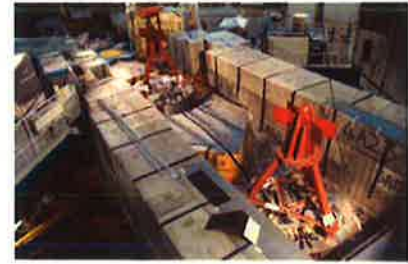
10:45
New plug installed into RAT

On re-entry, the team lowered the new plug on to the 760mm stools and drained down the RAT. The diaphragm was removed. Measurements were made of the gamma radiation inside the RAT at different levels. The high-range monitor saturated as it was lowered into the RAT, indicating the full scale deflection and a radiation level of $> 100 \text{ Gy h}^{-1}$ at a depth of 2.75 m. This value was probably driven by the source blocks in the horizontal tubes. Measurements using TLDs of the underside of the old top shield plug in the RSB gave a range of 10 – 60 Gy h^{-1} , which compared favourably with the shielded measurement of 33 Gy h^{-1} .

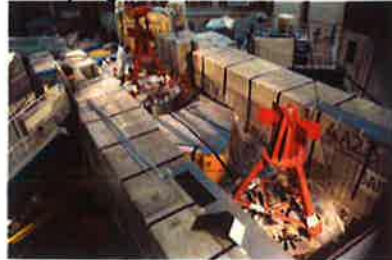
Health Physics monitor new and old plug positions

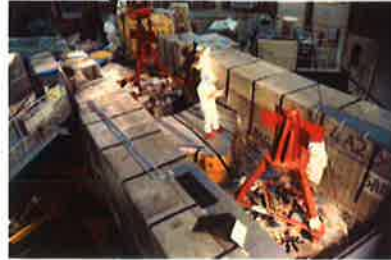
Overview, showing sheeting to aid decontamination

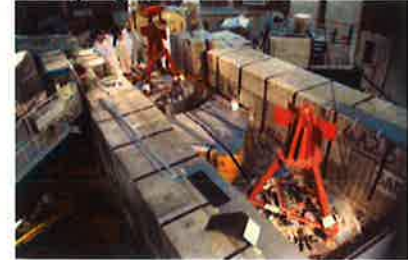
11:35
Re-occupation of reactor top

Two Health Physics surveyors entered the building and proceeded to the reactor top carrying radiation monitors and contamination-monitoring equipment. No significant contamination was found, and the remaining staff were admitted to the reactor building at 11.35 hours.

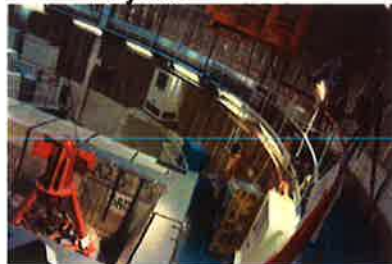
Fixed position video and auto-stills cameras

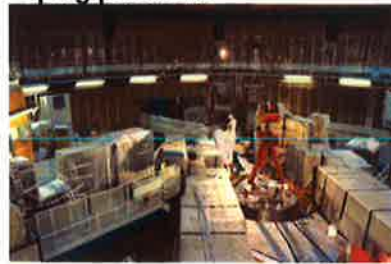
Overview, showing sheeting to aid decontamination

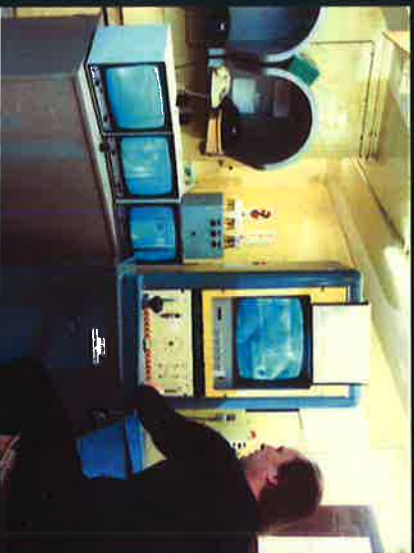
The ECR: Crane Operator's CCTV and remote controls

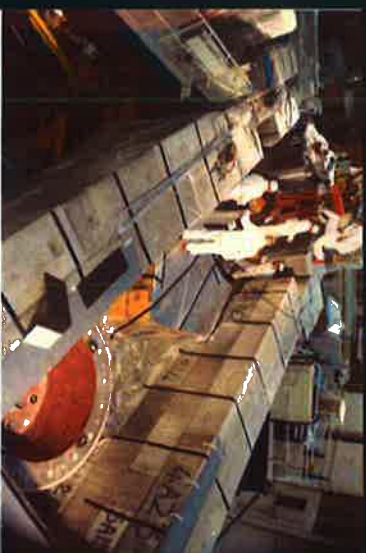
View from auto-camera - old top shield plug is prepared
