TV2GO - THE USE OF MINIATURE OFF-THE-SHELF CCTV DURING THE DECOMMISSIONING OF A CHEMICAL ENGINEERING BUILDING

E Abel, C Hamblin and A C Rose
AEA Technology⁺, Harwell

SYNOPSIS

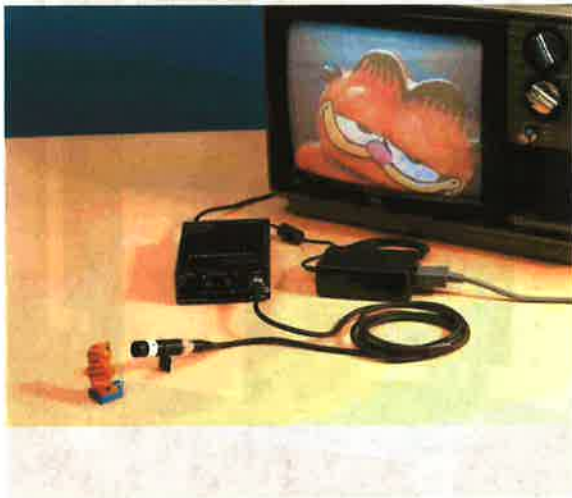
A lip stick camera

Table 1 - Details and Specifications of Chosen "Lip stick" Camera

Power Consumption	approx. 4 W
Device	½" CCD image area sensor, 579 x 583 pixels
Resolution	>370 lines(H), >420 lines(V)
Scanning Area	6.50mm x 4.85mm
Scanning	2:1 interlaced
Standard luminance	over 200 lux
Ambient temperature	-10°C to +40°C
Camera cable length	up to 30m
Weight	25g (head, without cable)
Pan (& tilt) unit range	340° (190°)
Pan & tilt unit weight	700g

The particular camera chosen was supported by a wide range of accessories. The camera control unit could be located up to 30m away from the head. Environmental and underwater housings were available, but for the mainly dry applications in this building they are not necessary. Contamination has been avoided by carefully double-wrapping the camera and cable in lay-flat plastic tubing. The camera was fixed to a miniature pan and tilt unit when used to observe work being carried out by decommissioning teams. The pan and tilt was either hung at height on a wall or mounted on a tripod that could be easily moved.

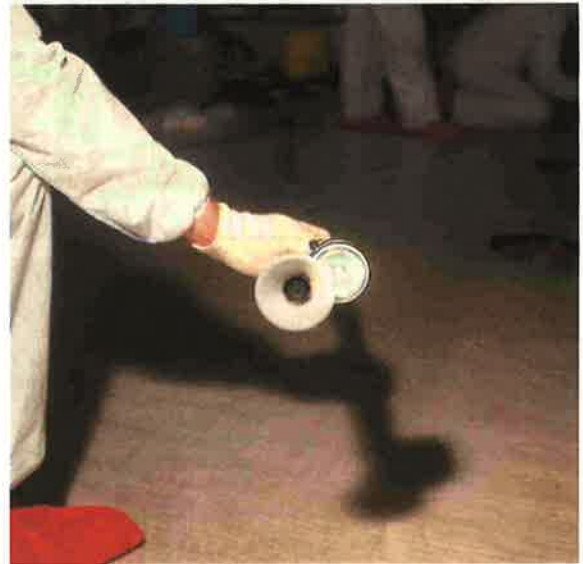
Camera plus simple shroud and light

A deployment system for the lip stick camera was based on a 5m length of plastic conduit. The camera was wedged at one end and the control and signal cable run inside. A cut down plastic filter funnel was fitted to shroud and protect the camera head, and a halogen light was strapped to the conduit. The maximum width of the assembly was 75mm, compared to the plant bore dimension of 150mm. Camera parameters such as aperture and focus were set beforehand by a trial inspection of a (clean) soil pipe.

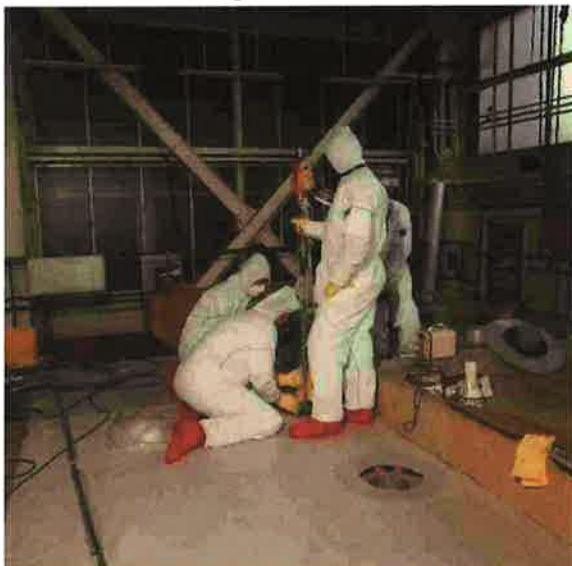
Camera and β/γ monitoring of FINGAL furnace

Working from the roof of the FINGAL Cell through the concrete shielding, a telescopic β/γ probe was used to map the radiation distribution of the furnace and two oven bores. The conditions of the inside surfaces were then inspected using the lip stick camera. High quality pictures of the bores showed that remarkably little debris remained and the furnace elements and ceramic bricks were mainly intact. This information strengthened the methodology proposed in the Decommissioning Safety Case. Correlation of the radiation measurements with the camera images clearly identified the location of the hot spots on specific areas above the furnace and ovens.

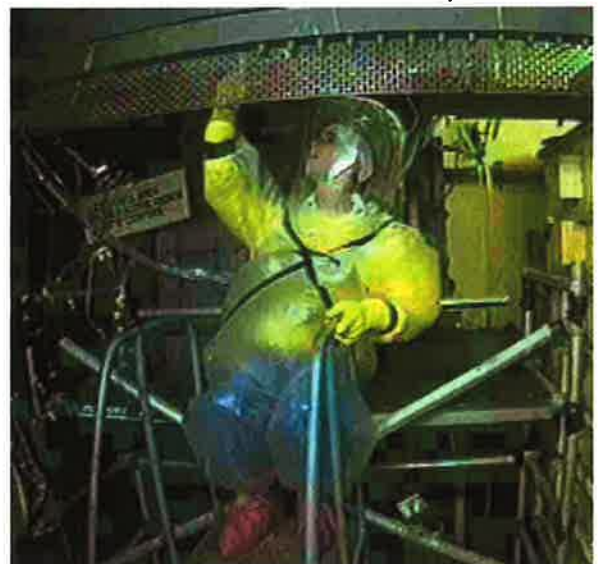
Inside the FINGAL Cell – lipstick camera image

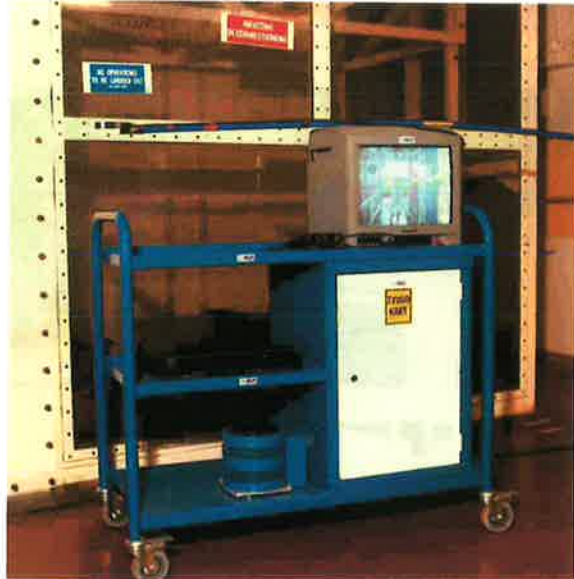
"TV2Go Kart" – trolley with camera, lighting and recording controls for use within Building 351

further into a duct. As with the FINGAL inspection, a halogen lamp was used. A more substantial shroud was provided so that the camera did not get trapped between duct obstructions. The CCU and VCR were mounted on a mobile trolley. Video and radiological records were compiled for each 1.2m section of each duct so that the eventual strip-out can be based on detailed knowledge of the ducts' contents.

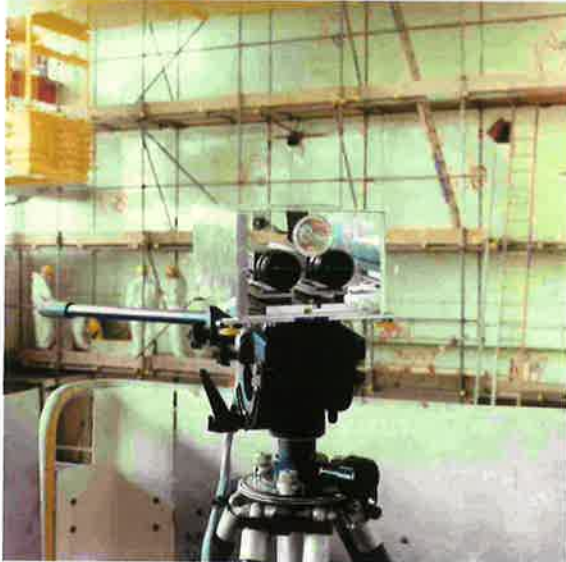
3-D TV camera head

TV2GO systems have been used to observe several other decommissioning operations where containment construction has prevented easy access by project management teams. 3D-TV has been used where the additional quality of information has been essential for the safe removal of the FINGAL Cell mass concrete shielding roof blocks. 3D-TV and lip stick cameras were placed inside the containment to monitor the progress of block lifting. The 20-tonne blocks had loose contamination tied-down onto their upper and lower surfaces. It was crucial for the safety of operators to see clearly the way in which the tie-down coating tore apart, sheared, delaminated and sagged, before the blocks were raised even a few inches. It would be impossible to get definitive, unambiguous visual cues using ordinary cameras. The stability of the supporting walls and the way in which the jointing cement (also contaminated) broke free had to be monitored remotely as the block removal progressed.

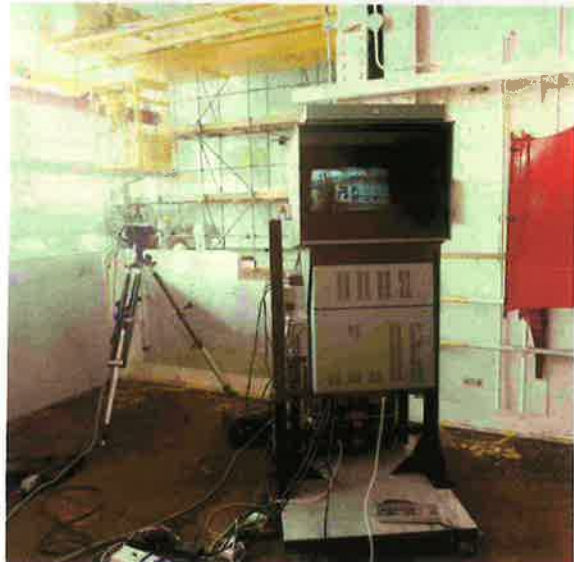
3-D TV monitor

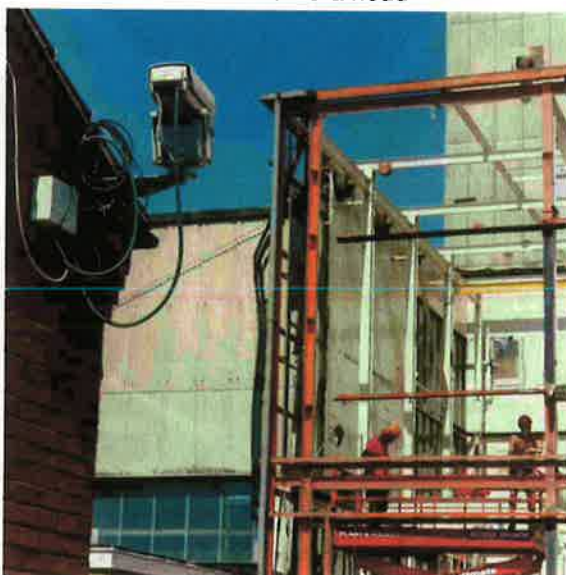
Building surveillance during decommissioning & demolition

Success in using CCTV within the building will be extended to external decommissioning and final demolition. Steerable, mast or building mounted surveillance cameras will be used to watch, record and control operations. The data will be relayed to a central point in B351, then as the building is vacated prior to demolition, to an adjacent building which will house the Project Team.

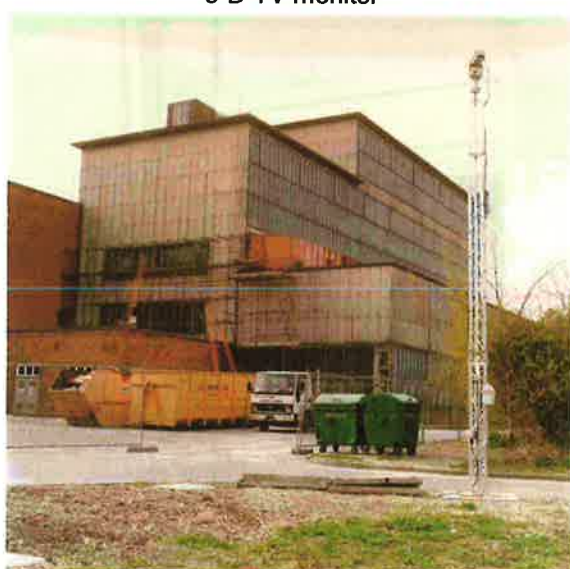
Camera mast for surveillance of decommissioning & demolition
