## Task Force SAFE

## Inspection-Report\_TFSAFE\_ATGXX\_JORSOF-Block-A-Rm-1\_116\_24-12-25\_1-4

Base Location	ATG (Syria)	Date:	2025-12-24
Base Code	ATGXX	Team #:	116
Building #	JORSOF-Block-A-Rm-1	System Voltage	230/400
Building Type	Barracks	Inspection Phase	Initial Inspection
Previous Report #:	N/A	Work Order:	TFS-ATGXX-2025-00050

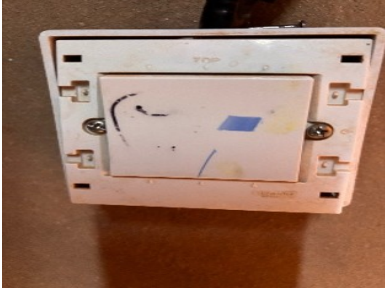
**Deficiency #1****RAC 2****Occurrences: 1****Description:** Unlisted switches installed.

<b>Location:</b>	Switches on the west and east walls.
<b>Category:</b>	Unlisted Equipment
<b>Equipment:</b>	WLT
<b>Imminent:</b>	No
<b>Action:</b>	N/A
<b>Code:</b>	BritishStandard 511: Compliance with standards
<b>Status:</b>	Open

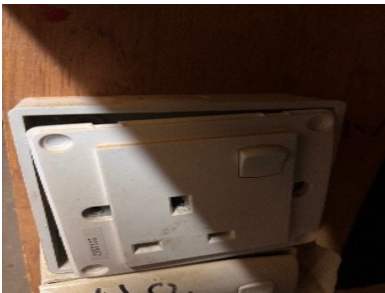
**Deficiency #2****RAC 2****Occurrences: 4****Description:** Unlisted sockets installed.

<b>Location:</b>	Socket outlets on all walls.
<b>Category:</b>	Unlisted Equipment
<b>Equipment:</b>	WLT
<b>Imminent:</b>	No
<b>Action:</b>	N/A
<b>Code:</b>	BritishStandard 511: Compliance with standards
<b>Status:</b>	Open

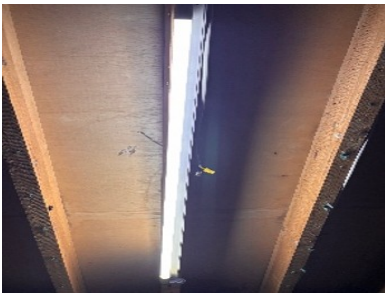
**Deficiency #3****RAC 2****Occurrences: 2****Description:** Unlisted light fixtures installed.

<b>Location:</b>	Light fixtures on the ceiling.
<b>Category:</b>	Unlisted Equipment
<b>Equipment:</b>	WLT
<b>Imminent:</b>	No
<b>Action:</b>	N/A
<b>Code:</b>	BritishStandard 511: Compliance with standards
<b>Status:</b>	Open

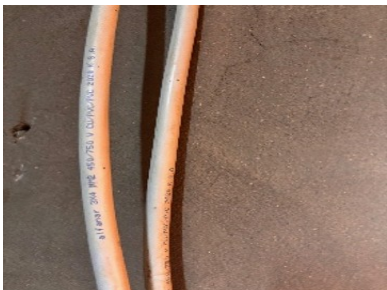
**Deficiency #4****RAC 2****Occurrences: 2****Description:** Unlisted cables installed on circuits.

<b>Location:</b>	Circuits within Rm-1.
<b>Category:</b>	Unlisted Equipment
<b>Equipment:</b>	WLT
<b>Imminent:</b>	No
<b>Action:</b>	N/A
<b>Code:</b>	BritishStandard 511: Compliance with standards
<b>Status:</b>	Open
