Re-Inspection-Report_TFSAFE_5VN8M_11200_102_17-01-22			
Base Location	JTC	Date:	17-Jan-22
Base Code	5VN8M	Team #:	102
Camp Name-BLD #	11200	System Voltage	230/400
Building Type	Office	Inspection Phase	Re Inspection
Previous Report #:	Inspection-Report_TFSAFE_5VN8M_11200_102_20-11-21_63-69		
Physical Building Location Description:	Mayor cell building.		
	Overall Building Electrical System:		Fair
Building Picture:	Inspector Name: Liam McCormack

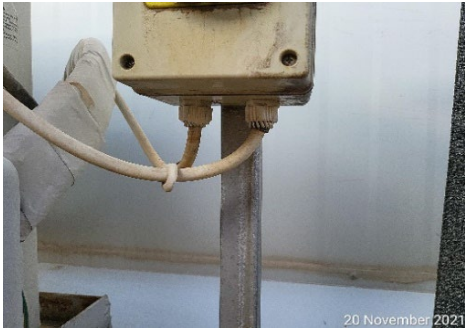
Signed:		
	Inspector Name:		Matthew Stead
	Signed:		
	QC Name:		Brian Thornton
	Signed:		
LHS Deficiencies:			
Deficiency Number:	63	RAC 2	Description of Deficiency Location:

Air-conditioning units 1-9		
	Number of Occurrences		9
	Deficiency Category :		Improper Use / Damaged
	Equipment Category:		WLT
	Imminent Danger?		No
	If 'Yes' : Action Taken:		N/A
	SOR Issued To:		O&M Provider
Description of Deficiency: (or Mitigated State)	The rotary isolators compression glands are showing signs of deterioration.

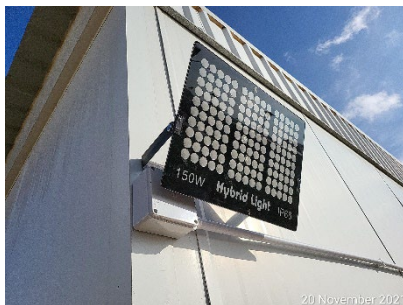
Deficiency Number: 65		RAC 2	Description of Deficiency Location:

Rear wall		
		Number of Occurrences		1
		Deficiency Category :		Unlisted Equipment
		Equipment Category:		WLT
		Imminent Danger?		No
		If 'Yes' : Action Taken:		N/A
		SOR Issued To:		O&M Provider
Description of Deficiency:		The light fixture installed has no visible listings compliant to BS7671		
(or Mitigated State)		regulations. Potentially counterfeit.		
Code Source:		BritishStandard	Deficiency Status: ReInsp-Open	
Code Reference:		511: Compliance with standards		
Deficiency Number: 66		RAC 2	Description of Deficiency Location:

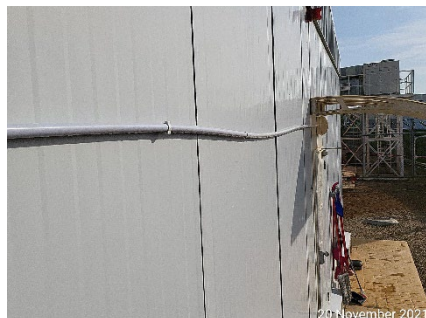
Rear wall.		
		Number of Occurrences		1
		Deficiency Category :		Improper Use / Damaged
		Equipment Category:		WLT
		Imminent Danger?		No
		If 'Yes' : Action Taken:		N/A
		SOR Issued To:		O&M Provider
Description of Deficiency:		The conduit is not fully supported.		
(or Mitigated State)				
Code Source:		BritishStandard	Deficiency Status: Closed / Repaired

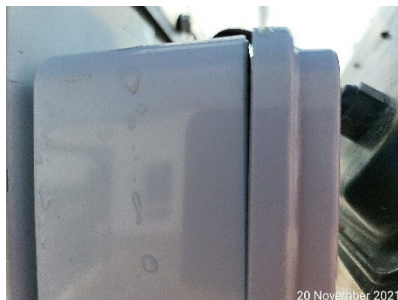
Code Reference:		522: Selection and erection of wiring systems in relation to external influences		
Deficiency Number: 67		RAC 3	Description of Deficiency Location:

Rear wall.		
		Number of Occurrences		1
		Deficiency Category :		Poor Workmanship
		Equipment Category:		WLT
		Imminent Danger?		No
		If 'Yes' : Action Taken:		N/A
		SOR Issued To:		Task Force SAFE
Description of Deficiency:		The IP rated junction boxes lid was not installed correctly. Repaired by TFS.		
(or Mitigated State)				
Code Source:		BritishStandard	Deficiency Status: Closed Previously	
Code Reference:		522: Selection and erection of wiring systems in relation to external influences

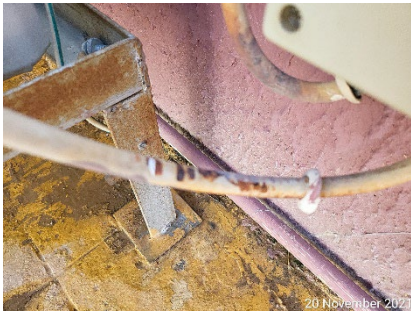
Deficiency Number:	68	RAC 2	Description of Deficiency Location:

Air-conditioning units 1-7		
	Number of Occurrences		7
	Deficiency Category :	Improper Use / Damaged	
	Equipment Category:	WLT	
	Imminent Danger?	No	
	If 'Yes' : Action Taken:	N/A	
SOR Issued To:		O&M Provider	
Description of Deficiency:	The flexible cables feeding the AC units are showing signs of deterioration.		
(or Mitigated State)			
Code Source:	BritishStandard	Deficiency Status:	ReInsp-Open
Code Reference:			
Deficiency Number:	69	RAC 2	Description of Deficiency Location:

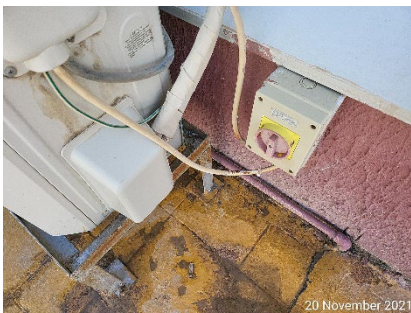
Air-conditioning units 1- 9		
	Number of Occurrences		9
	Deficiency Category :	Improper Use / Damaged	
	Equipment Category:	WLT	
	Imminent Danger?	No	
	If 'Yes' : Action Taken:	N/A	
SOR Issued To:		O&M Provider	
Description of Deficiency:	The flexible cable installed seems to be not listed for outside use.		
(or Mitigated State)			
Code Source:	BritishStandard	Deficiency Status:	ReInsp-Open
