Cross Guns Former Mill Site Bat Assessment To Inform Proposed Development of the Site for Housing

Brian Keeley B.Sc. (Hons) in Zool.

August 2020

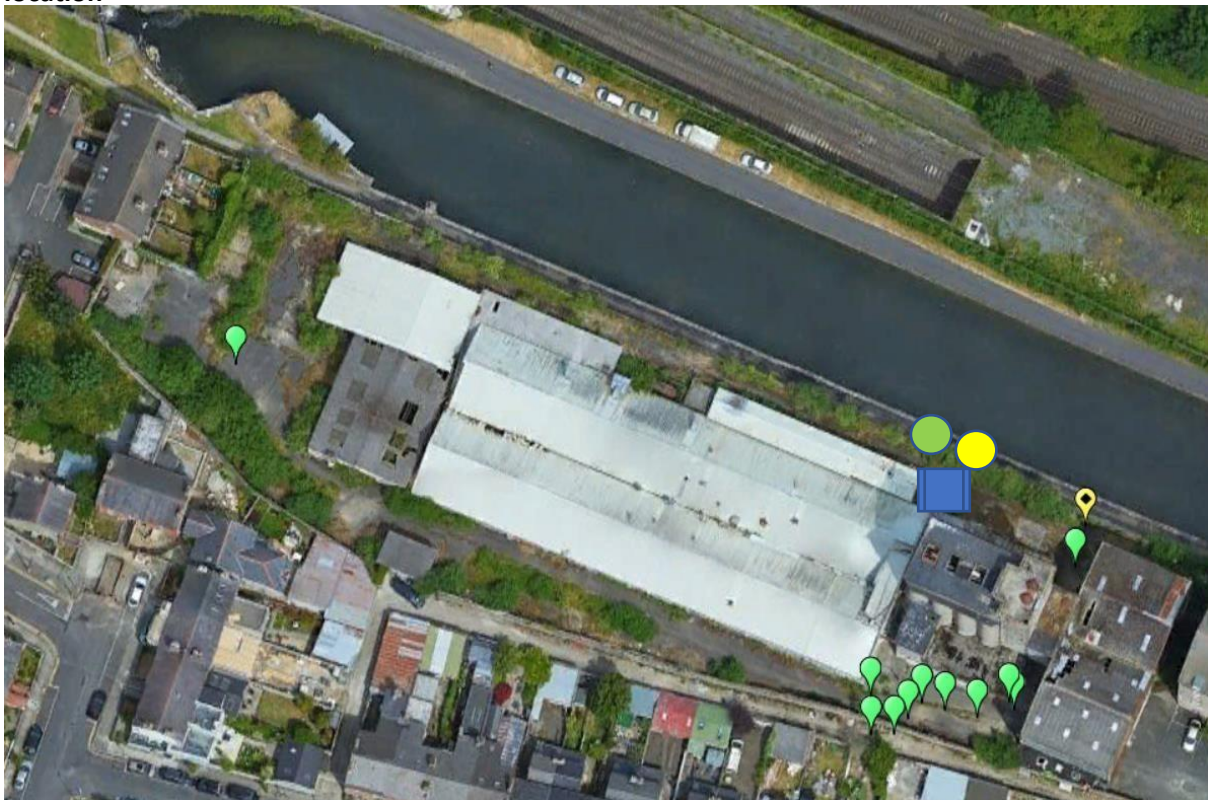
at the Cross Guns site July 2020

Bat activity

Common pipistrelle recorded by Mini

Leisler's bat recorded by Mini
