Sixth Plenary Meeting of UN-GGIM-AP

**Special Session on
Geospatial Information for Disaster Response**

-Case Study on 2016 Kumamoto Earthquake-

**Part 4
Activities for Recovery and Reconstruction**

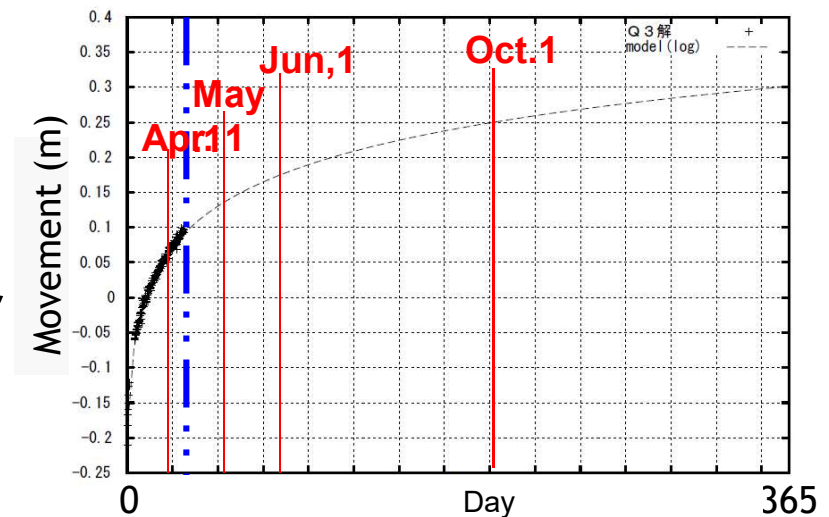
- Early coordinates revision was required for reconstruction work
- But post-seismic surface movement (after-slip) was observed in Kumamoto area
- A stalemate condition
 - If we resurvey too early, survey-error will be inevitable due to further after-slip
 - If we resurvey later, reconstruction work will be delayed

Example of after-slip, CORS “Yamada”, in case of Great East Japan Earthquake in 2011

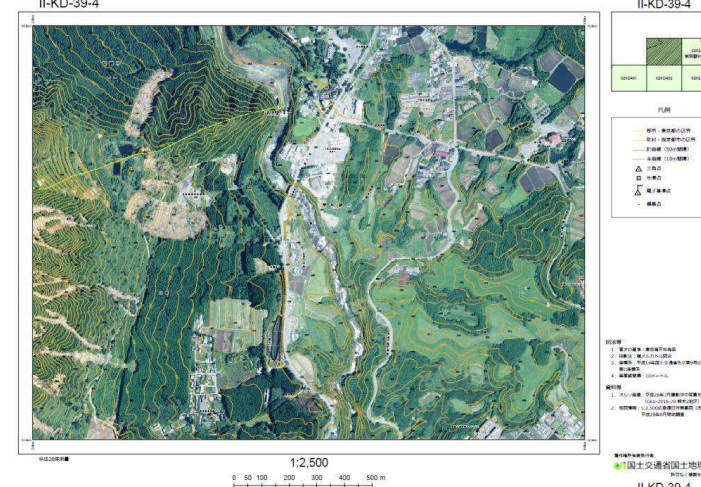
II-KD-39-4

- 30 & 31 May 2016: Air-photo taken.
- July 2016: Simplified preliminary version for municipalities and public organizations
- Sept. 2016: Ortho-photo maps final
- Dec. 2016: Line maps final
- Published maps are also available for the general public

1:2,500 地形图 (地形图)

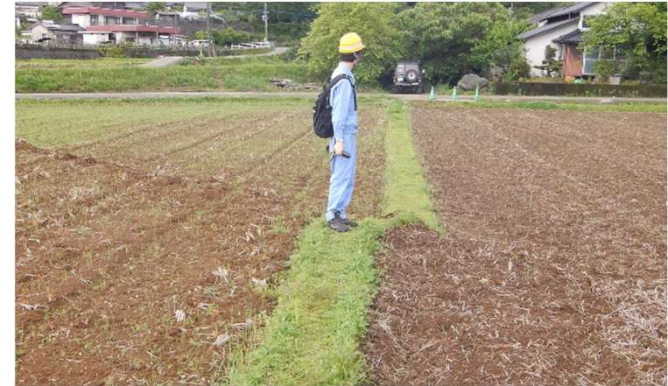
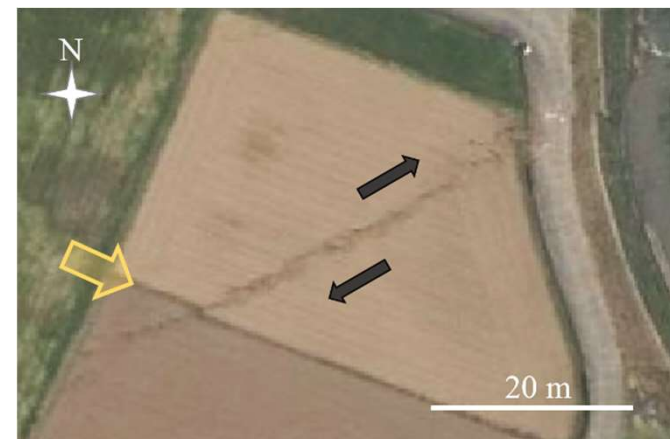
Earthquake fault
appeared on the ground

- Some of the faults were unknown
- GSI decided to revise the active fault maps with an expanded coverage
- Working with researchers, GSI is revising the contents.

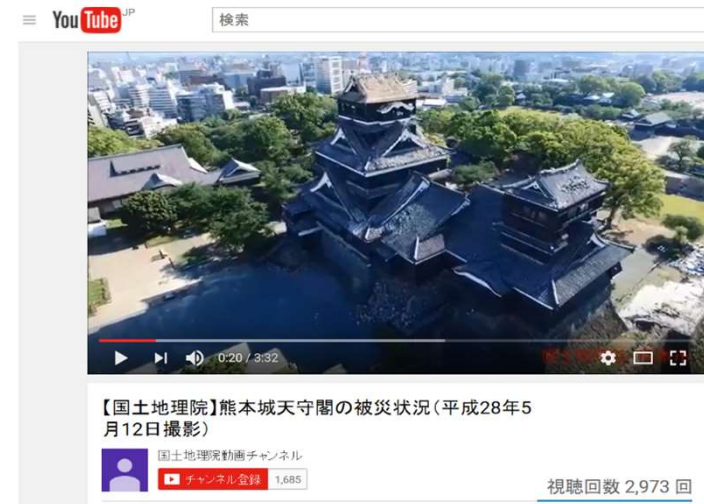
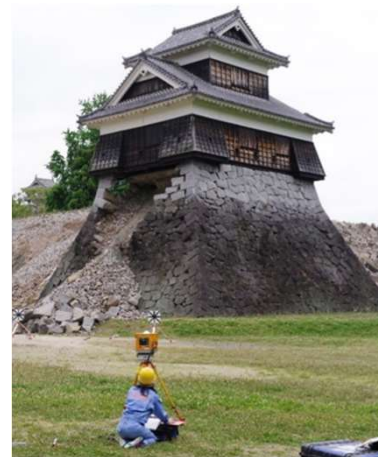
- In May 2016, Kumamoto city asked GSI to develop a 3-D model of collapsed stone walls and damaged parts of Kumamoto castle.
- GSI deployed a UAV team to capture the requested features.
- Also, terrestrial laser survey was conducted.
